**SERVICE BULLETIN**

**APPLICABILITY:** 2020-21MY Legacy and Outback Models      **NUMBER:** 15-261-20R  
**SUBJECT:** Reprogramming File Availability for Optimization of Gen 4 Denso CP1 Infotainment Systems      **DATE:** 03/10/20  
**REVISED:** 07/19/21

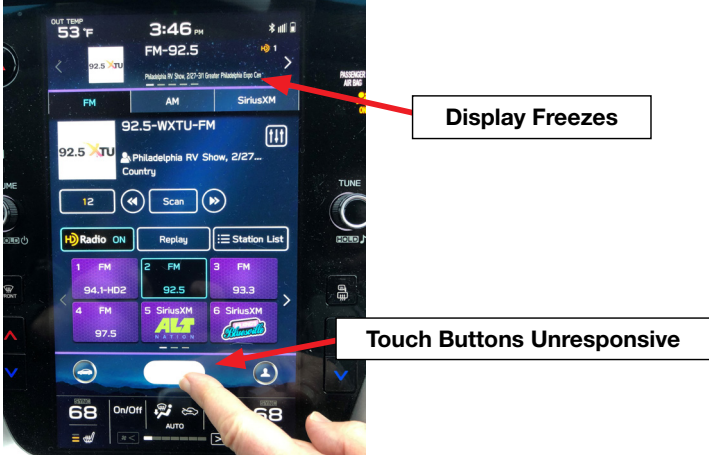
Symptom #	Description of Symptom:
1	<p>The CP1 display and/or center Combination Meter display freezes. No response from touch screen or voice guidance. After switching the ignition off and opening the driver’s door, the system does not recover**.</p>

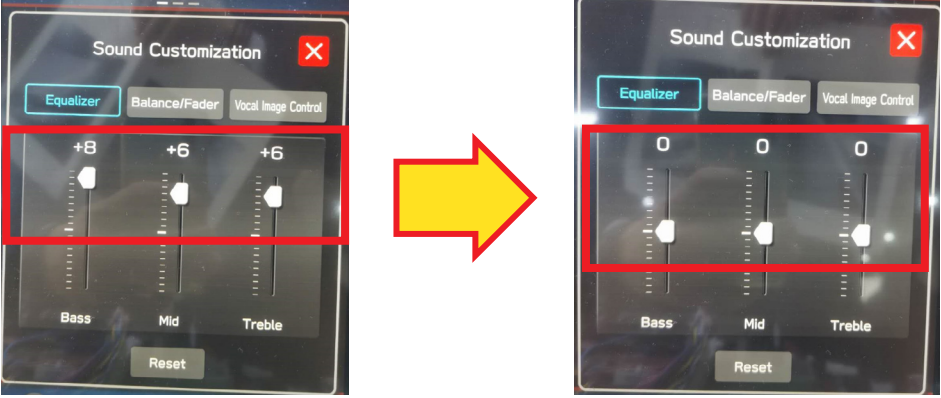
7	<p>Customer-selected Equalizer settings are lost. Equalizer returns to the default settings after ignition switch is turned OFF and back ON.</p>
