SERVICE BULLETIN

APPLICABILITY: 2019-21MY Impreza
 2019-21MY Crosstrek (Including Hybrid Model)
 2019-21MY Forester
 2019MY Legacy/ Outback
 2019-21MY WRX
 2019-20MY BRZ- Navigation -equipped ONLY
 2019-21MY Ascent

NUMBER: 15-236-18R

SUBJECT: Reprogramming File Availability for Optimization of Harman Gen 3.1 and Gen 3.1α Audio and Navigation Head Units

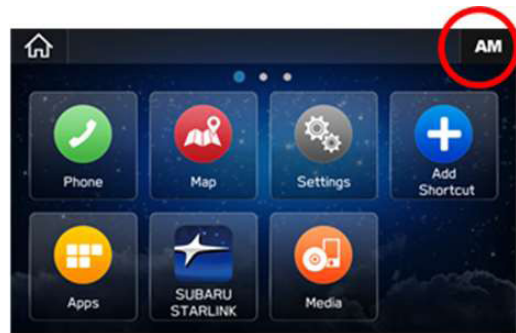
On Ver. 6.0 and before:

Music playing via iPhone in CarPlay.

After disconnecting, the music source changes to Radio automatically.

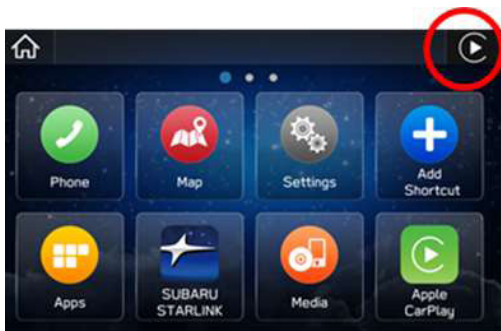
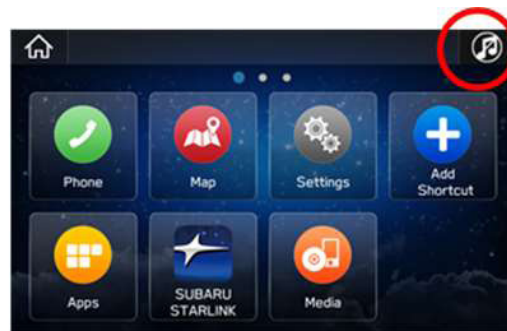
Music playing via iPhone in CarPlay.

After disconnecting, no music source is selected automatically.

If a source of music other than CarPlay has been playing when the iPhone is disconnected, the music source remains same (it is not turned off.)

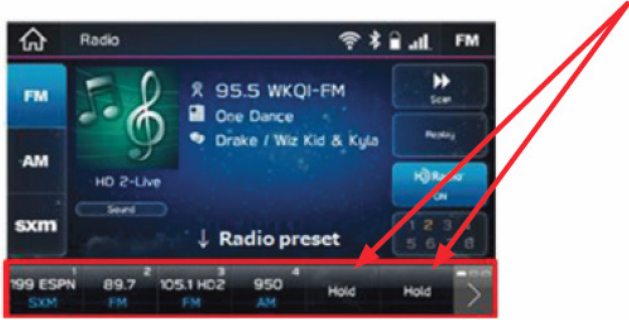
- 1) Station presets are lost. Touch buttons read “Hold”. (Applicable for software versions Rel_4.18.25.50 (or before)). Included in software version Rel_U1.18.38.50.
