## TECHNICAL SERVICE BULLETIN

### 3.5L PowerBoost/3.5L EcoBoost/2.7L EcoBoost - Illuminated MIL With DTC P04F0 And/Or P144C

**21-2280**24 August  
2021

<b>Ford</b>
2018-2021 Expedition
2018-2021 F-150
<b>Lincoln</b>
2018-2021 Navigator

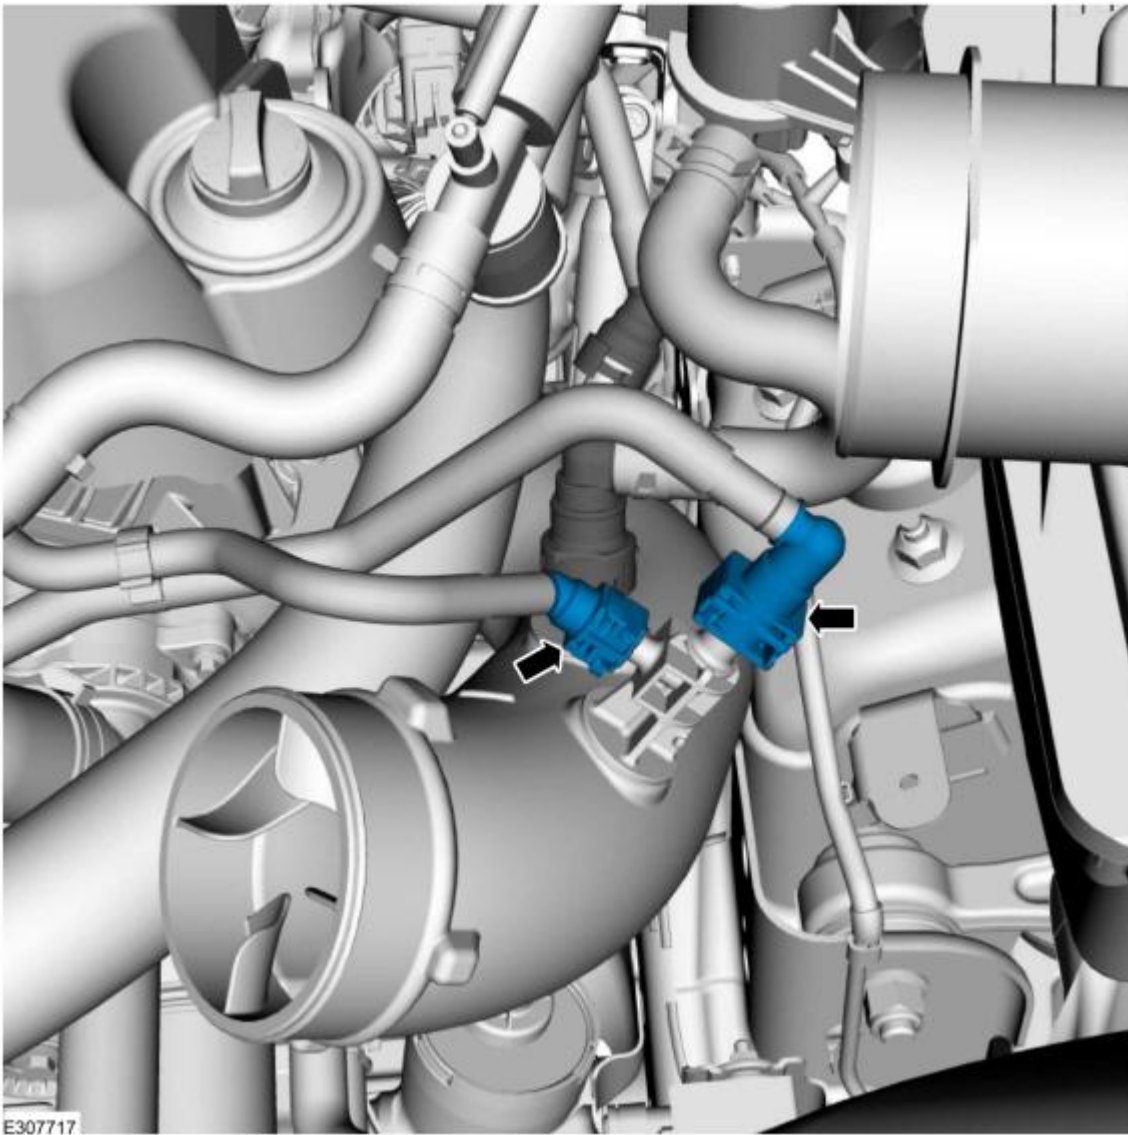
Figure 1 - 3.5L PowerBoost or 3.5L EcoBoost

- Vapor line connections to the vacuum port side and pressure port side of the ejector. Refer to Figure 1 for 3.5L PowerBoost or 3.5L EcoBoost and Figure 2 for 2.7L EcoBoost.

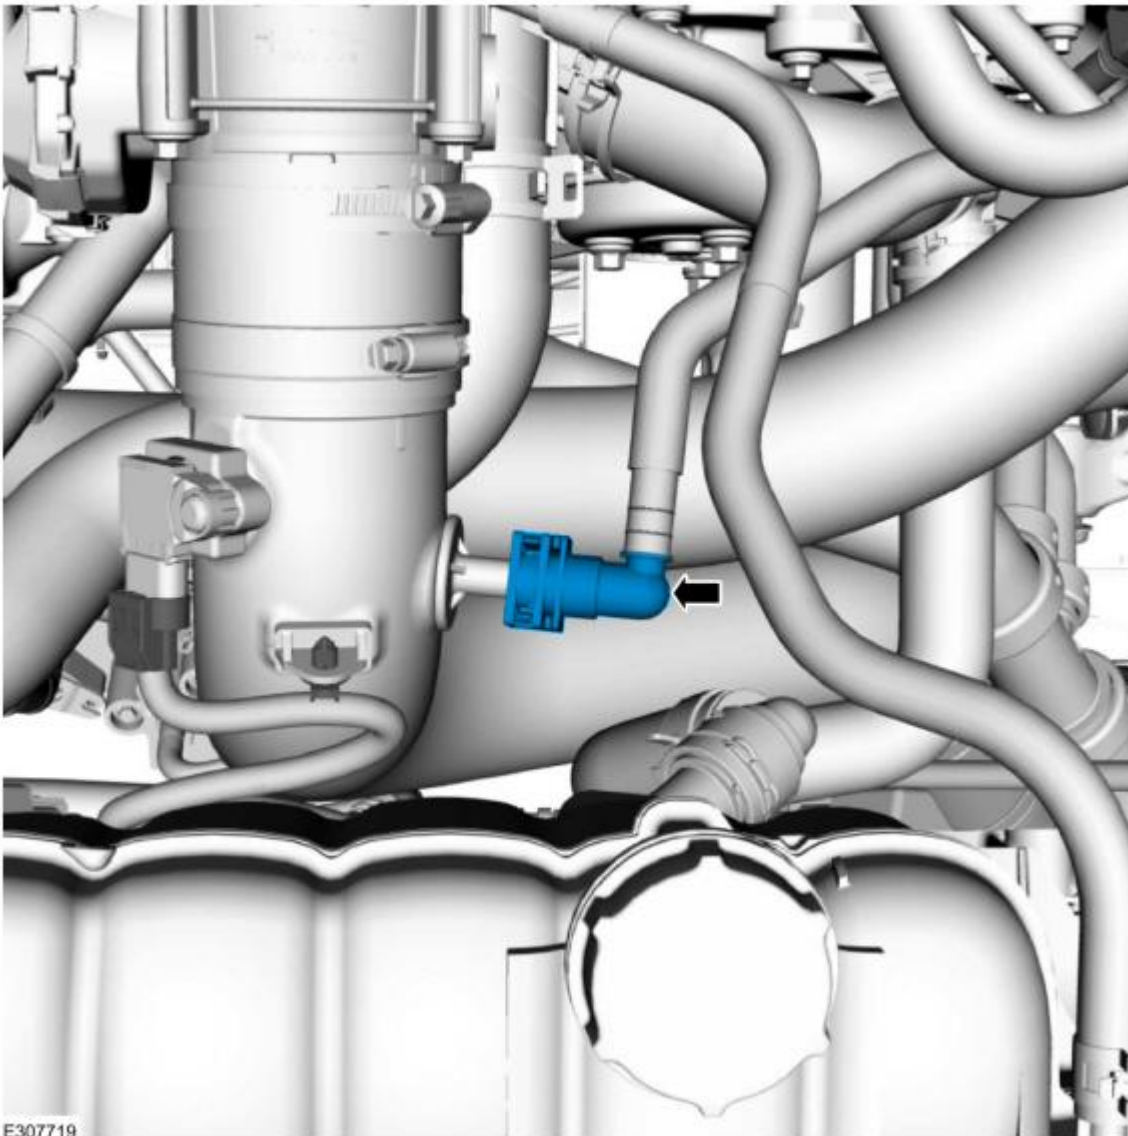
Figure 3 - 3.5L PowerBoost or 3.5L EcoBoost

- Vapor line connection at the port on the air intake system duct at the throttle body inlet. Refer to Figure 3 for 3.5L PowerBoost or 3.5L EcoBoost and Figure 4 for 2.7L EcoBoost.

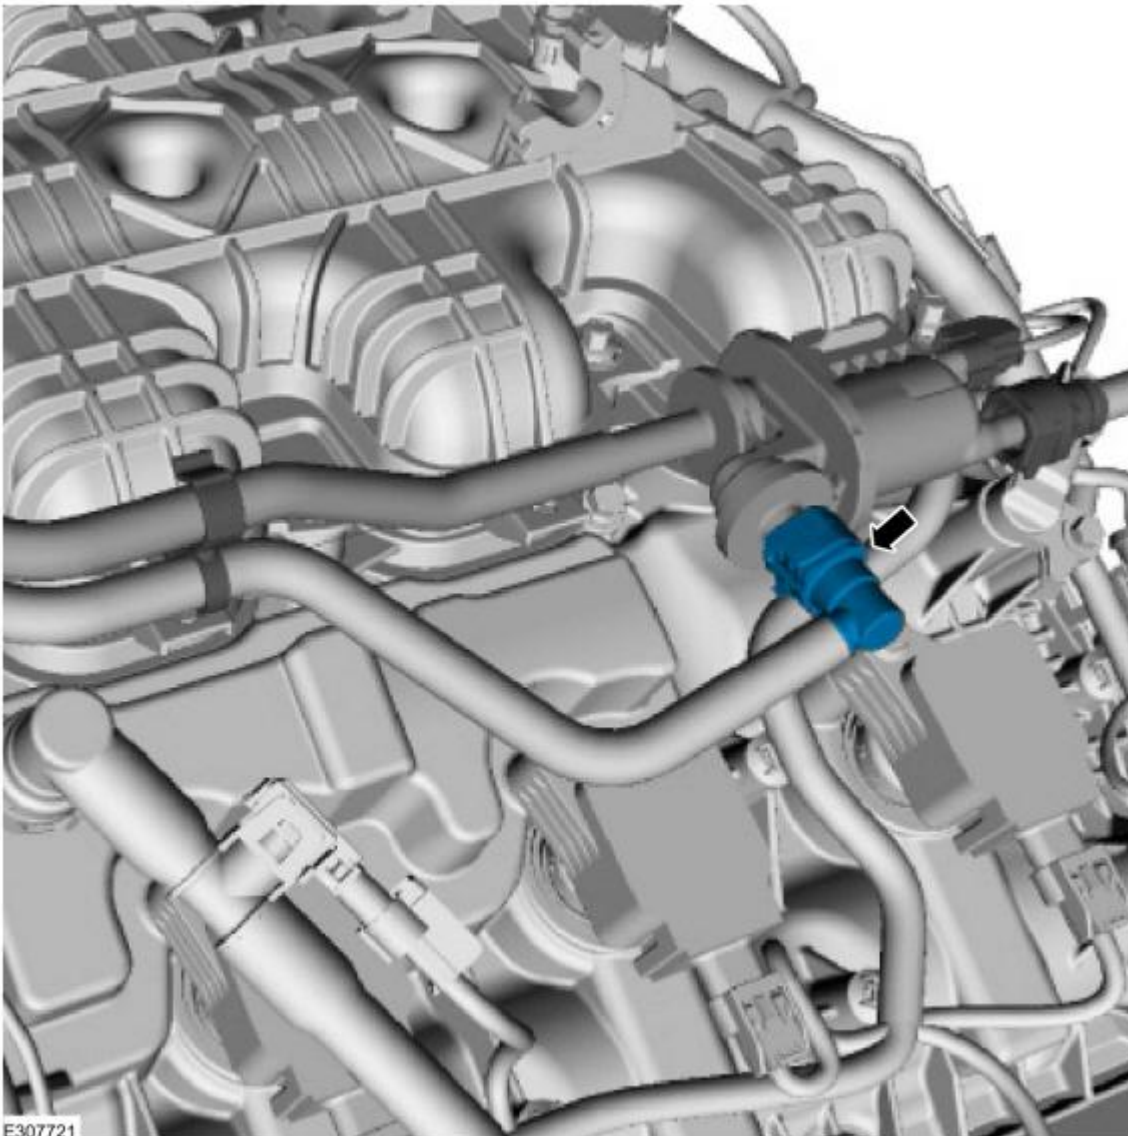
Figure 5 - 3.5L PowerBoost or 3.5L EcoBoost

- Vapor line connection at the vacuum side of the purge valve (side port on the purge valve). Refer to Figure 5 for 3.5L PowerBoost or 3.5L EcoBoost and Figure 6 for 2.7L EcoBoost.
