SERVICE INFORMATION BULLETIN

APPLICABILITY: 2020-2021MY Outback
2019-2021MY Forester
2019-2021MY Ascent

NUMBER: 07-199-21R

SUBJECT: Measurement of Dark Current
(Standby Current Draw)

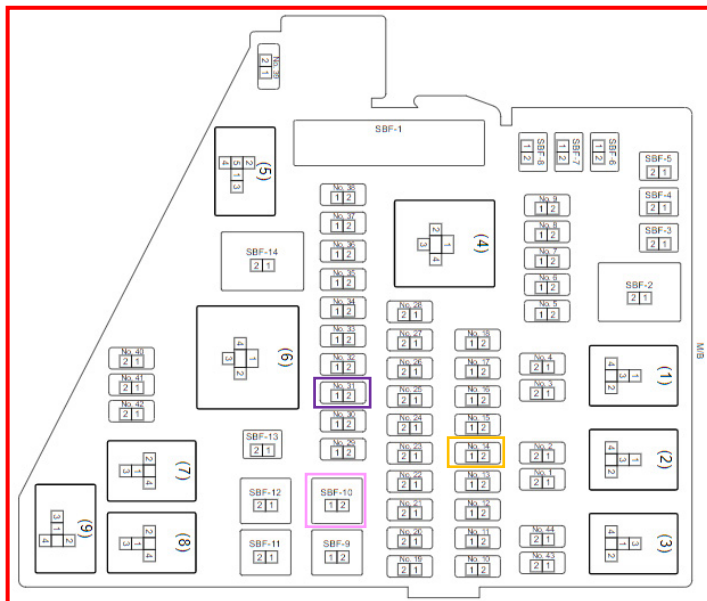
Ascent & Forester

VDC Fuse

Fuse No.31

SBF No.10

Power Rear Gate Fuse

Fuse No.14

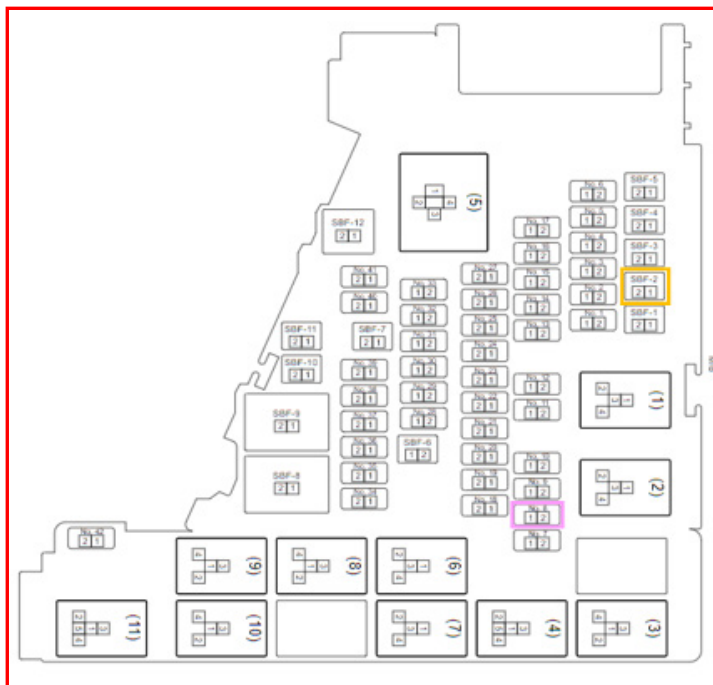
Outback

VDC Fuse

Fuse No.8

Power Rear Gate Fuse

SBF No.2

Fuse No.37

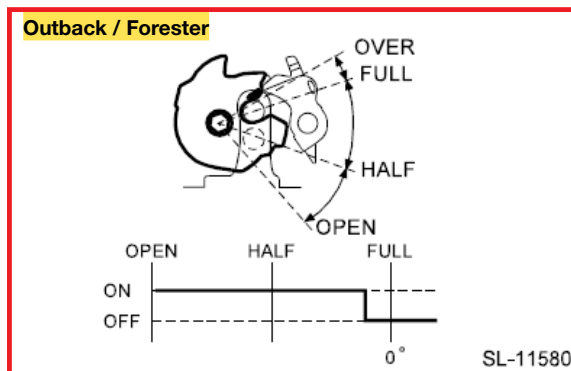
NOTE 5) How to check resistance between terminals for Courtesy Switch.

Terminal No.	Inspection Conditions	Specification
7 to 8	Open	Less Than 1 Ω
7 to 8	Half	Less Than 1 Ω
7 to 8	Full	1MΩ or More

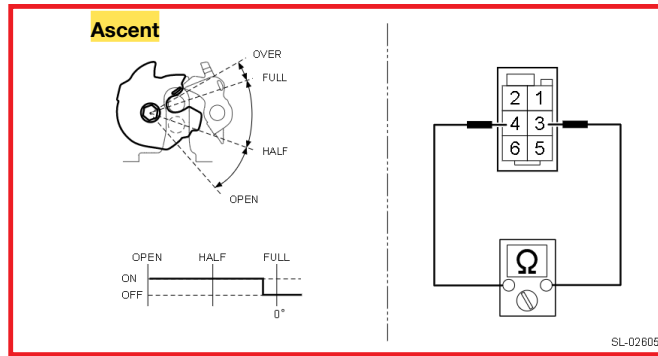
Terminal No.	Inspection Conditions	Specification
5 to 4	Open	Less Than 1 Ω
	Half	Less Than 1 Ω
	Full	10 k Ω or More
