Service Bulletin

Subject: Front Lower Ball Joint and Knuckle Inspection After Road Hazard Tire/Wheel Damage and/or Noise from Front End

Brand:	Model:	Model Year:		VIN:		Engine:	Transmission:
		from	to	from	to		
Chevrolet	Corvette	2014	2016			All	All

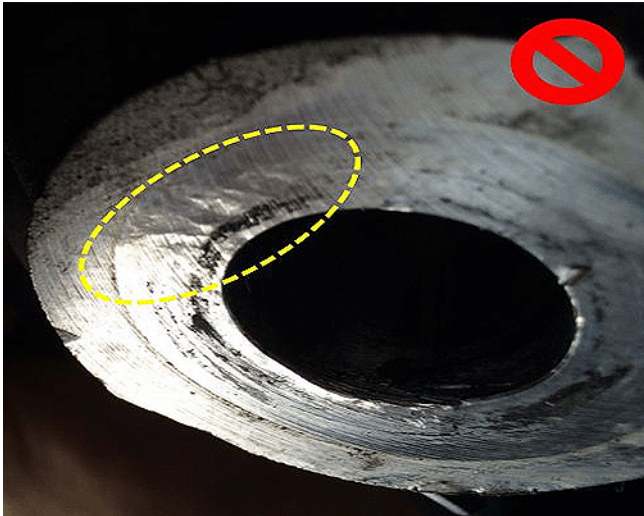
- 4.4. Remove and discard the lower ball joint nut.
- 4.5. Clean the upper and lower boss surfaces with an approved parts cleaner and rag.
- 4.6. Start by visually inspecting the tapered-hole edges on both top and bottom surfaces of the lower boss of the knuckle, looking for evidence of oblong wear/damage.

- If the knuckle shows **NO** evidence of hole elongation, “bubbling” from yielding, or a failed straight edge test, as indicated throughout step 4 above, continue on to step #5 of this inspection procedure.
- If the knuckle **DOES** show evidence of hole elongation, “bubbling” from yielding, or a failed straight edge test, it will be necessary to replace the lower control arm and knuckle. Jump ahead to the Lower Control Arm and Steering Knuckle Replacement procedure in SI.

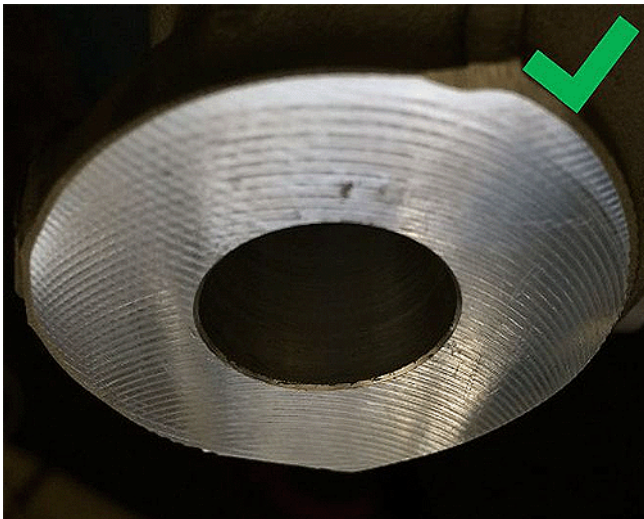
- 4.7. Next, visually inspect the knuckle's machined lower boss face, looking for evidence of material yielding. Yielding will manifest itself visually on this surface as a "bubbling" condition.

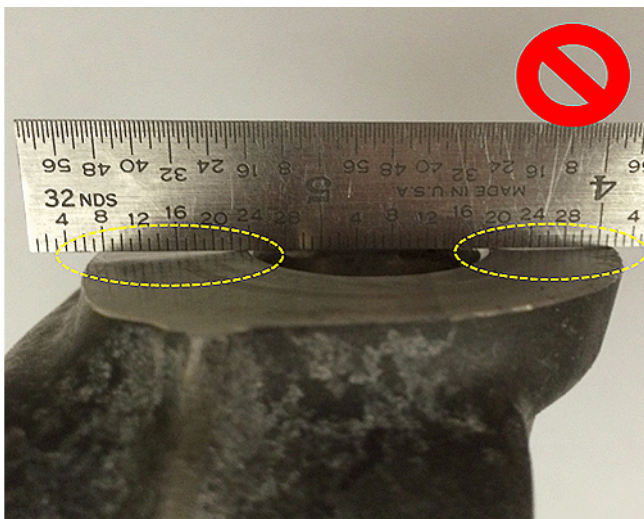
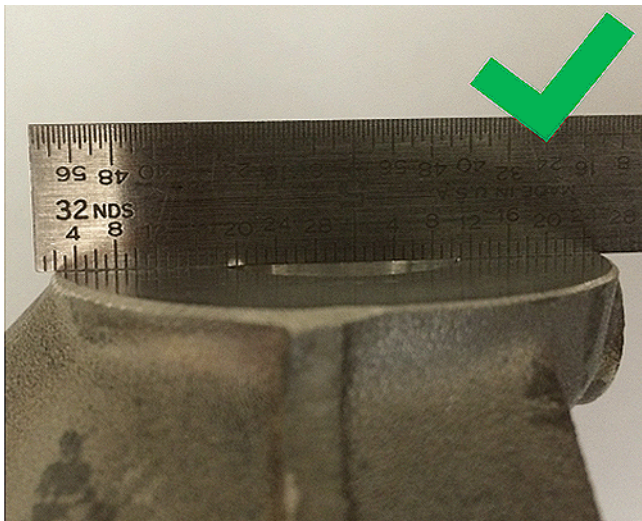
Note: The surface will likely show a uniform pattern of machining marks across the entire face, which should **NOT** be confused with the "bubbling" condition.
