Service Bulletin

Subject: Body Pop or Click Noise at Rear When Driving Over Bumps at Slow Speeds

Brand:	Model:	Model Year:		VIN:		Engine:	Transmission:
		from	to	from	to		
Chevrolet	Malibu	2014	2015			All	All
Chevrolet	Malibu Limited	2016	2016			All	All

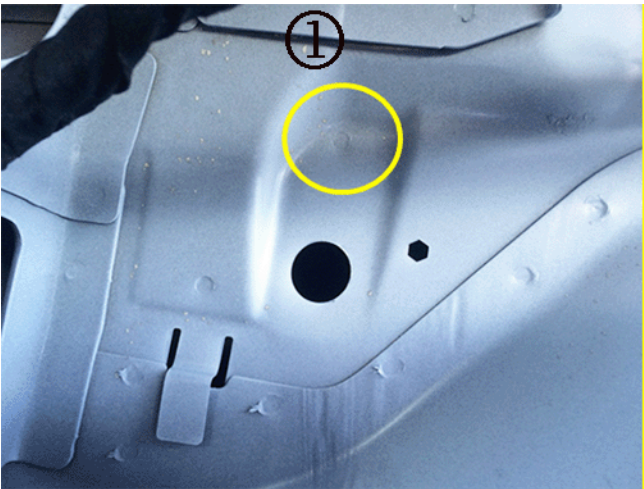
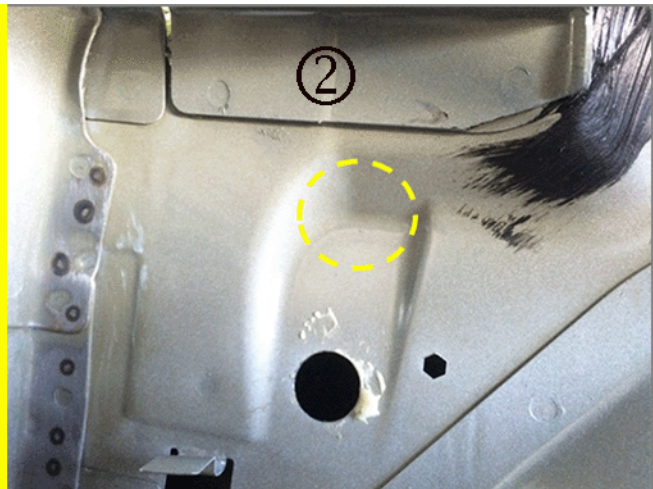
Condition	Some customers may comment that an intermittent pop or click noise is heard when driving over bumps at slower speeds. This noise may be most noticed near the passenger side C-pillar, just behind the rear seatback.
Cause	The cause of the condition may be due to a process weld missing from the passenger side inner body sheet metal. This process weld normally joins the right quarter inner panel brace to the right quarter inner panel to reduce noise between the two panels. The vehicles missing the process weld were specifically found to be Fairfax built vehicles. All vehicle testing and validation were performed without this process weld.
Plant Location	VIN position 11 – F (Fairfax)

3. Inspect the inner sheet metal to verify the missing weld. Examples of a proper weld (1) and missing weld (2) are shown in the graphic above.

For those vehicles missing the weld, a rivet will need to be installed at the location noted in the repair procedure below.
