Service Bulletin

PRELIMINARY INFORMATION

Subject: Difficult to Shift into Gear, Intermittent Gear Pop Out and/or Mushy Shifts (No Grind)

Models: 2014-2015 Chevrolet Corvette
Equipped with 7 Speed Manual Transmission (RPO MEL, MEP, MEK)

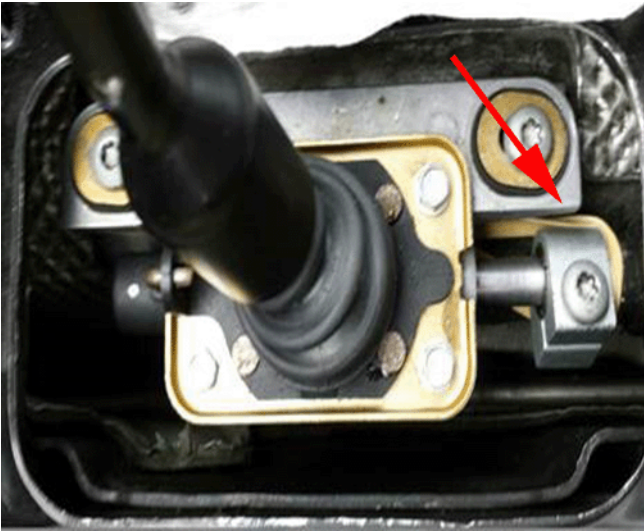
Note: There may be some variation on how and where the rubber band is placed. The above picture shows one possible location.

5. Before performing the shifter adjustment, make sure that the rubber band used to retain the shifter link during assembly is removed.

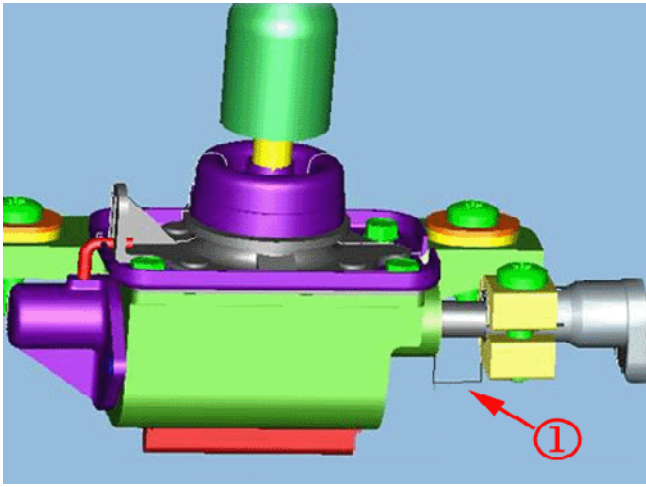
10.4. Inspect for proper alignment in the Neutral position. When the shift rod clamp is properly positioned the bolt will engage the slot/relief in the shift rod and be positioned approximately 15 mm from the shifter assembly as shown above (1).

10.5. Fix if incorrectly aligned by grabbing the linkage and push/pull to the proper gate.
