Bulletin No.: PIP5762A  
Published date: 06/3/2021

### PIP5762A 3.0L LM2 Diesel With Possible Oil Consumption, With or Without DTC P06DD

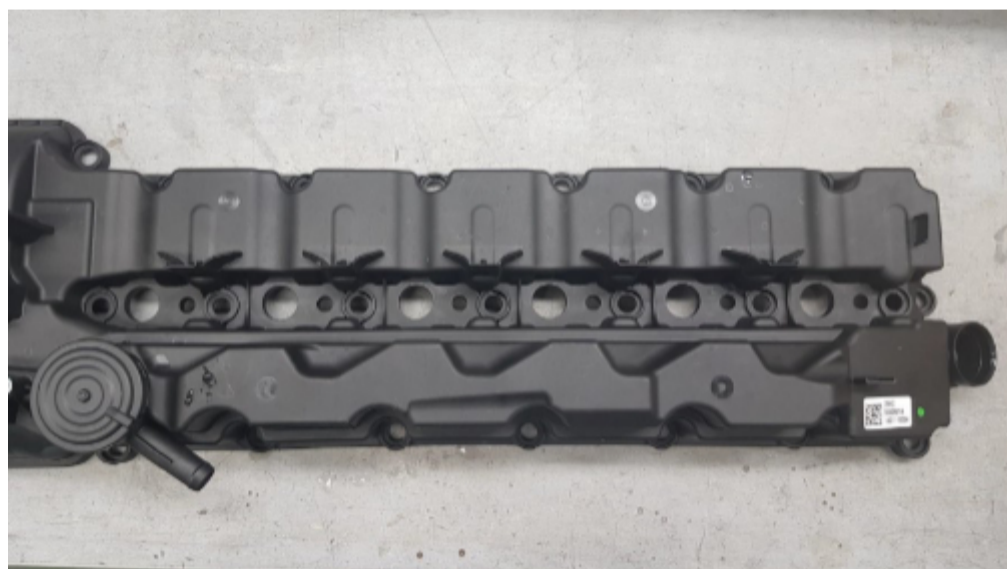
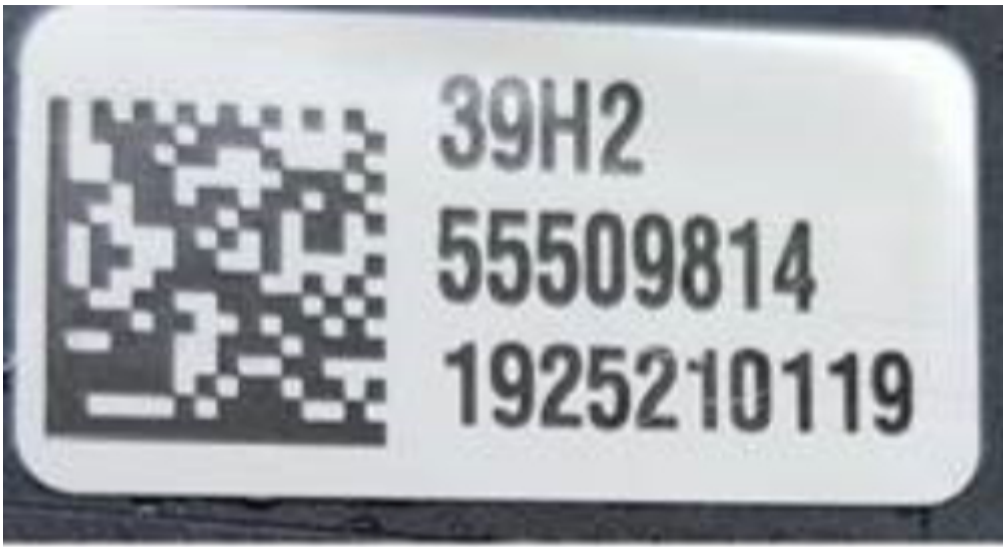
Involved Region or Country	North America
Condition	A customer may have a concern with oil consumption. The technician may find DTC P06DD set.
Cause	Camshaft housing (cover) may have a baffle plate weld that is not adequate.

Inspect the cam cover label for Julian dates and daily progressive number starting from 39H219 249 1 0098 through 39H219 253 1 0037.

If the serial number is from 39H219 249 1 0098 through 39H219 253 1 0037 and the customer's concern is oil consumption:

- 1) Replace the camshaft housing cover.
- 2) Replace the #2 glow plug.
