Bulletin No.: PIC6418B

Preliminary Information

PIC6418B Navigation Loading Message And Navigation Won't Start or Slow to Start When Ignition Is First Turned On

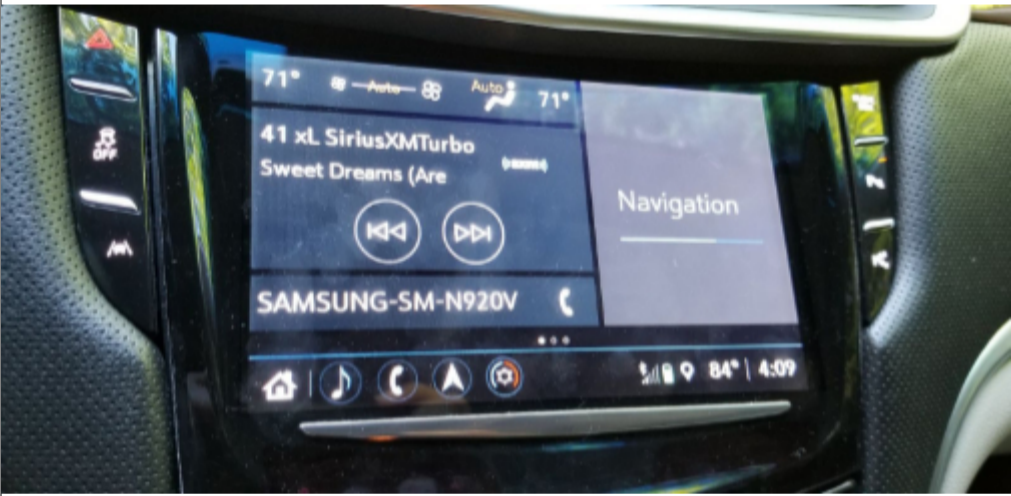
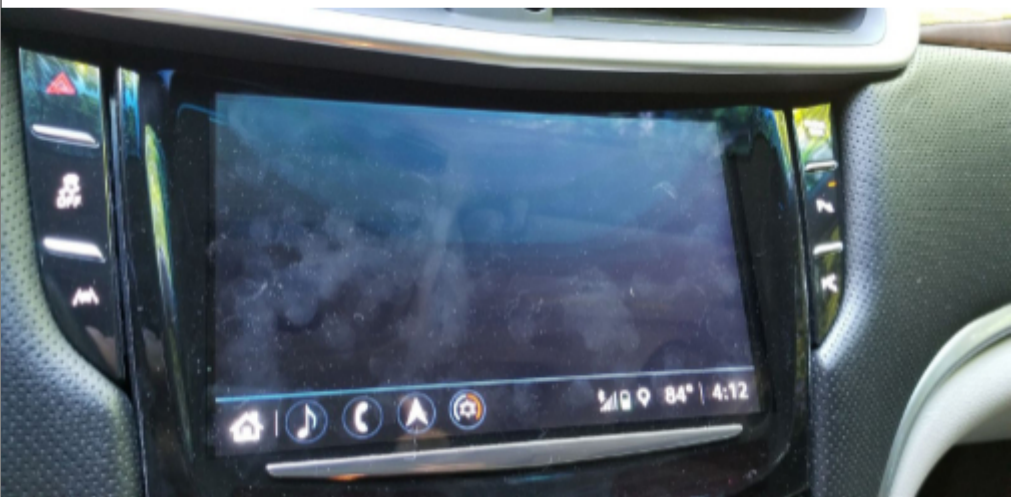
Condition When the vehicle is first started, or when Navigation is first launched, the radio may display Navigation Loading, may show a scrolling circle, or may only show the home bar at the bottom of the display.
