Preliminary Information

PIT5666C Squeak/Creak/Squawk/Itch Type Noise Heard From The I/P or Center Console Area

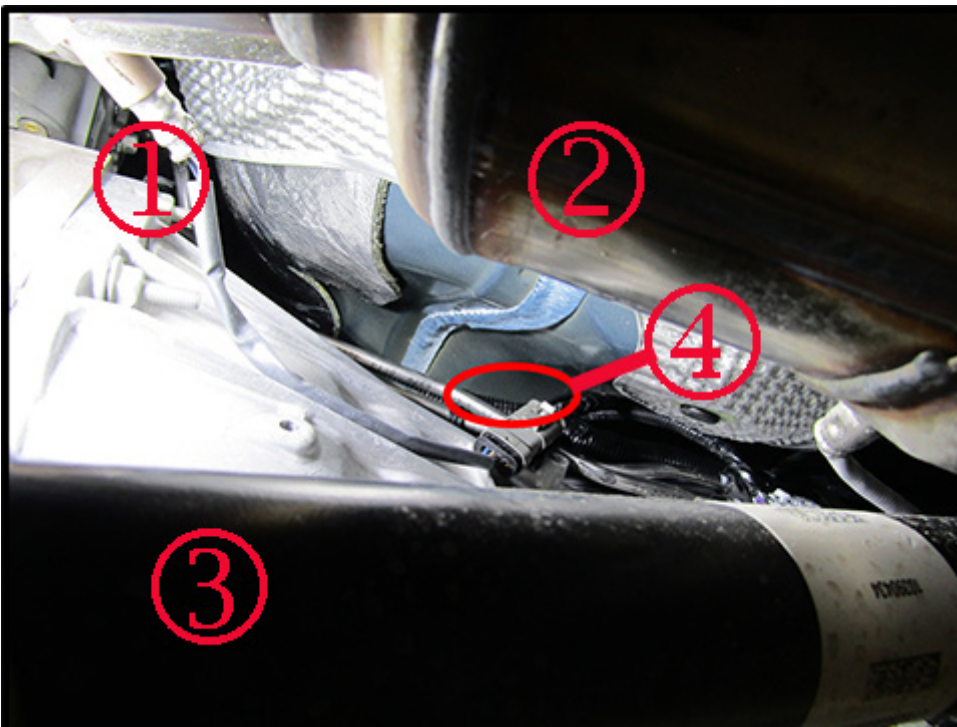
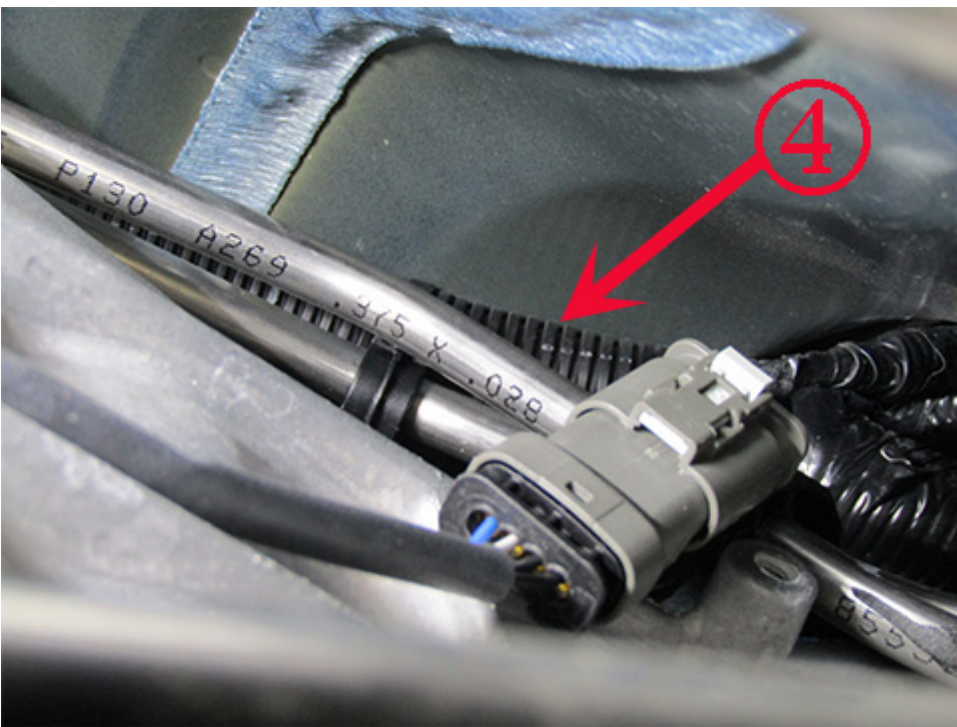
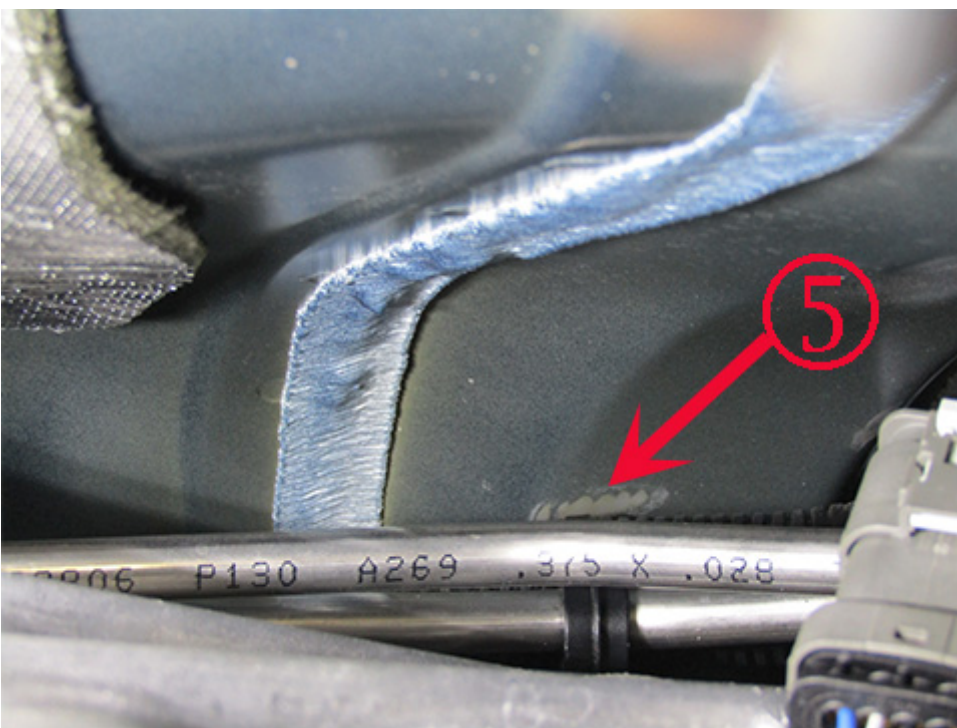
Involved Region or Country	North America
Condition	<p>Note: The Labor Code in this PI should not be used if it wasn't the root cause of the customer's complaint.</p> <p>Some customers may comment of a squeak, creak, itch, or rubber type noise heard from the IP dash or center console area. The noise may be duplicated by the following:</p> <ul style="list-style-type: none"> - Driving over bumps (noise may go away if coasting or if transmission is shifted into "N") - During acceleration - Brake torqueing in drive (noise may not occur when brake torqueing in reverse)
Cause	<p>This noise could be caused by the engine harness rubbing on the floor pan above the transmission (item numbers 4 and 5), as shown below. The photos below were taken from under the vehicle looking up along the driver's side of the transmission bell housing.</p> <p>Callout 1 - Bank 1 Sensor 1 O2 sensor Callout 2 - Bank 1 Catalytic Converter Callout 3 - Front Driveshaft (on 4WD vehicles) Callout 4 - Engine Harness rubbing on floor pan Callout 5 - Engine Harness pushed aside to show the contact on the floor pan</p>

Reposition and secure the engine harness down beside the fuel/evap lines so it no longer contacts the floor pan, as shown below. The rear transmission crossmember may need to be removed so that the transmission can be slightly lowered to gain access to the area. To allow enough slack in the engine harness to reposition it down

beside the fuel/evap lines, it needs to be moved/repositioned forward in the clips at the rear of the harness above the rear of the transmission/transfer case. First, release the rear harness clips and move/reposition the harness forward in the clips, then lock the clips closed. This will create enough slack in the harness to reposition and secure the harness down beside the fuel/evap lines, as shown below.
