Bulletin No.: PIT5689D  
Published date: 06/10/2021

**PIT5689D No Restart after an Auto Stop Event / No Crank / Dead Battery / DTC P0562 P0617 P0621 P0622 P0700 P1005 P26E6 P305D P305E P2796 U010E U0102 U0106 U0284 U0285 U0672 U029D U029E U02A1 U02A3 U0623 U111A U111E U1348 U18DE**

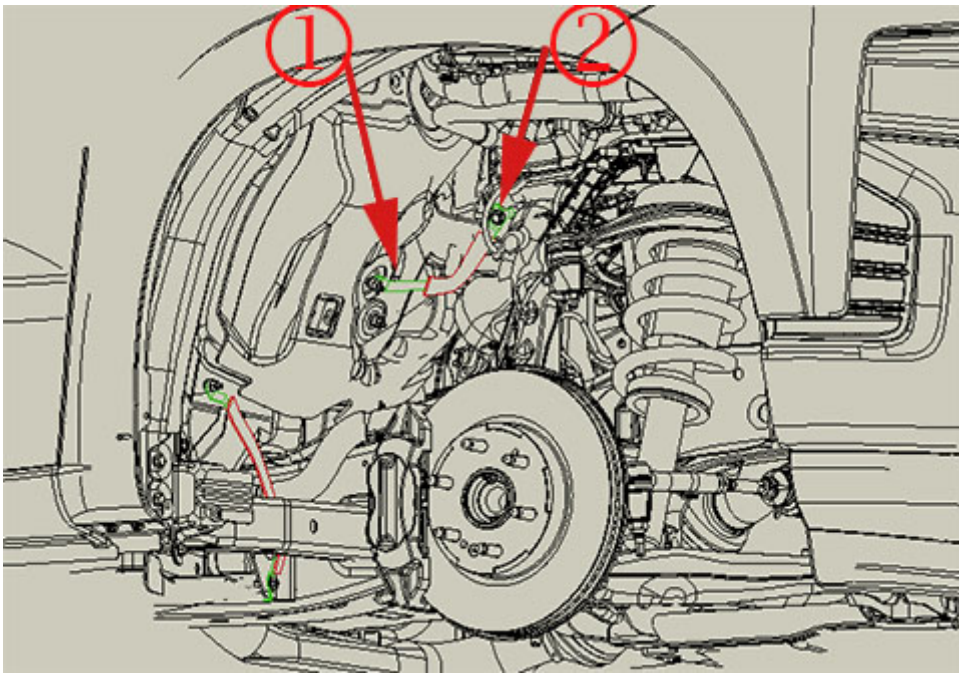
1 - G132  
2 - G134

Involved Region or Country	North America
Condition	<p>Some customers may comment of the following:</p> <ul style="list-style-type: none"> <li>- After an auto-stop event the engine does not restart (if equipped).</li> <li>- No crank (may be intermittent)</li> <li>- Dead Battery</li> <li>- SES MIL with any of the following DTCs: P0562, P0617, P0621 P0622, P0700, P1005, P26E6, P305D, P305E, P2796, U010E, U0102, U0106, U0284, U0285, U0672, U029D, U029E, U02A1, U02A3, U0623, U111A, U111E, U1348, U18DE</li> </ul>
Cause	These concerns could be caused by a broken or loose engine ground cable/strap, which grounds the engine (2) to the body (1), as shown below.

Inspect the engine to body ground cable/strap, G132 and G134. Tighten any loose ground connections or replace any damaged ground cable/strap. Ensure that the ground cable/strap is properly orientated to prevent damage to the ground cable/strap caused by powertrain movement.

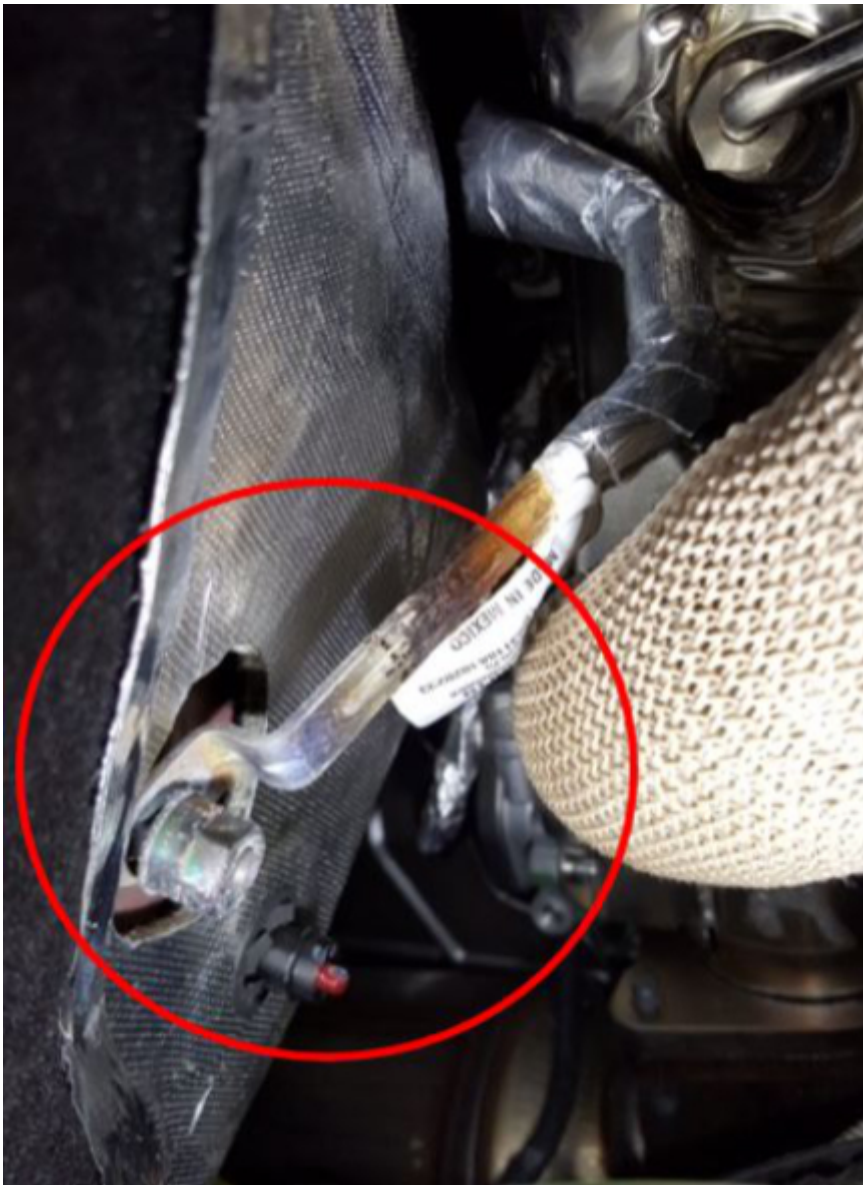
Shown above is ground G132 loose.
