Preliminary Information

PIC6289B Noise from Exhaust Valves

Brand:	Model:	Model Years:	VIN:		Engine:	Transmissions:
			from	to		
Chevrolet	Camaro	2016 - 2021	All	All	LGX, LT1, LT4	All

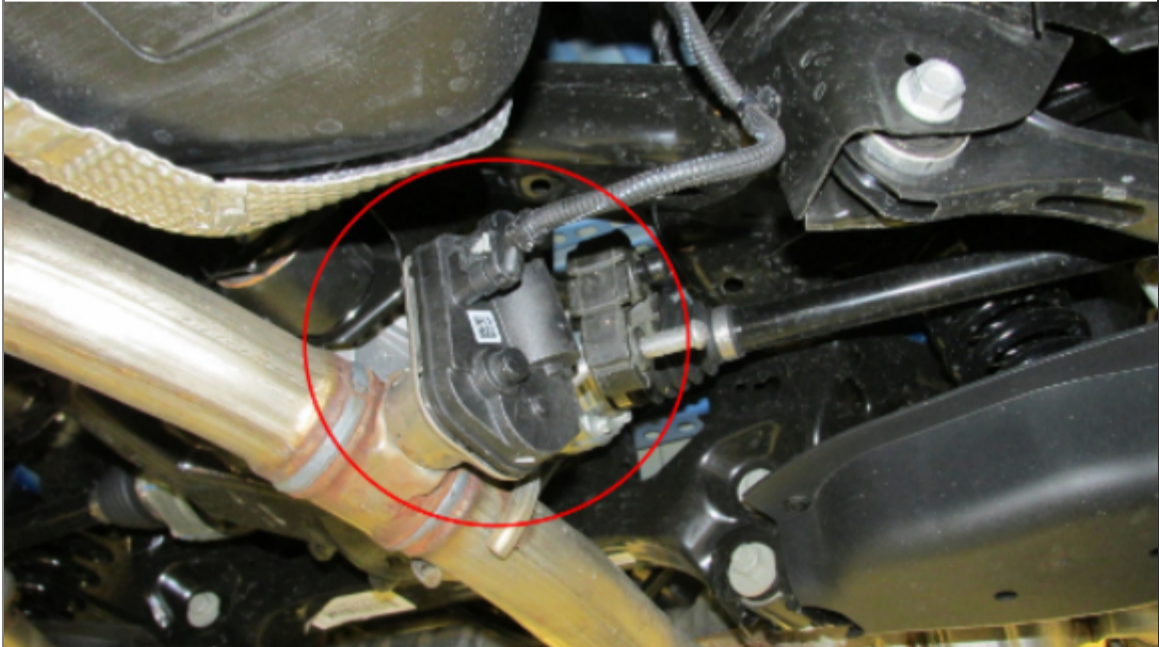
Involved Region or Country	United States, Canada, Mexico, United Kingdom, Sweden
Condition	Some customers may comment on a Check Engine Light (CEL) or an exhaust noise. Upon further inspection, dealership technicians may find a P12FD or a P12F0 set.
Cause	<p>This concern may be caused by an exhaust actuator that was installed but the learn procedure was not completed. This concern will occur on new vehicles with low mileage, or on vehicles that recently had service work done to the exhaust system.</p> <p>Note: This PIC is intended only for electronically controlled exhaust valves. Some vehicles are equipped with Passive Exhaust Valves (PEVs) that are purely mechanical in nature. They are spring operated and they are not able to be externally controlled. Photos of each type of valve can be seen in the two photos below:</p> <p>Electronically Operated Exhaust Valve</p>

Dealership technicians are to relearn the Cylinder Deactivation Valves using GDS2 to resolve this concern. These valves are also referred to as the Active Fuel Management (AFM) valves. They are located before, or in front of, the muffler. Do not replace any parts for this concern.
