Bulletin No.: PIP5806A

PIP5806A Intermittent Extended Crank No Start And A Possible DTC P0341 Set

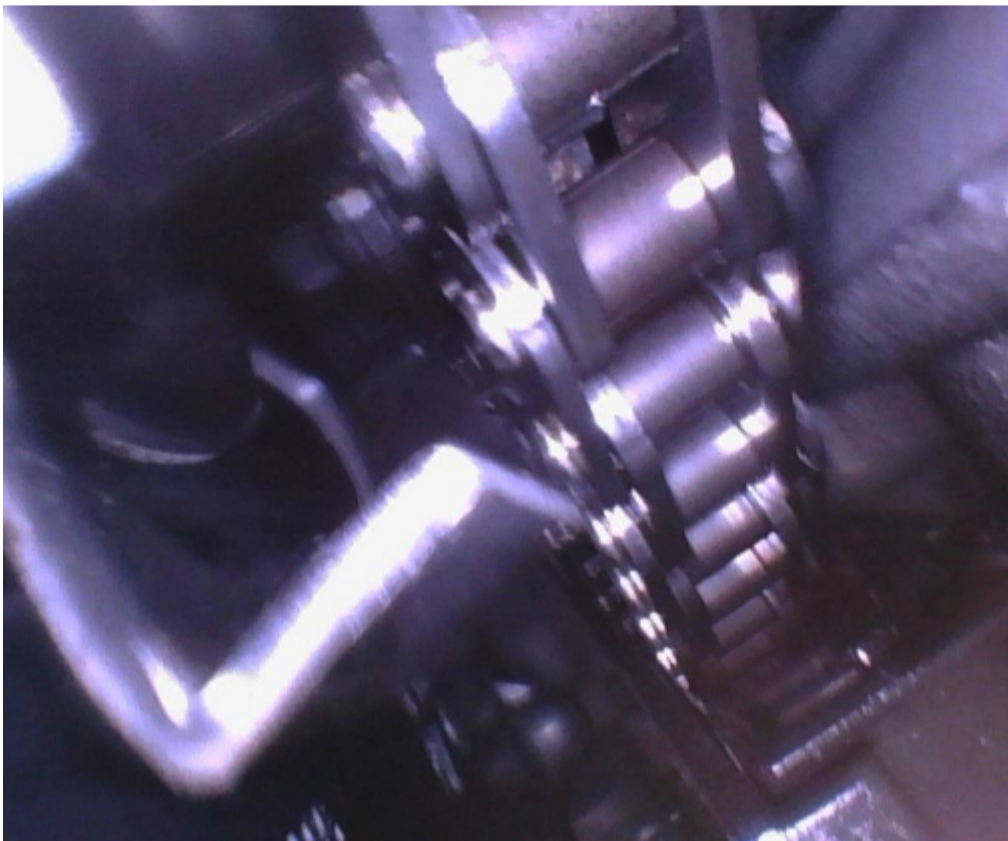
Involved Region or Country:	North America
Condition:	Some customers may experience an intermittent extended crank or intermittent crank/no start, and may find DTC P0341 set.
Cause:	This may be due to a bent trigger wheel on the camshaft.

Above is a bent trigger wheel. It may or may not make contact with the timing chain.

If you find the cam sensor trigger wheel bent, replace it.
