Bulletin No.: PIP5806B

PIP5806B Intermittent Extended Crank No Start And A Possible DTC P0341 Set

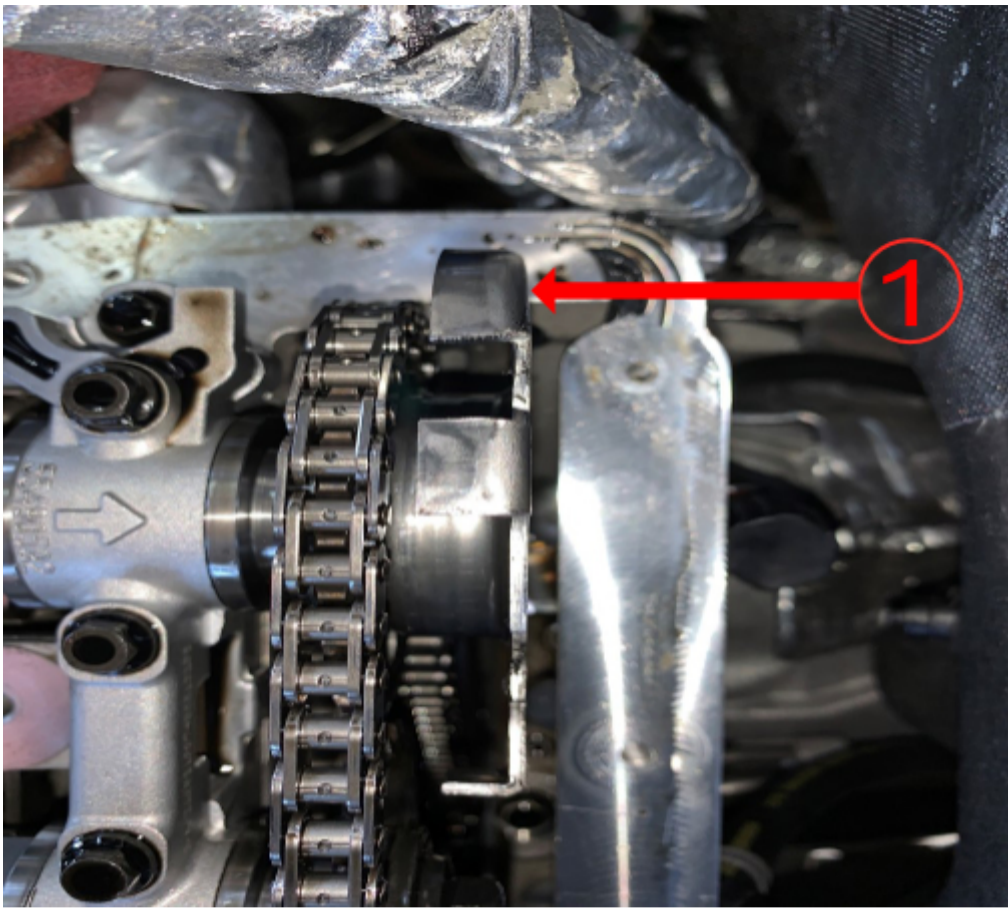
1. Camshaft Position Reluctor Wheel
