Preliminary Information

PIP5794B Diagnostic Tips For Engine Related Shudder / Surge Concerns

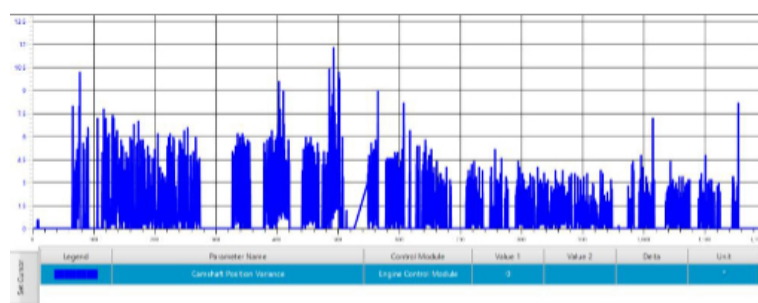
Any variance exceeding 3-4 degrees could potentially cause a noticeable shudder / surge concern.

Fault in camshaft actuator system (variance over 4 degrees):

If the concern has been isolated to the camshaft actuator system, it is recommended to replace the camshaft actuator magnet and re-evaluate.

If the shudder / surge is still present after camshaft actuator magnet replacement and camshaft actuator variance is over 4 degrees, refer to GM Service Information or GM TAC for further assistance with diagnosis.
