Preliminary Information

PIT5245D HVAC Blower Motor Is Noisy Or Vibrates

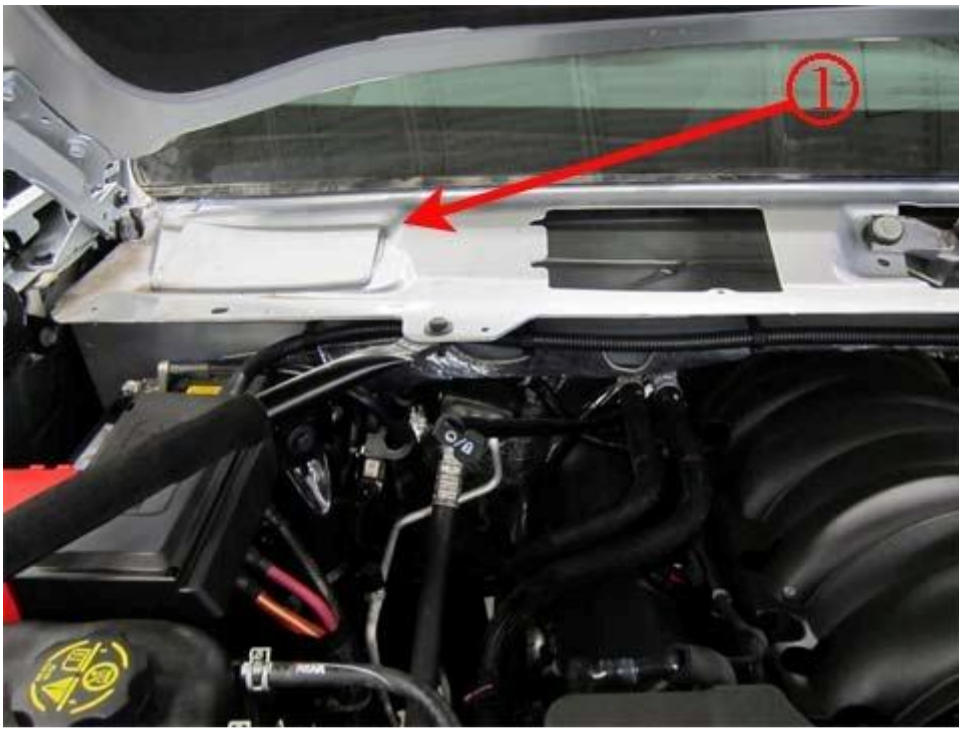
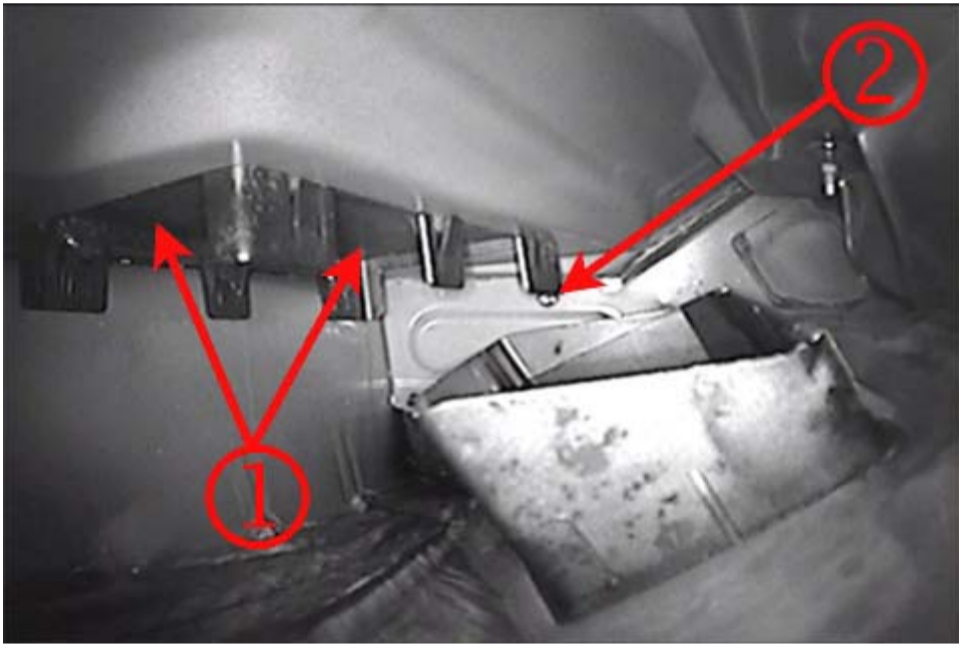
Some owners may comment that when the HVAC blower motor is running, it is noisy or may vibrate.

This concern will only occur when temperatures are below 32 deg F (0 deg C). If the blower motor is removed while it is still cold, ice may be found on the blower motor cage.

If the cabin air filter is removed while still cold, snow and/or ice may be found on the filter. This concern could be caused by either a water leak into the HVAC case or snow ingestion into the HVAC case.

1. Perform normal water testing diagnostics while the HVAC is running (high blower and in fresh/outside air mode). Inspect for any water leaking past the plenum cover cap, as shown below (1). Water could drip off the bottom of the plenum cover cap (1) into the HVAC fresh air inlet, as shown below (2).

2. If water is leaking past the plenum cover cap (1) it will need to be removed and resealed. While the plenum cover cap is removed also complete the next steps to add a low pressure drop fine snow resistant screen over the fresh air inlet to prevent snow ingestion.
