Preliminary Information

PIC6445 Carpet Appearance Near the Center Console Area

Brand:	Model:	Model Years:	VIN:		Engine:	Transmissions:
			from	to		
Chevrolet	Corvette Stingray	2020 - 2021	All	All	All	All

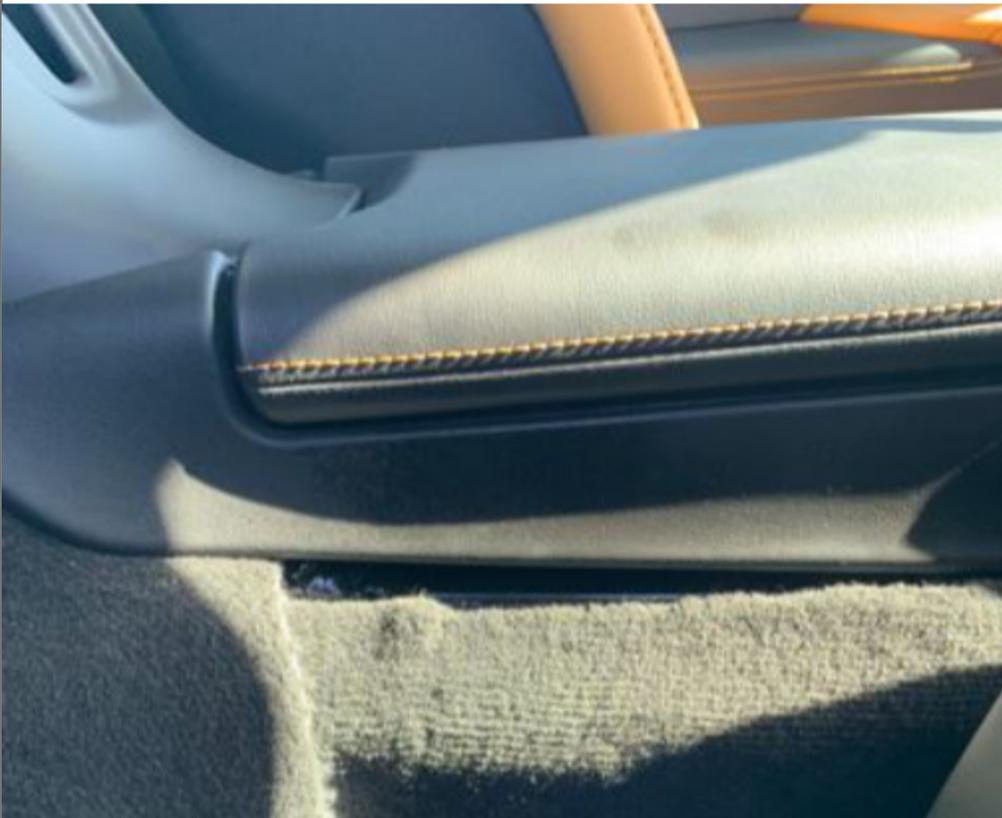
Involved Region or Country	North America and Export Regions
Condition	<p>Some technicians or customers may comment on the fact that there is a noticeable gap, or it appears that the carpeting has been cut too short to be completely covered by the trim on the center console. A visible edge of the carpeting may be noticed on either side of the console. This will typically be noticed during PDI (Pre-Delivery Inspection) of the vehicle. This concern can be seen in the photo below:</p>

Concern	<p>This issue may be caused by improper carpet installation when the vehicle was assembled. During the installation of the front seat(s), the carpeting may become pinched under the seat track and this will cause the carpet to be pulled down around the center console area. This will give the appearance of a gap, or that the carpeting has been cut too short.</p>

Correction: If you have a vehicle that exhibits this concern, do NOT replace the carpeting. As a first step, pull upwards on the edge of the carpeting that exhibits this condition. Although the carpeting may have to be pulled quite forcefully, once it "pops" out from underneath the seat track, it will provide enough slack so that the carpeting can be fully and correctly inserted underneath the center console trim. In most cases this should be able to be accomplished without the need to remove the seat from the vehicle. In certain rare exceptions, the seat may need to be unbolted in order to allow the carpeting to be freed from it's trapped position under the seat track.
