**SERVICE BULLETIN**

**APPLICABILITY:** 2019-21 MY Ascent  
**SUBJECT:** Brake Pad Design Change

**NUMBER:** 06-78-20R  
**DATE:** 08/18/20  
**REVISED:** 09/02/21

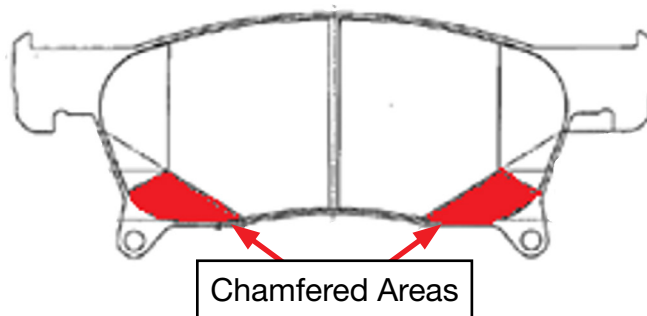
This Bulletin announces availability of new front brake pad kit established to address concerns of a squeaking sound heard when coming to a stop and / or a pulsation (judder) heard and felt during braking. Strong pressure on the outside brake pad causes a stick / slip condition which can create the sound condition. When the brake pads and rotor are both new, the brake friction is uneven and varies between the pads and the rotor. Under this condition, a contact vibration occurs at the edge of the brake pads, resulting in the squeak sound. A chamfer has been added to the edges of the front brake pads shown in red on the illustration below. The new kit contains a packet of special brake grease developed to work in conjunction with these new brake pads to prevent the contact vibration and resulting squeak sound.
