## SERVICE INFORMATION BULLETIN

**APPLICABILITY:** 2020MY-**2022**MY Legacy & Outback

**SUBJECT:** Denso CP1 BASE (Dual 7" Display Screen)  
Erratic Operation

**NUMBER:** 15-273-20

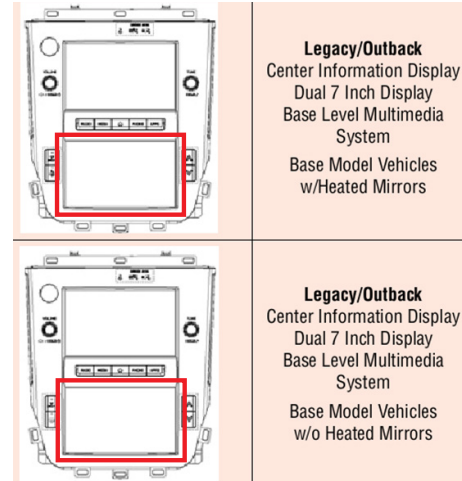
This Service Information Bulletin addresses isolated customer concerns regarding the pictured CP1 BASE Model Center Information Display (CID) LOWER 7-inch display screen flashing, not responding to touch inputs and / or shutting off intermittently.

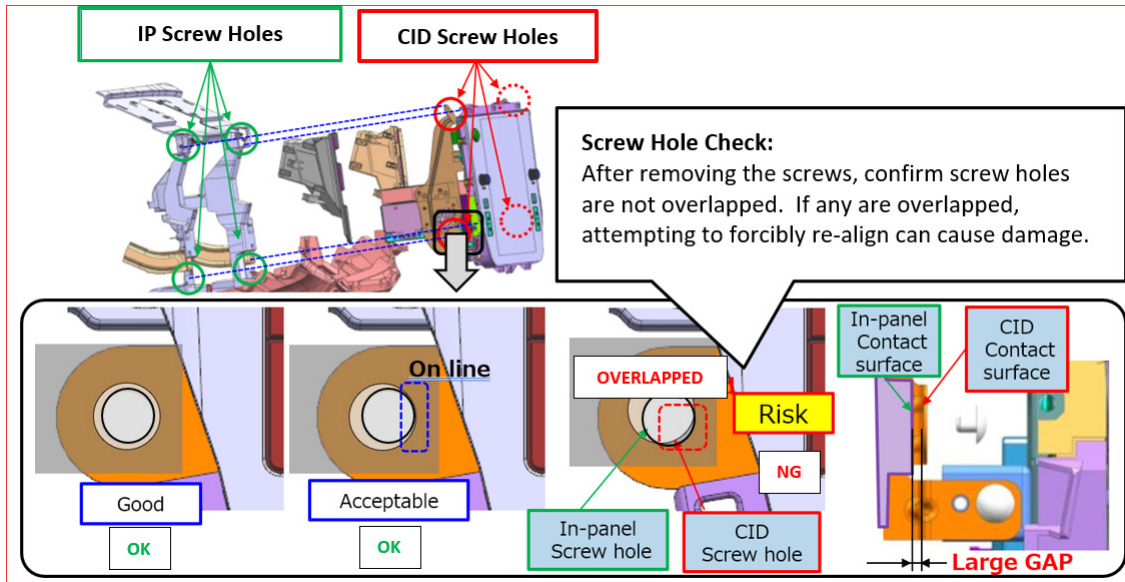
**Step 4: Check condition of the retaining screw holes and contact surfaces between the instrument panel (IP) and CID after removing the screws.**

- Inspect the screw holes of the IP and the bracket following the illustrations below. If the screw hole(s) are overlapped, **CAREFULLY** re-align to Acceptable or “**OK**” as shown below.
- Inspect the gap between contact surfaces of the IP and the bracket following the illustration below. If a gap exists between the two contact surfaces, **CAREFULLY** adjust the seating / alignment by changing the tightening order of the retaining screws.

**TIP:** If there is too much mis-alignment, **CAREFULLY** loosen the other three screws, let things settle, then try tightening them again in a different order to see if the alignment improves before installing the final screw or, loosen them all, let things settle then tighten again but in stages so any one hole is not too far offset (beyond **OK**).

- **If YES:** The condition persists, replace the CID.
- **If NO:** The condition no longer persists. Operate the unit for an extended period to confirm a successful repair.
