Bulletin No.: PIP5680D  
Published date: 09/7/2021

### PIP5680D Excessive Oil Smoke From the Exhaust On Cold Start

Brand:	Model:	Model Years:	VIN:		Engine:	Transmissions:
			from	to		
Cadillac	ATS	2016	All	All	3.6L LF4	All

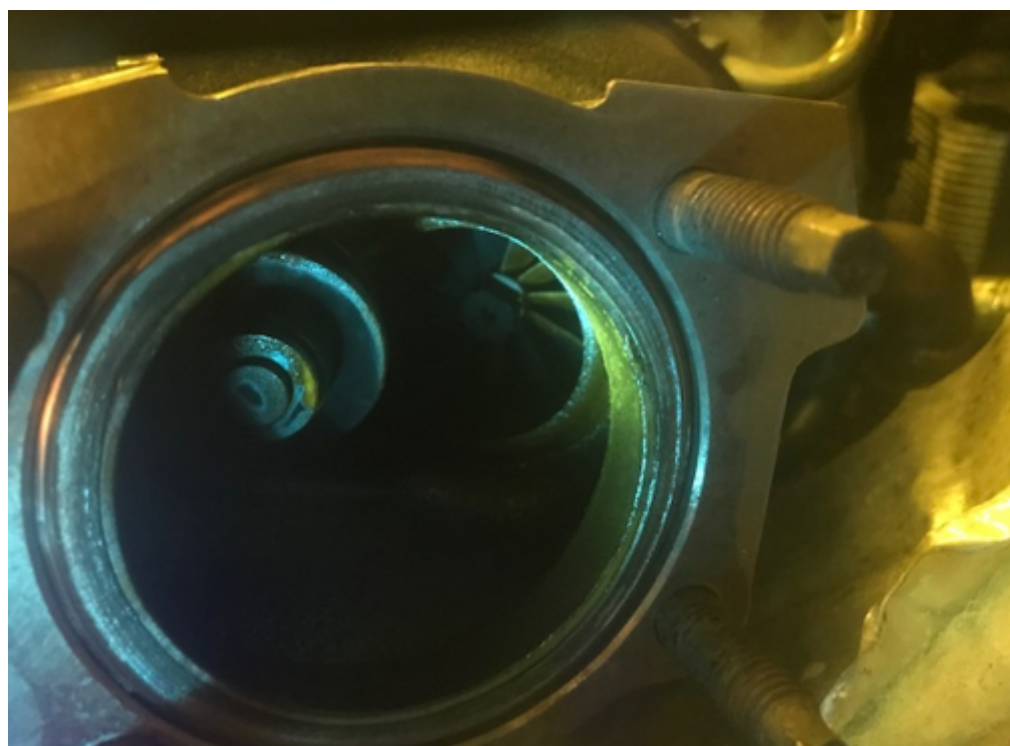
To check for this concern first inspect the outlet of the turbochargers for the presence of oil with dye in the system. (See below)

If oil is found at the outlet of the turbocharger on either side, then replace the turbocharger, drive to clean out the exhaust and then let sit to get cold and reevaluate.
