# Preliminary Information

## PIT5847B SES Light - Reduced Power - DIC Warning Messages - Reduced Steering Message - Stabilitrack Message

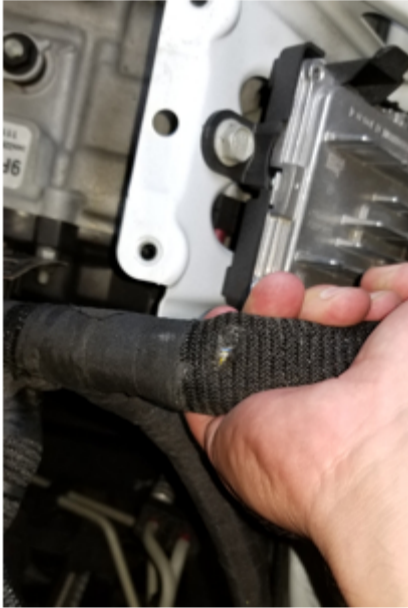
Harness may chafe in the areas shown in the photos above and below.

Above shows a harness that was chaffed by the bracket.

If damage is found repair any damaged circuits and tape up the harness.

Reroute or properly secure the harness to prevent further damage.

It may also be necessary to install a piece of heater hose, conduit or both over the harness to prevent a reoccurrence of the concern.
