Preliminary Information

PIP5812B Diagnostic Tip: Potential For Oil/Moisture Condensate Freezing Up in Turbocharger Wastegate Regulator Solenoid Valve (TCV)

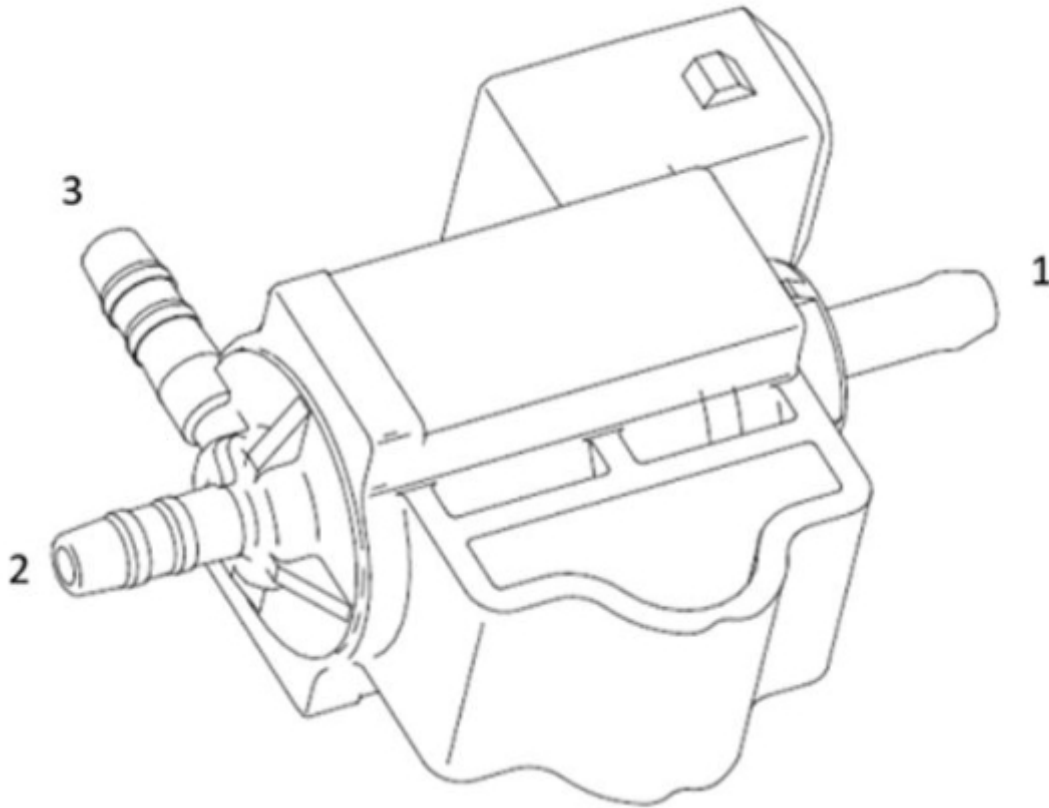
Involved Region or Country:	North America, Argentina, Brazil, Colombia, Ecuador, Paraguay, Uruguay, Israel, Palestine, Middle East, Israel, Chile, Peru, China, Thailand, Australia, New Zealand, Egypt, Africa
Condition:	Possible DTC P0234 P0299 that can occur during cold weather driving.
Cause:	Oil/moisture condensate freezing up in Turbocharger Wastegate Regulator Solenoid Valve (TCV).

Note: Check port #2 to assure the spring gets lifted off the seat. This will be determined by the compressed air not dead-heading when applied to port #2. When applying air to this port a small amount of air should be observed at port #3 and even less air will be noticed at port #1. If this does not happen, the TCV plunger may have hardened deposits from hot operating conditions which will impede TCV plunger movement and the Turbocharger Wastegate Regulator Solenoid Valve should be replaced.

1. **Remove Turbocharger Wastegate Regulator Solenoid Valve**
2. **Drain Turbocharger Wastegate Regulator Solenoid Valve (TCV) by turning valve upside down.**
3. **Using clean shop air regulated to 15-20 PSI (103kPa), blow through all three ports (1, 2 &3) for 5 seconds each. Repeat twice.**

4. Reinstall Turbocharger Wastegate Solenoid Valve (TCV) using the latest service information and clear all DTC's using GDS and evaluate.
