SERVICE BULLETIN

APPLICABILITY: 2020-22MY Legacy / Outback
 2012-22MY Impreza
 2012-22MY Crosstrek
 2011-22MY Forester
 2013-21MY BRZ
 2019-21MY Ascent

NUMBER: 02-188-21

SUBJECT: Timing Chain / Camshaft Sprocket Installation-Procedure Information

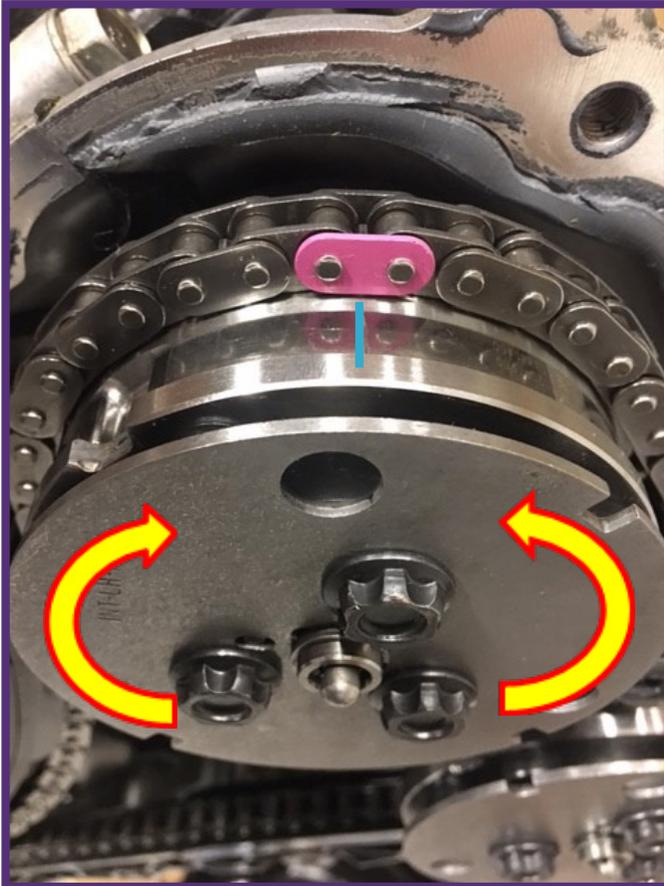
EXAMPLE: (FA20 Left Intake Cam Sprocket)

In this case, the Housing and Sensor Plate are moving free of each other.

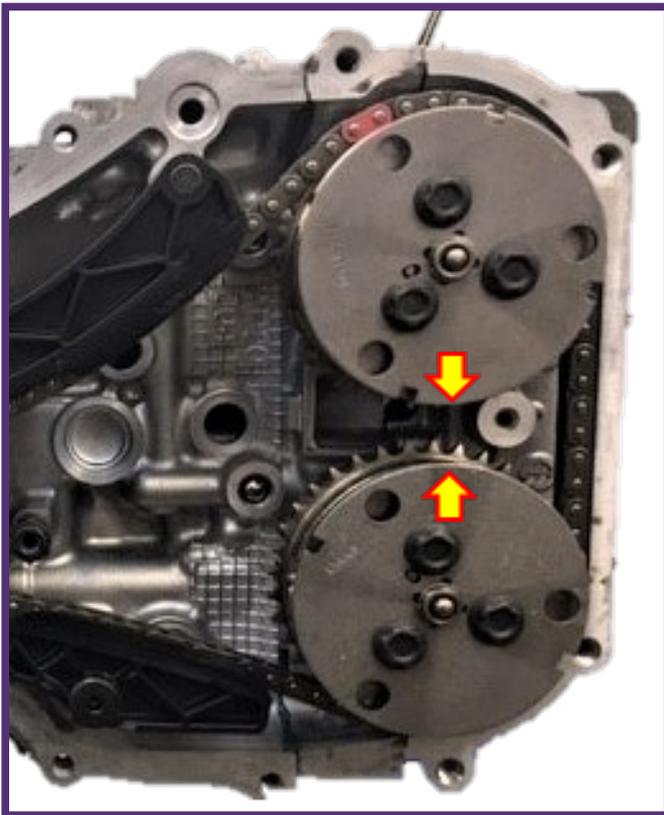
The Alignment Marks on the “free moving” Sensor Plate DO NOT need alignment since the plate is not locked to the housing at this time.
