SERVICE BULLETIN

APPLICABILITY: 2020 Outback & Legacy **NUMBER:** 15-270-20R

SUBJECT: FOTA (Firmware Over-The-Air) Reprogramming for DENSO Gen 4 Audio / Navigation Infotainment Systems **DATE:** 8/19/2020

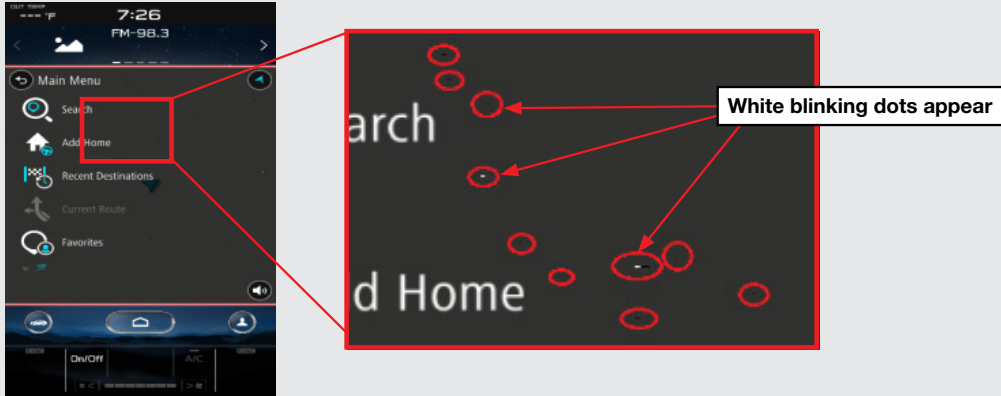
No.	Symptom to be improved	FOTA
1	Several minutes after Engine start, Center Information Display (CID) reboots itself	Yes
2	<p>After extended usage, white blinking dots appear on the display.</p>

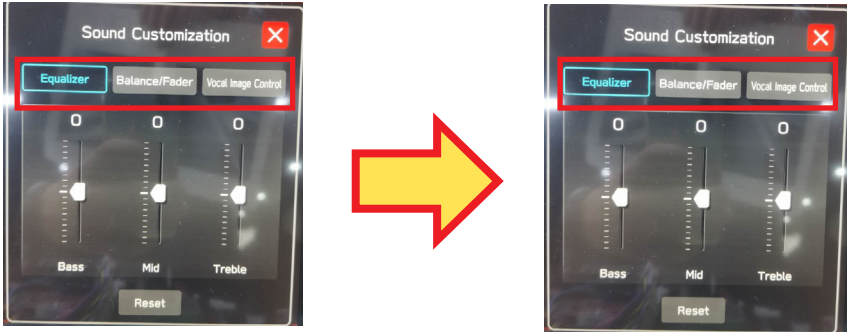
7	<p>Equalizer setting returns to default setting. After ignition switch is turned Off and ON, the equalizer returns to default setting.</p>

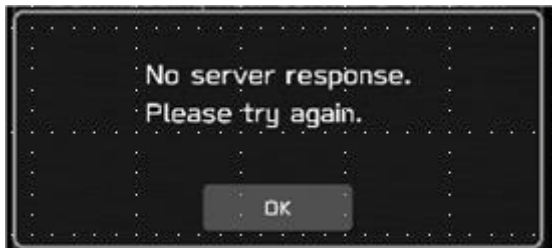
2. What if the server response error message below displays when downloading the update?

- a. Check the internet connection to ensure it is active and shows full signal strength.
- b. Try moving the vehicle closer to the WiFi source or if not possible, try a different WiFi connection such as a mobile hotspot.

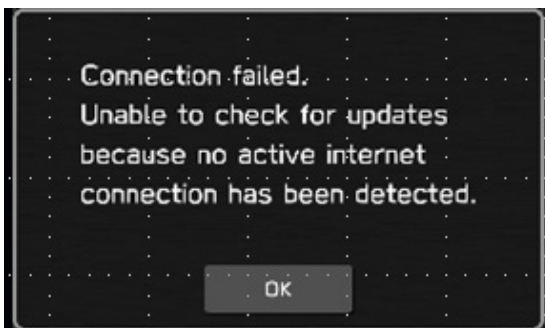
3. What if the below “Connection failed” error message appears before downloading the update?

- a. Follow Tips from Item 1 above.
- b. Change “Wi-Fi” to Off then back to On. This setting is found under the General tab on “Settings” screen.

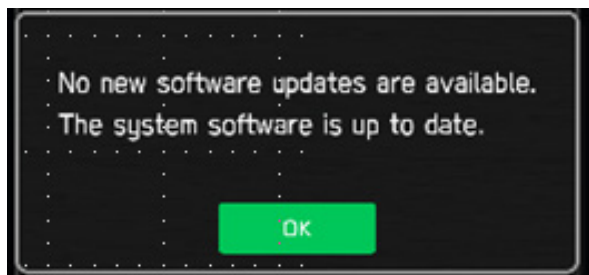
4. What if the system says the system is up to date when checking for updates?

- a. Go to Settings, General, System Information. If the version shows **F11GMM021-704**, or, if the last six digits are any of the following: 020-704, 021-704 or 022-504, the system is already up to date.
- b. If this version is not shown, ensure the clock time is correct.

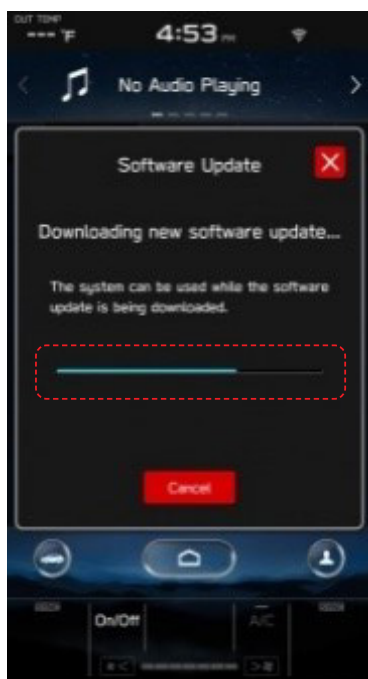
5. What if the “Progress Bar” does not progress for a long time after selecting “Download” or the screen shows the “Connect to Wi-Fi” pop-up when downloading?

- a. Reconnect to Wi-Fi device by following the instructions provided in **Step 1** above.
