SERVICE BULLETIN

APPLICABILITY: Legacy & Outback 2010-19MY Equipped with CVT
 Forester 2014-22MY Equipped with CVT
 (Except Wilderness)
 Impreza 2012-22MY Equipped with CVT
 Crosstrek 2012-19MY Equipped with CVT
 WRX 2015-21MY Equipped with CVT

NUMBER: 16-102-16R
DATE: 07/11/16
REVISED: 10/15/21

SUBJECT: DTC P0841 Diagnostics

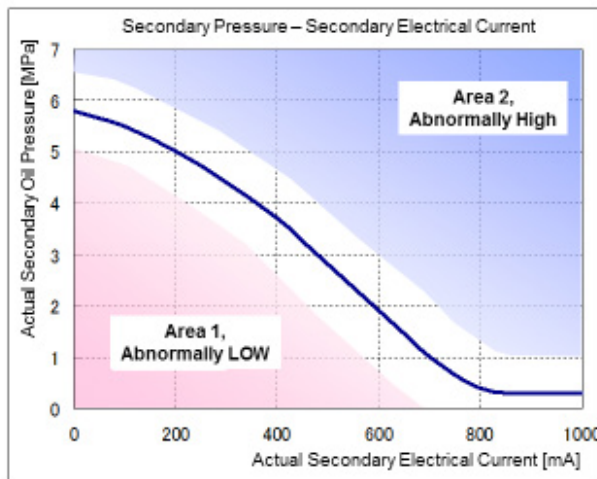
The condition causing P0841 is either:

1. The Secondary Oil Pressure is abnormally low (lack of necessary pressure)
2. The Secondary Oil Pressure is abnormally high (excess pressure occurs as compared to necessary pressure).

Check the Actual Secondary electrical current [mA] and Actual Secondary oil pressure [MPa] stored in the FFD then determine if P0841 has set because of:

1. abnormally low
2. abnormally high Secondary Oil pressure.

TIP: Consider performing the pressure testing using a mechanical pressure gauge **BEFORE** electrical testing and compare the test results (between the gauge and SM4 displayed values). Both test results should be very close. If there is a significant discrepancy between them (e.g. the (known good) gauge results are significantly higher than the SM4-supplied values), the pressure sensor would be suspect.

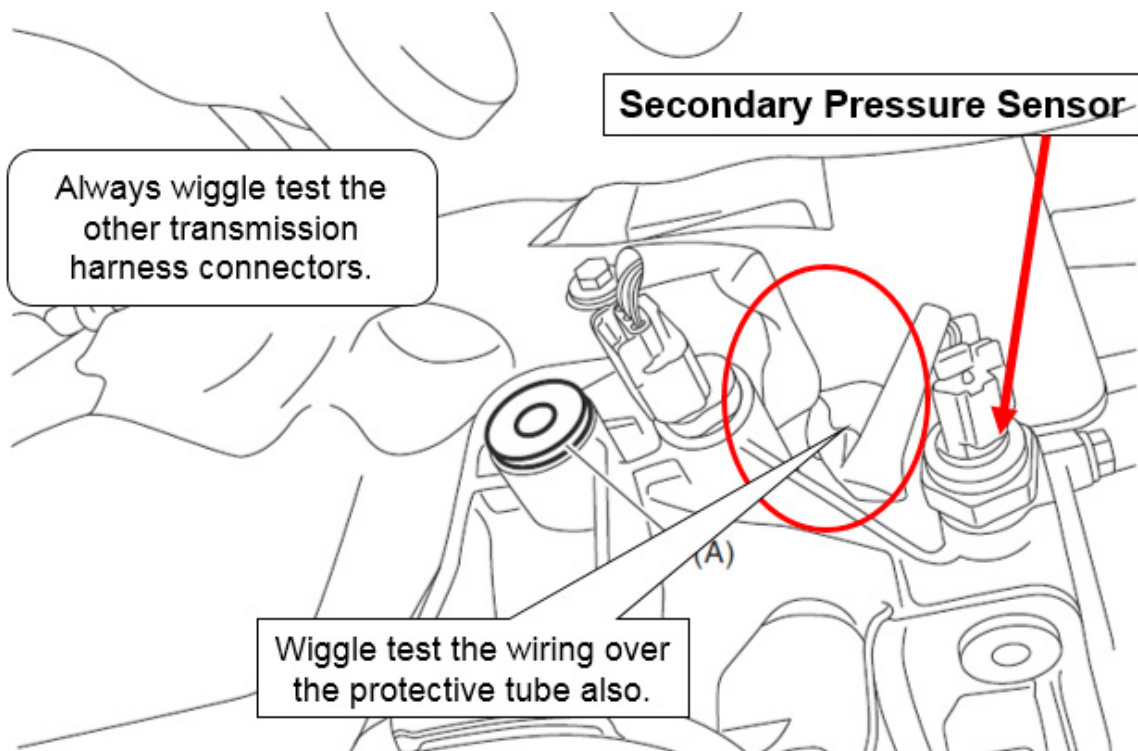
“Wiggle-Testing” Wiring:

(1) The pin for the secondary oil pressure sensor is located at the end of connector and can be affected by ambient temperature. The sensor wiring can develop an open circuit when cold caused by freezing but be normal at normal temperatures. Keep temperature conditions in mind when testing. Always wiggle test the wiring and connections when testing and watch for any fluctuations.

(2) Check, record and confirm the "Secondary Oil Pressure A/D Value" is correct with SSM while wiggling the T/M wiring, TCM connectors and the Secondary Oil Pressure sensor harness connector.

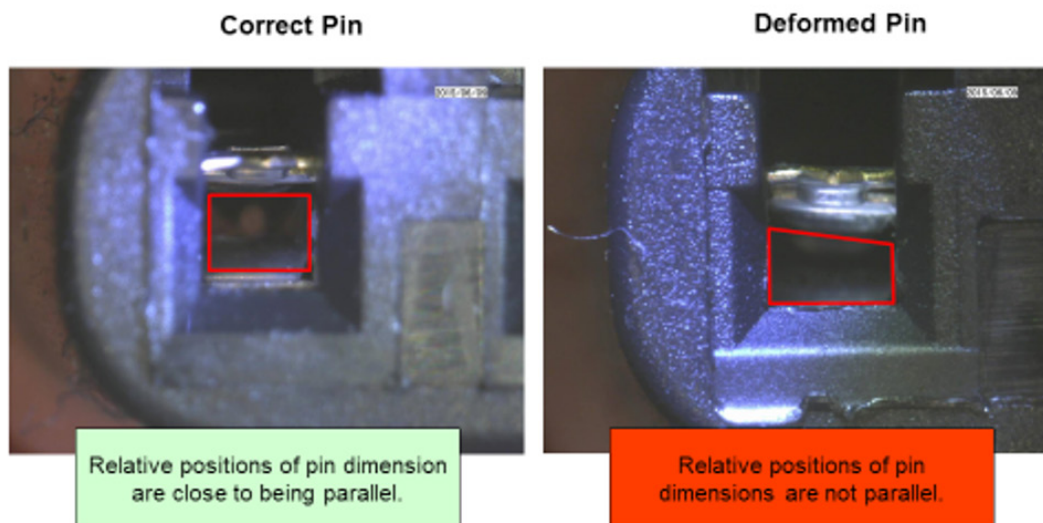
(1) Inspect for any abnormalities with the pins like: deformation, scratches, discoloration or evidence of any foreign materials inside them or the connectors.

Example of a Deformed Pin Terminal:

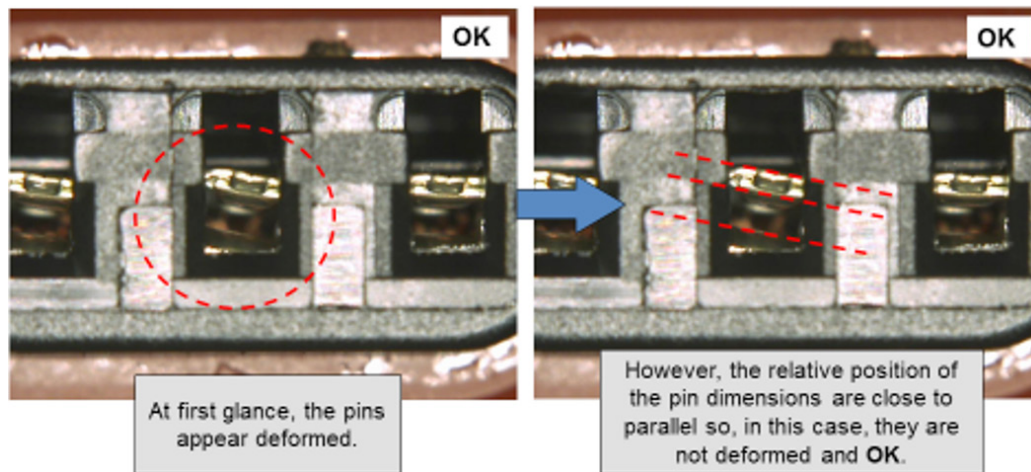
Example of Incorrect Judgement of a Damaged or Deformed Pin Terminal:
