SERVICE BULLETIN

APPLICABILITY: 2015-2018MY Legacy and Outback
 2012-2018MY Impreza
 2013-2018MY Crosstrek
 2014-2018MY Forester
 2015-2018MY WRX

NUMBER: 16-112-18R

SUBJECT: Ignition Key Sticking / Design Change to CVT Shifter / Selector Lever Components / **Parking Brake Switch Warranty Extension**

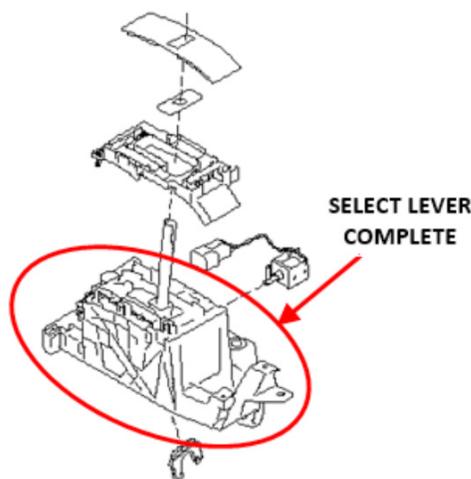
For Legacy and Outback:

- For **Legacy and Outback**, the shifter assembly (SELECT LEVER COMPLETE) must be replaced if the Park-Range switch is found to be faulty.

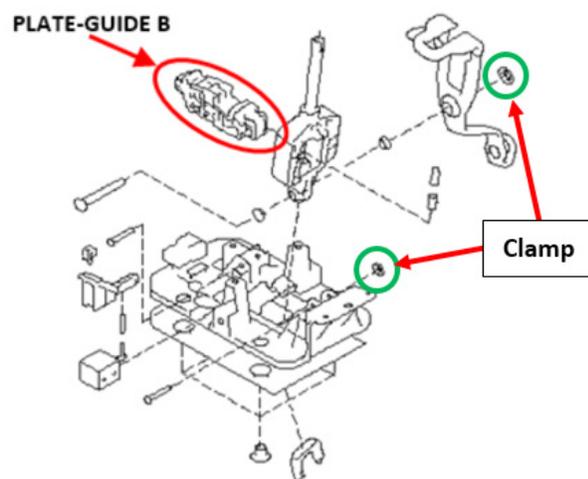
For all other models listed:

- The term PLATE-GUIDE B refers to the Park-Range switch which is a serviceable part of the select lever assembly on all models listed above **EXCEPT** Legacy and Outback. See the illustrations provided below for more details.
