TECHNICAL SERVICE BULLETIN

Water Dripping Into The Front Passenger Side Footwell When A/C Is Operating - Built On Or After 01-Feb-2013

21-2379

Ford 2014-2020 Transit Connect

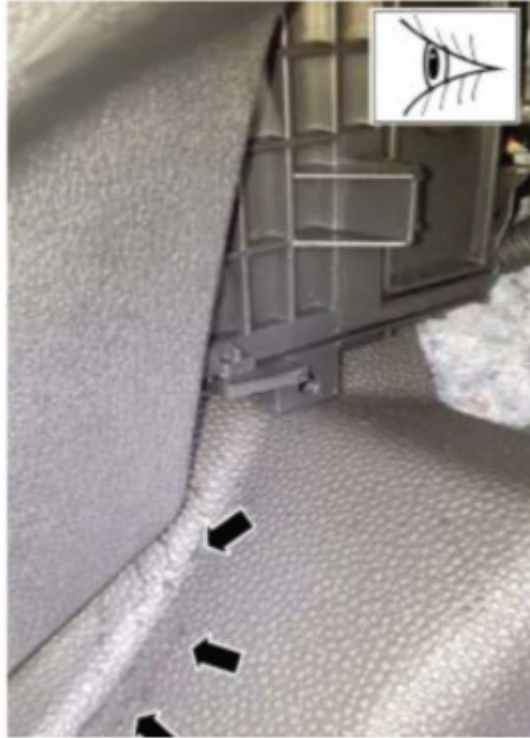
Figure 1

1. Is the concern as shown in Figure 1, water dripping onto the trim panel, or Figure 2, water dripping onto the floor covering?
