INTRODUCTION:

This bulletin announces a design change to the CVT select lever (shifter) mechanism in response to isolated customer concerns of not being able to remove the key from the ignition switch when the vehicle is in Park. The cause is contamination of the Park-Range switch internal components.

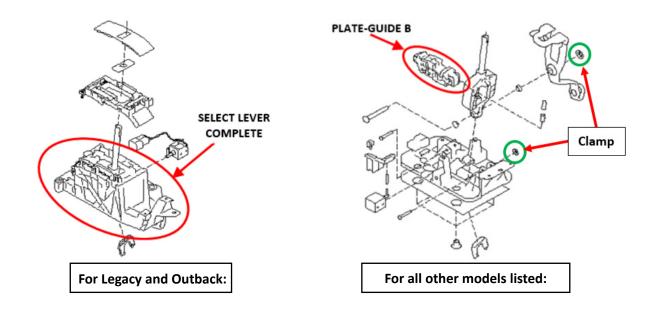
• The term PLATE-GUIDE B refers to the Park-Range switch which is a serviceable part of the select lever assembly on all models listed above **<u>EXCEPT</u>** Legacy and Outback. See the illustrations provided below for more details.

• For Legacy and Outback, the shifter assembly (SELECT LEVER COMPLETE) must be replaced if the Park-Range switch is found to be faulty.

- a) Replace the SELECT LEVER COMPLETE assembly (on Legacy and Outback models) or,
- **b)** Replace the Park-Range switch (PLATE-GUIDE B) following the Select Lever disassembly / assembly procedure in the applicable Service Manual.
