**FORD:**

2015 Transit

**ISSUE**

**TSB 15-0160 (Continued)**

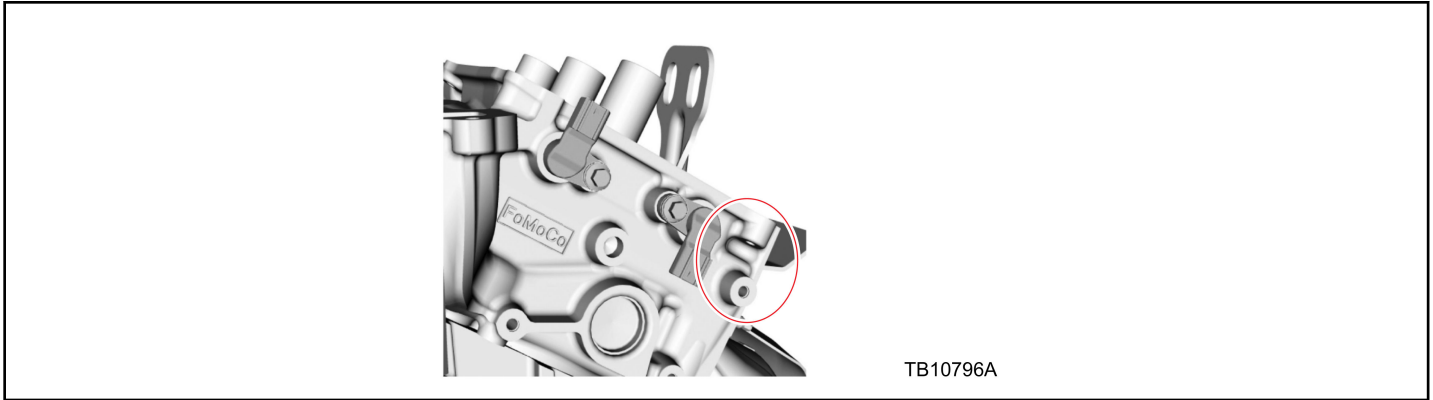
Figure 1 - Article 15-0160

14. Position the detached section of the harness on top of the engine to allow harness inspection and repair.
15. Inspect the harness takeout for HO2S11 electrical connector C1571 for chafing or wire worn through that may have been caused by contact on the back of the cylinder head. (Figure 1)

16. Repair any wire chafing found using the solder splicing method. Refer to Wiring Diagram Cell 5-1.
  - a. Use a commercially available sheathing ripper, such as Rotunda Technician Tool Program (RTTP) JSP95978-04 or equivalent, to carefully strip the wire harness tape from the section of wire harness.
  - b. Insert the ball end of the sheathing ripper into the wire harness. Use caution not to damage the wires or wire insulation when stripping the wire harness.
17. Use Coroplast™ tape or equivalent and wrap the affected area of the takeout to H02S11.
18. Properly route the harness and make sure the HO2S11 wire harness takeout is positioned correctly to prevent future chafing. (Figure 2)
