FORD:

2015-2016 F-250, F-350, F-450

This article supersedes TSB **15-0106** to update the Issue Statement, Service Procedure and Part List.

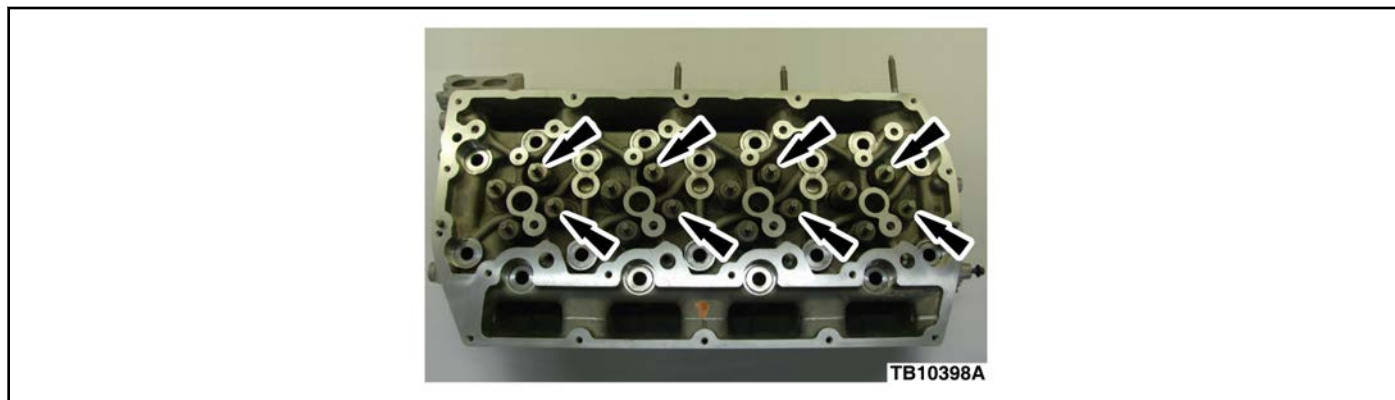
Figure 1 - Article 16-0041

Some 2015-2016 F-Super Duty 250-450 Pickup vehicles equipped with a 6.7L diesel engine and built on or before 2/23/2016 may exhibit a runs rough/misfire condition only during the exhaust regeneration process. This condition typically occurs on light throttle tip in between 64-113 Km/h (40-70 MPH) and will not set diagnostic trouble codes (DTCs). The concern may be intermittent and a knocking noise may be present during the concern.

1. Reprogram the powertrain control module (PCM) to the latest calibration using Integrated Diagnostic System (IDS) release 99.03 or higher. Make sure you are connected to the internet when entering module programming to obtain the latest updates. Calibration files may also be obtained at www.motorcraftservice.com
2. Did the customer indicate the message center displayed a Cleaning Exhaust Filter message prior to the concern?
 - a. Yes - proceed to Step 3.
 - b. No - proceed to Step 6.
3. Remove the left cylinder head. Refer to Workshop Manual (WSM), Section 303-01.
4. Replace all eight (8) exhaust valves and valve seals. Refer to WSM, Section 303-01. (Figure 1)
