# Service Bulletin

Bulletin No.: 18-NA-073

**Subject:** Repair Guidelines for Engine Component Wear

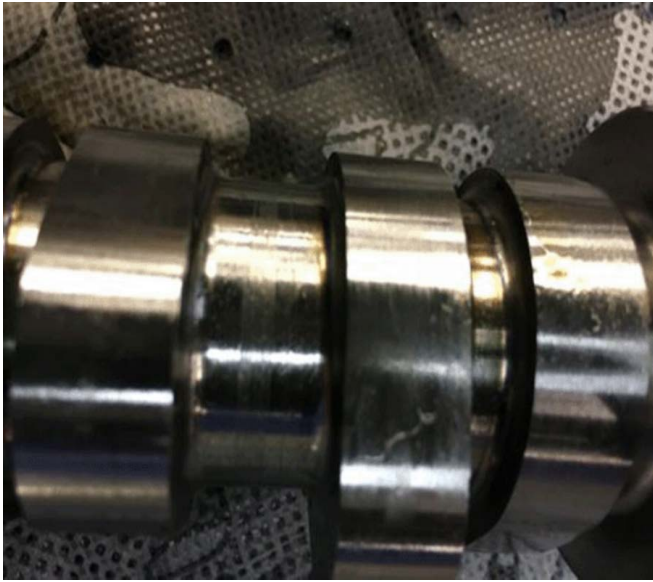
4994025

Example of minor scratching/scoring visible on camshaft lobes and/or camshaft bearing journals. In this example, the scored components can be replaced without need for engine assembly replacement.

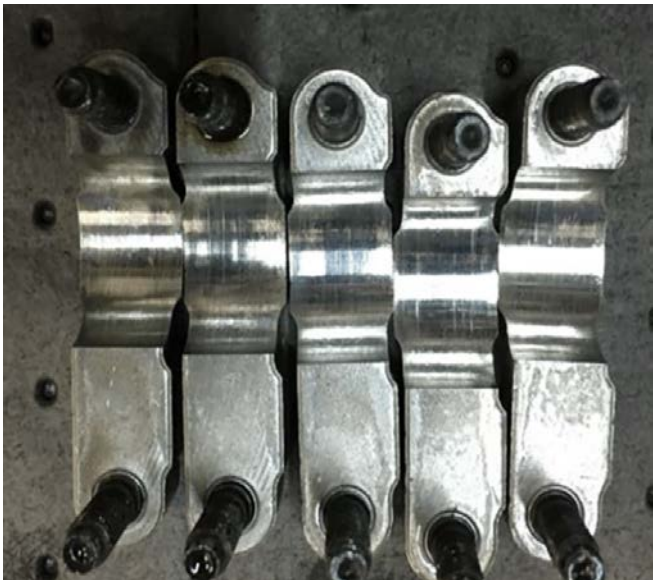
4991477

Example of minor scratching/scoring visible on camshaft bearing caps. In this example, the scored components can be replaced without need for engine assembly replacement.

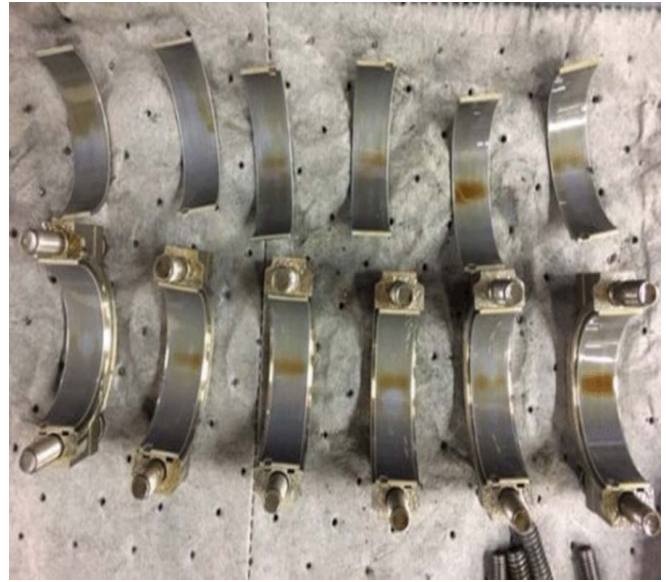
4992132

Example of minor scratching/scoring visible on connecting rod bearings. In this example, the scored components can be replaced without need for engine assembly replacement.

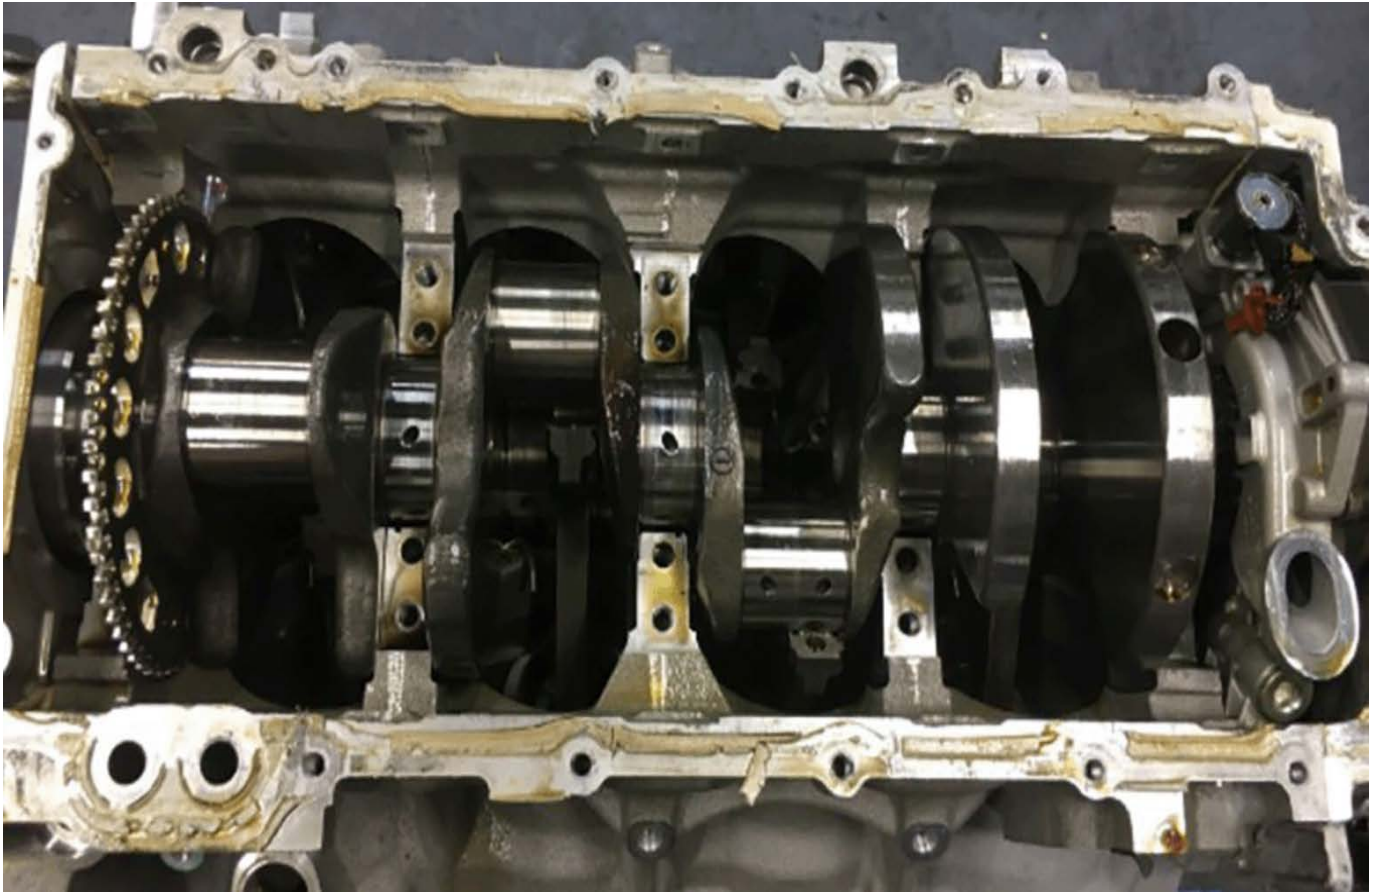
4990880

Example of minor scratching/scoring visible on crankshaft. In this example, the scored components can be replaced without need for engine assembly replacement.

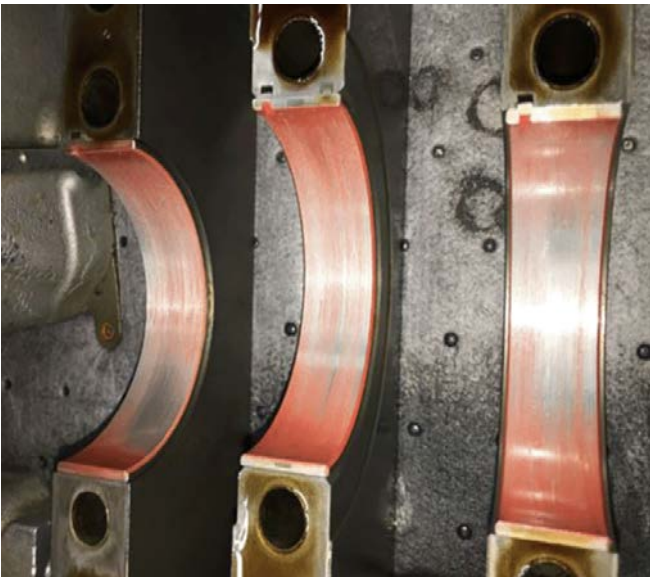
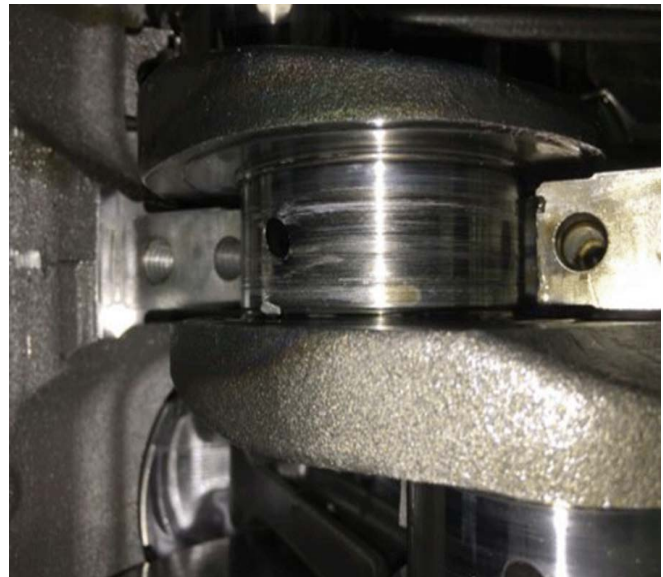
Example of minor scratching/scoring visible on crankshaft. In this example, the scored components can be replaced without need for engine assembly replacement.

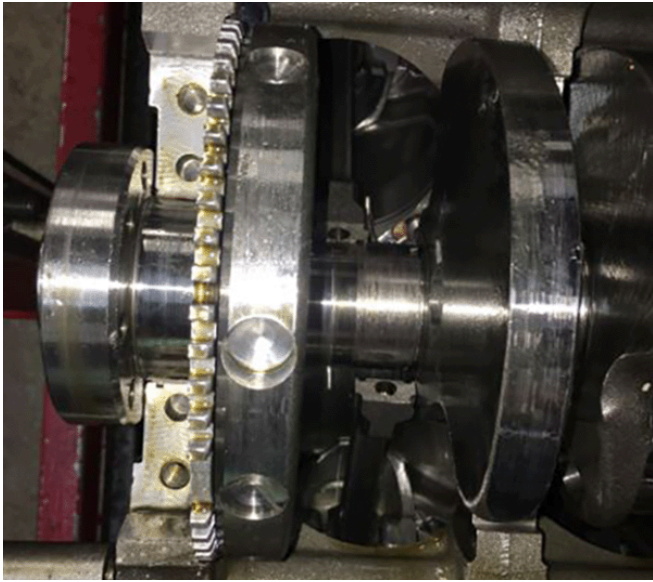
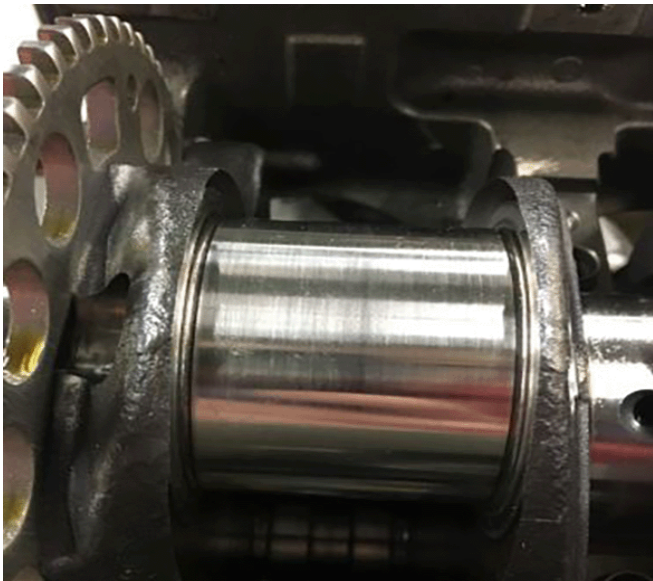
Example of minor scratching/scoring visible on crankshaft. In this example, the scored components can be replaced without need for engine assembly replacement.

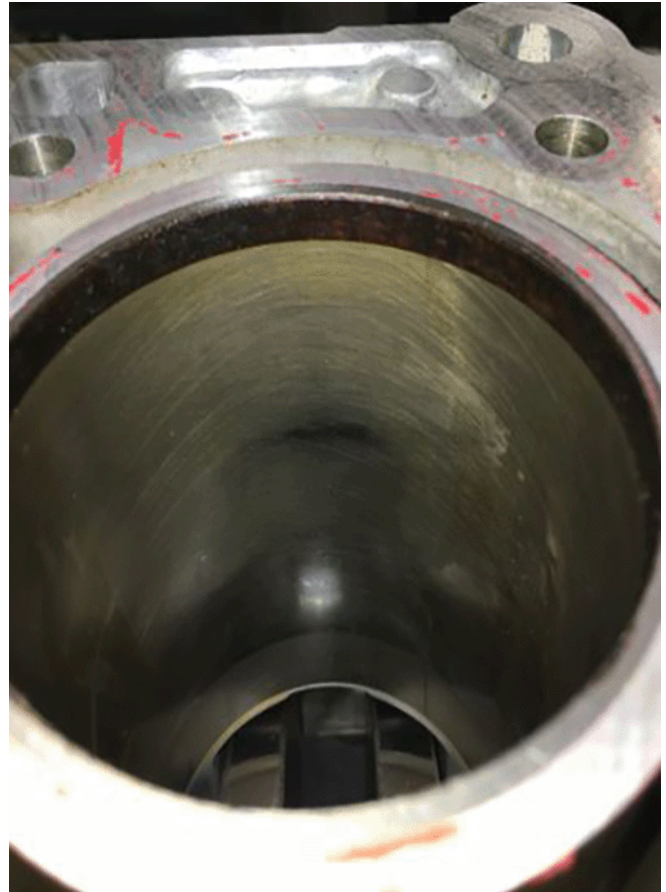
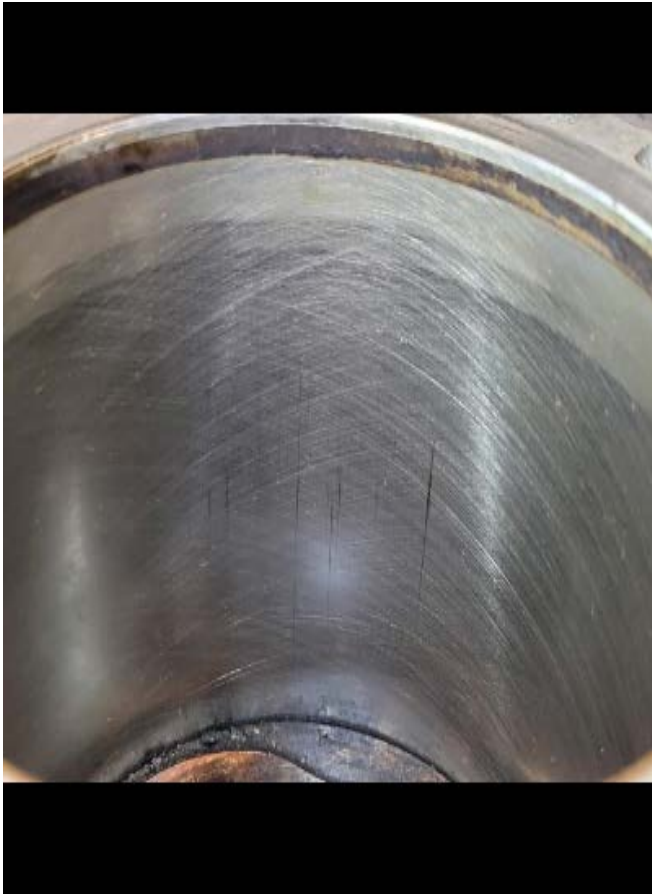
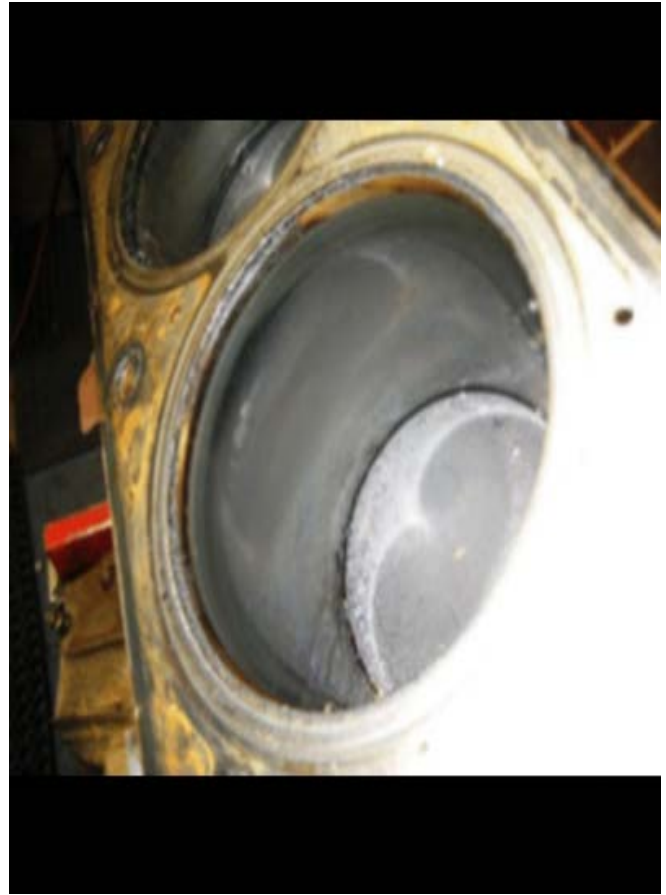
Example of minor scratching/scoring visible on cylinder wall. In this example, if you cannot catch a pick or fingernail on the scratch, the cylinder bore/engine block does not require replacement. If the piston is slightly scored, the scored piston can be replaced without need for engine assembly replacement.

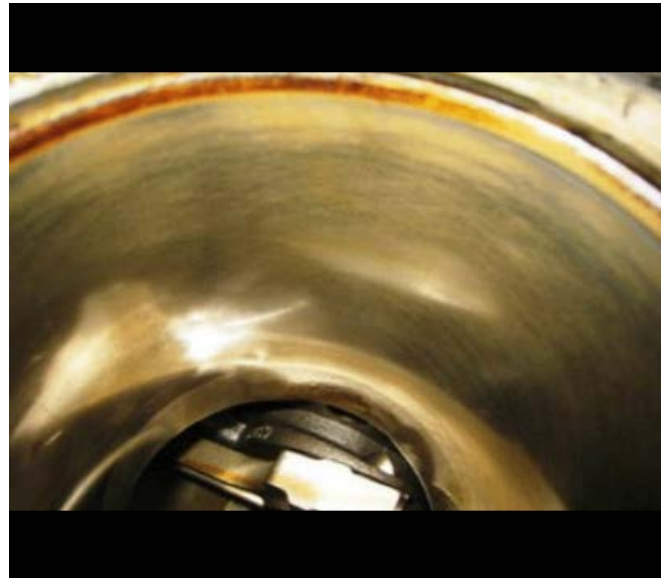
5788571

When inspecting the engine block to determine if the cylinder bores are good, look for the following:

1. Cylinder damage or scoring – The cylinder walls will contain grooves deep enough to catch with a fingernail.
2. Out of round cylinder bore – Contains areas where the crosshatch is missing or worn from different sections of the cylinder bore. If there is crosshatch all the way around the bore from top to bottom, the cylinder bore is not out of round.

3. Dirt intrusion – If the filtering system has been compromised, the engine will wear out very quickly. You will find grit in the intake runners and the cylinder bores will look lightly sand blasted. The crosshatch will be faint and there will not be sharpness. At high mileage this may not be sharpness. Warrantable if the air filtering system has been opened numerous times for service in dusty climates.

4. Catalytic converter failure – If a converter fails and the brick is broken, the dust can be drawn back into the engine. A block showing this type of failure will have bores that look to be sand blasted. Back cylinders go first if caught early. Otherwise there will be no crosshatch and the engine will need to be replaced.

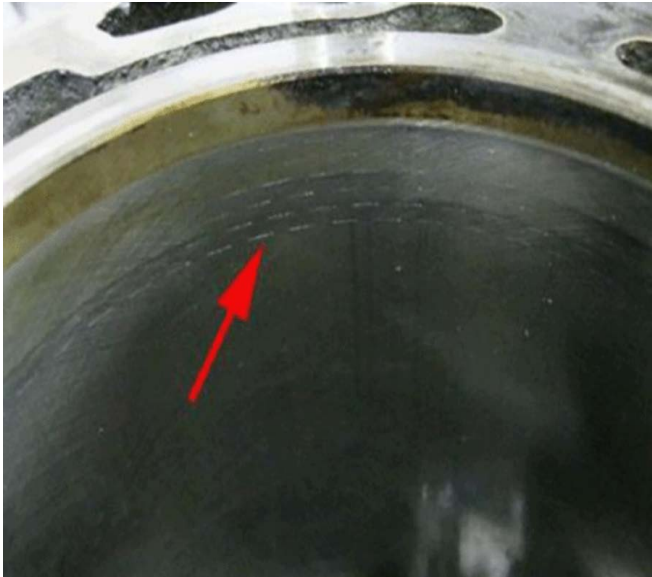
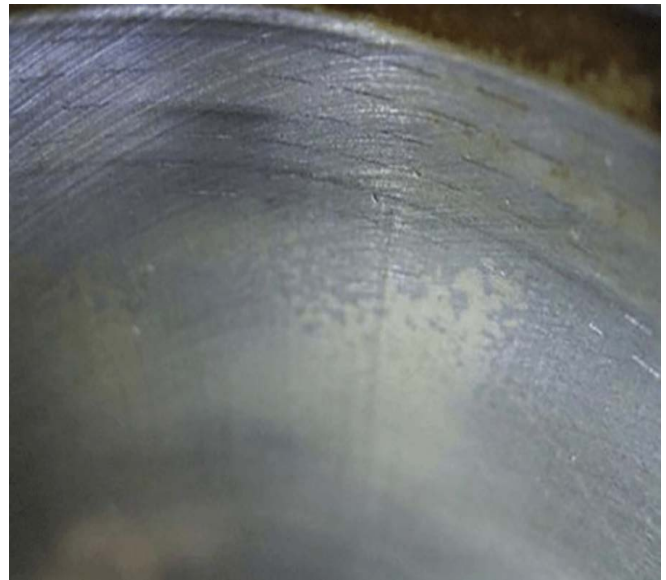
Some technicians may be replacing entire engine assemblies due to marks found at the top of the cylinder bore. These marks are considered normal and are left as a result of a manufacturing laser honing process. **DO NOT** replace the cylinder block or the engine for these normal laser honing marks (refer to PI0725B).

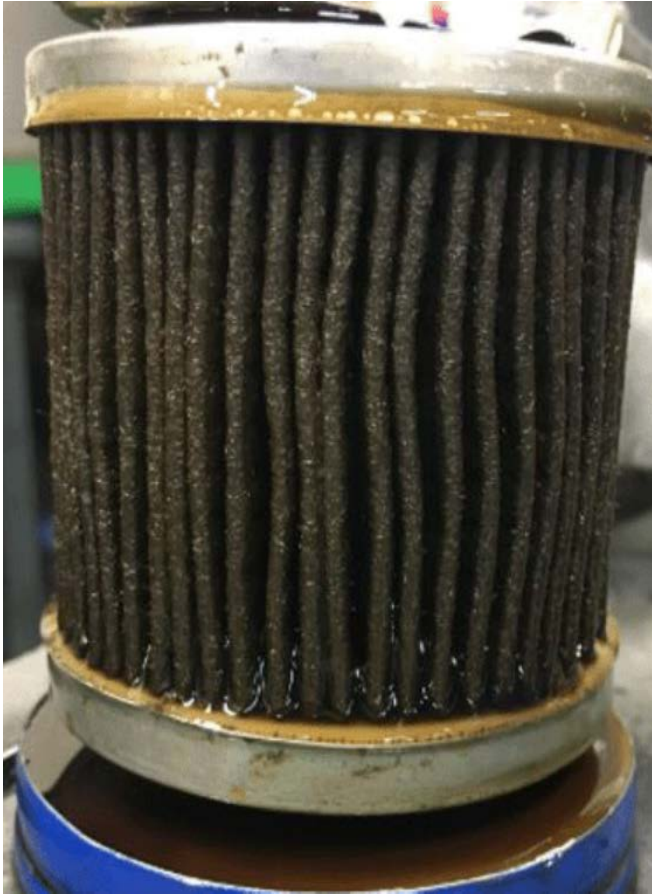
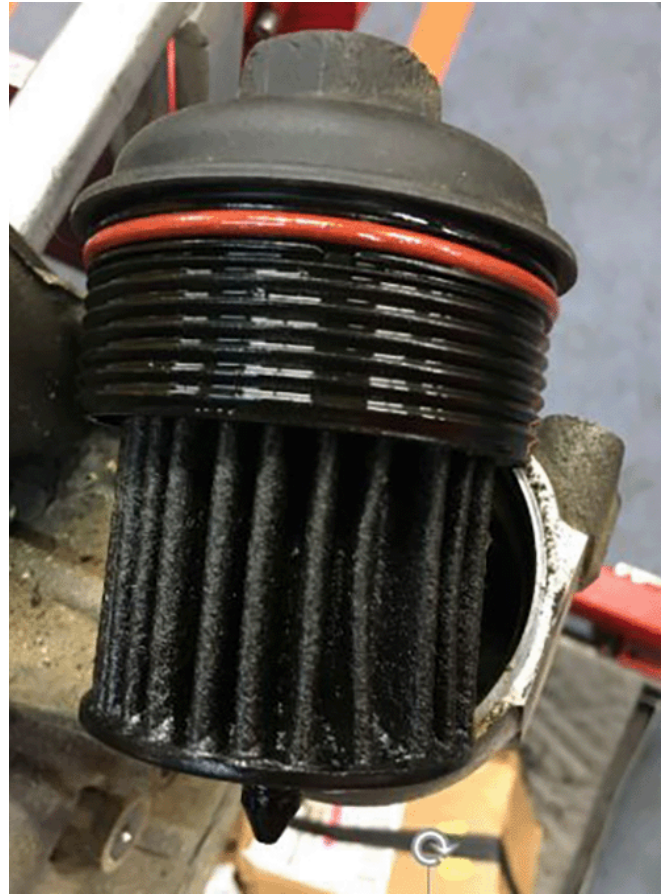
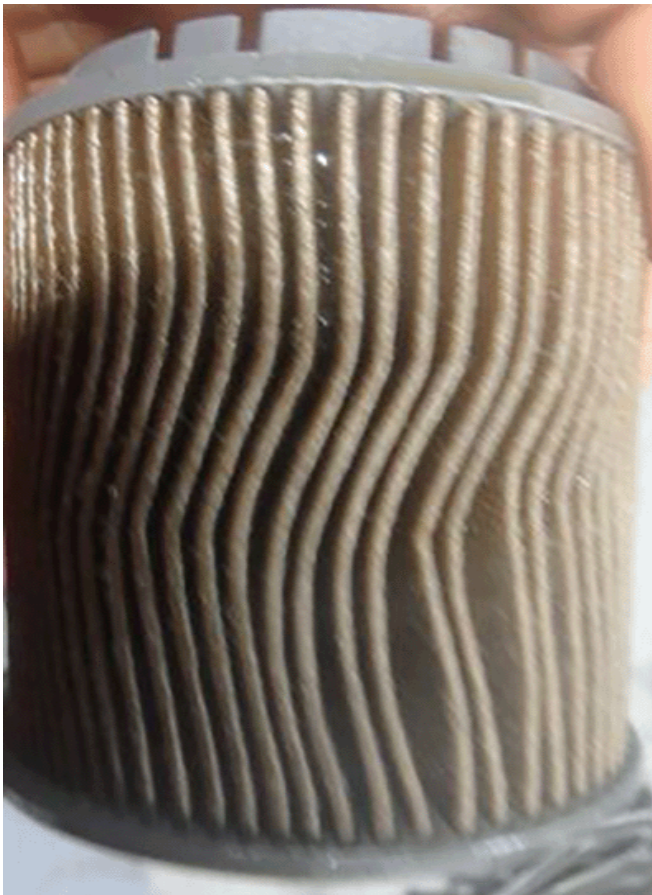
Shown are oil filter pleats with visible metal particles. In this example, minimal amounts of metal particles are visible on oil filter pleats and should not pose a concern.

If excessive amounts of metal particles are observed, or if there is evidence of damaged oil filter pleats, then unfiltered oil with bearing debris may have been pumped into the oil lubrication galleries throughout the engine. This will require further inspection to confirm the degree of contamination and appropriate repair direction. Refer to Service Bulletin #19-NA-256 for HFV6 Gen 1 and Gen 2.
