Service Bulletin

Bulletin No.: 20-NA-136

Subject: 9T65 Automatic Transmission Replacement Pilot Program (U.S. Only)

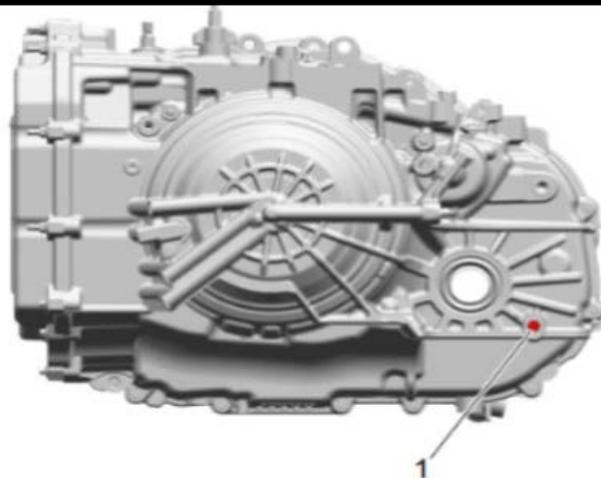
5619626

6. While the vehicle is idling, remove the oil level set plug (1). Allow any fluid to drain:
 - If the fluid is flowing as a steady stream, wait until the fluid begins to drip.
 - If no fluid comes out, add fluid until fluid drips out.
7. Record fluid level; overfilled, under-filled, correct on repair order and how much was needed to fill or came out:
 - If fluid is overfilled, set correct level and retest.
 - If fluid is under-filled, inspect for external leaks. Refer to *Fluid Leak Diagnosis*.
8. If fluid level is correct, then check condition of the fluid.

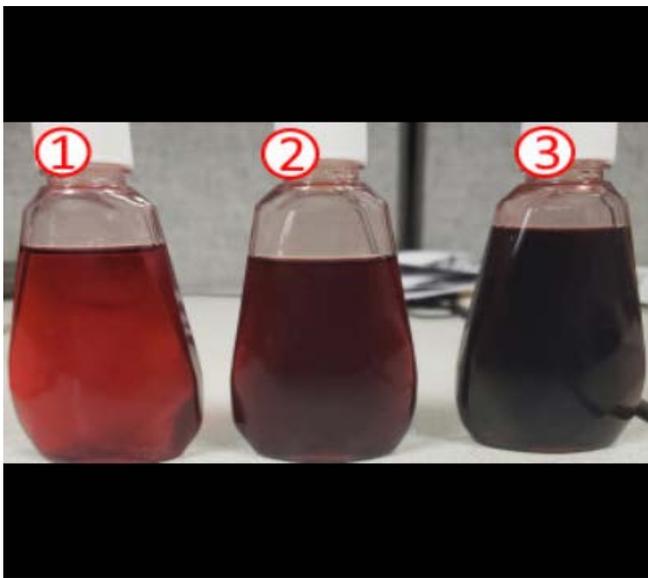
5840393

- 8.1. Inspect the fluid color.
 - The fluid should be red or dark brown.
 - It should be transparent so that objects or writing can be seen through it. Sample #1 is an example of acceptable fluid. Sample #2 is an example of very dark fluid. Sample #3 is an example of black fluid.

- In addition to checking the fluid color and transparency the fluid should be smelled to check for an odor of burnt fluid.
 - If the fluid is very dark, black, or has a burnt odor then, record on the repair order and replace the transmission assembly.
