# TECHNICAL SERVICE BULLETIN

## 2.3L EcoBoost - Illuminated MIL With DTC P04F0 And/Or P144C

**21-2446**

<b>Ford</b> 2020-2022 Explorer	Engine: 2.3L EcoBoost
-----------------------------------	-----------------------

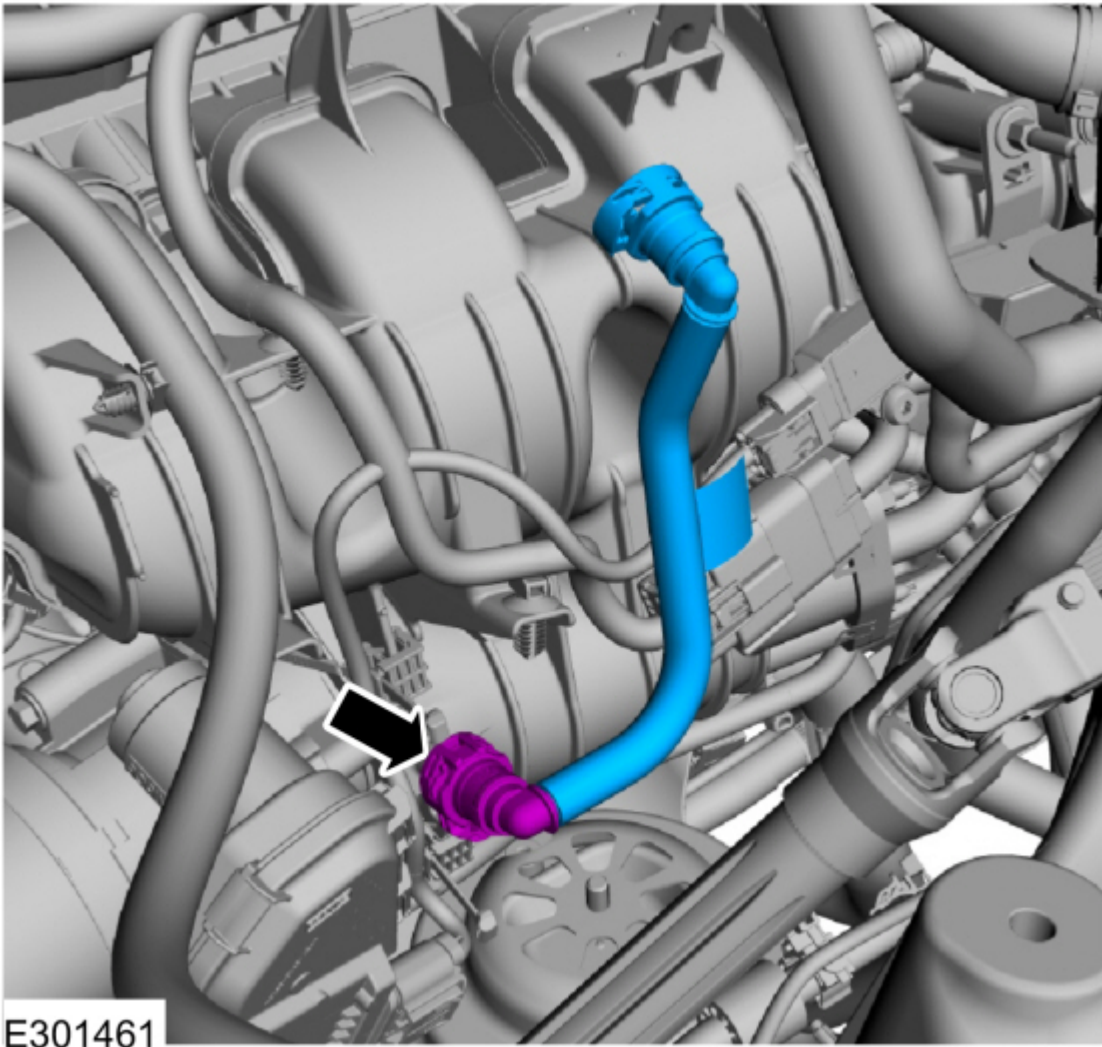
Figure 1

- (1). Vacuum port side and pressure port side of the ejector. (Figure 1)

1. Visually inspect and push and pull on each of the following EVAP connections to verify a proper connection:

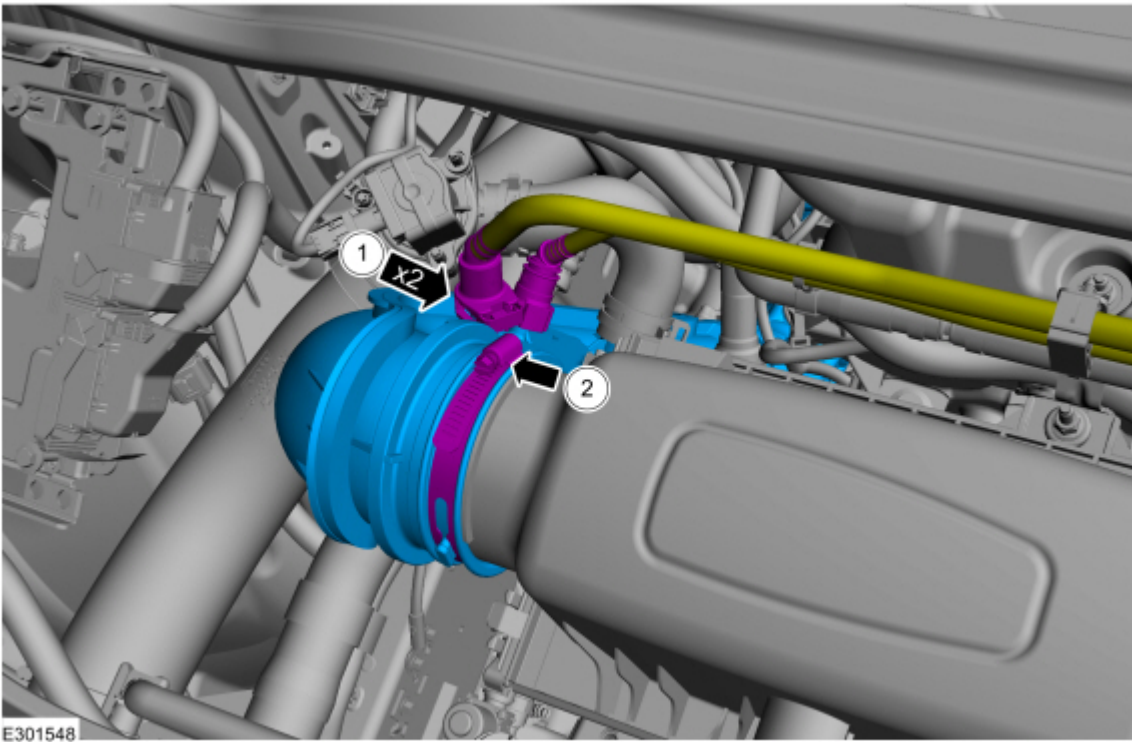
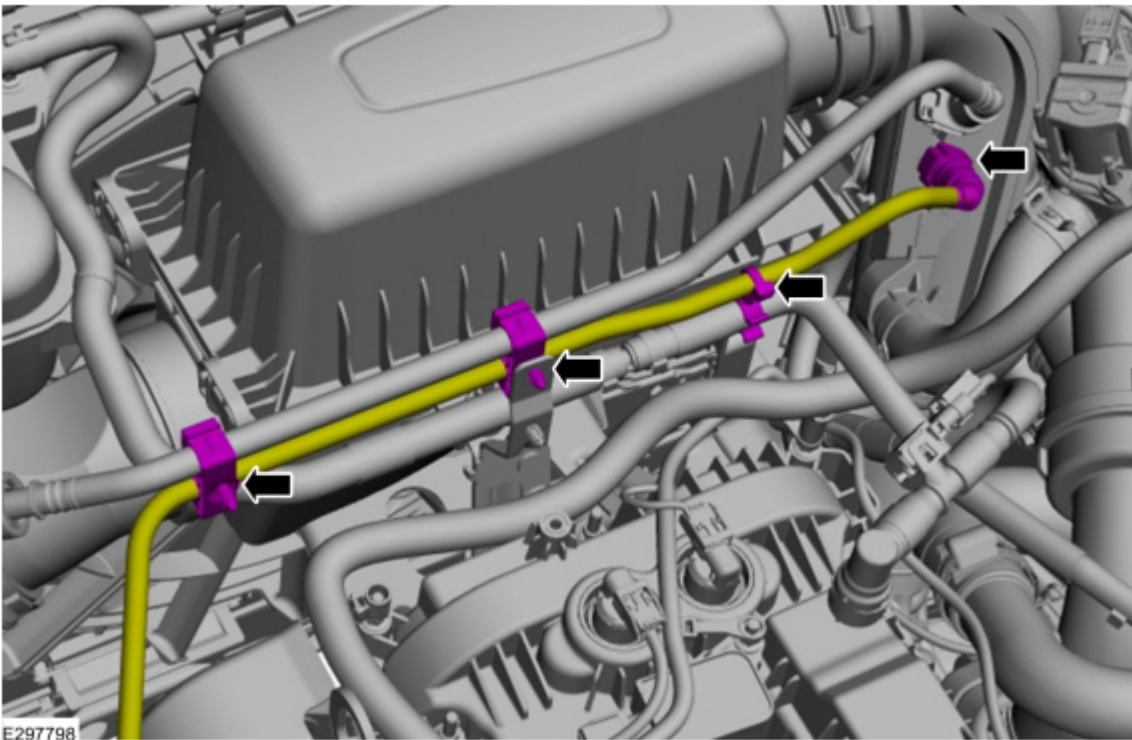
Figure 2

(2). Port on the air intake system (AIS) duct at throttle body inlet. (Figure 2-3)

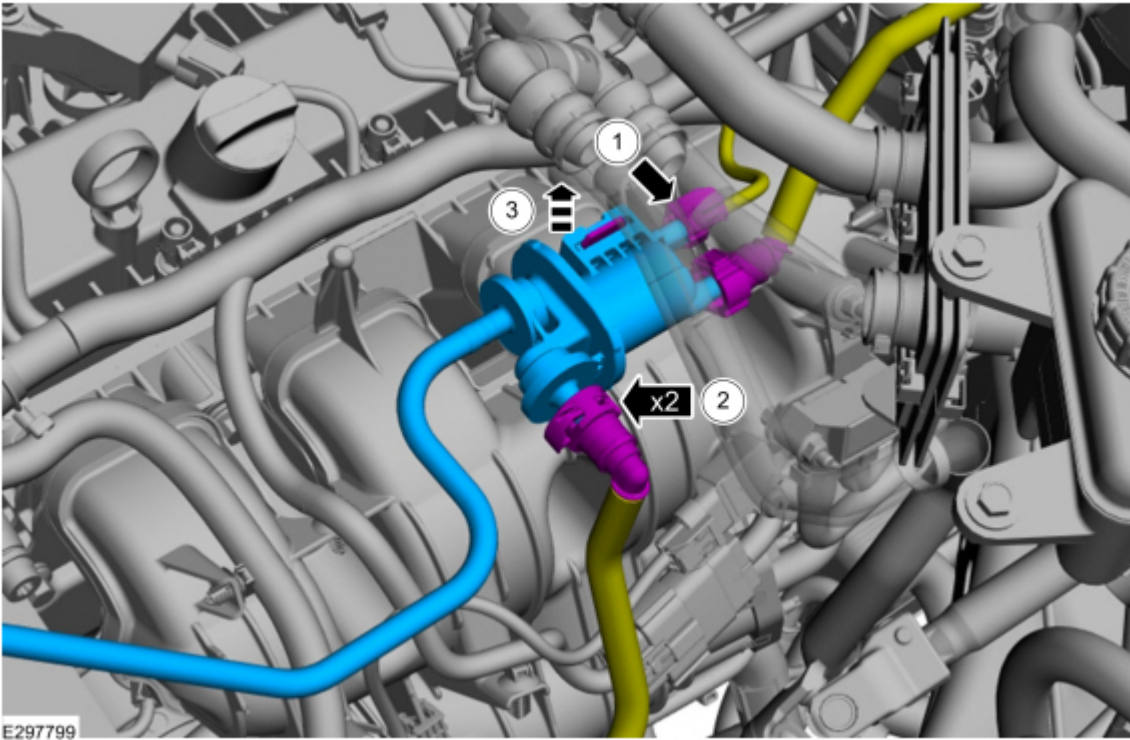
Figure 4

(3). Vacuum side of the purge valve (side port on the purge valve). (Figure 4)
