## Subject: Malfunction Indicator Lamp (MIL) Illuminated - DTC P0741 Set

Brand:	Model:	Model Year:		VIN:		En- gine:	Transmission:
		from	to	from	to		
Chevro- let	Colorado	2016	2019				MYB, MYC, MYD
	Express	2014					
	Silverado		2018				
	Silverado LD	2019					
	Suburban	2014	2019				
	Tahoe						
GMC	Canyon	2016	2019				
	Savana	2014					
	Sierra		2018				
	Sierra Limited	2019	2019				
	Yukon	2014

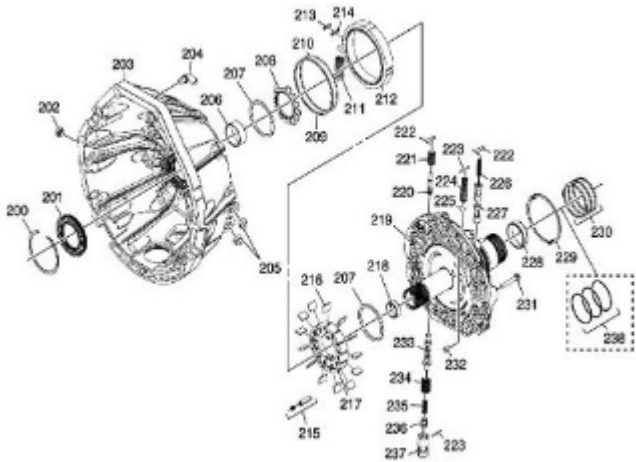
<p>5448383</p> <p>This condition may be caused by a damaged turbine shaft front bushing (218) in vehicles with mileage less than 10,000 miles (approx. 16,000 km).            ⇒ The turbine shaft may also be damaged in the journal area that is in contact with this bushing.</p>

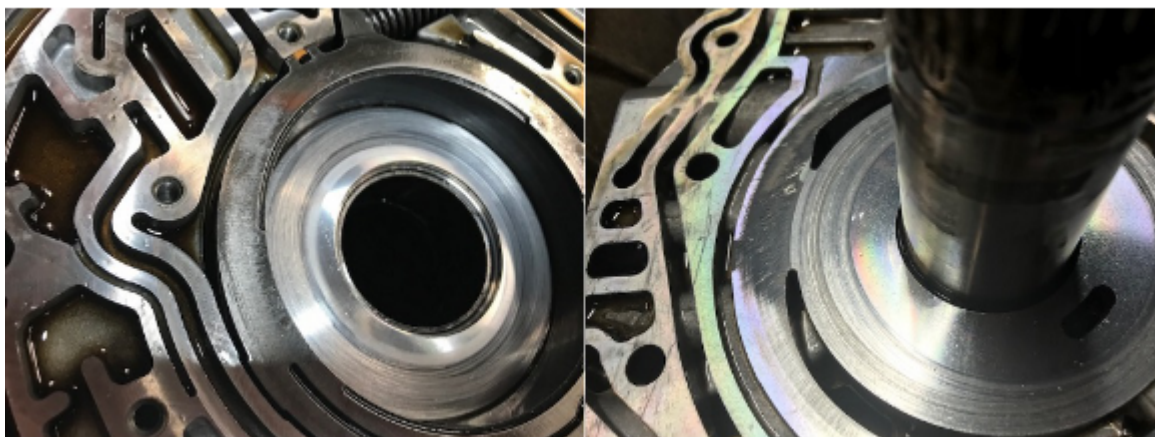
5360218

**Note:** Refer to the latest version of PI1447 for possible bushing/shaft scoring. Replace parts as necessary. Perform an inspection of the transmission pump for signs of excessive wear as shown above.

Replace pump components as necessary.
