Service Bulletin

Bulletin No.: 20-NA-188

Subject: Rear View Camera Image Flickers When Brake Lamps or Turn Signals are On

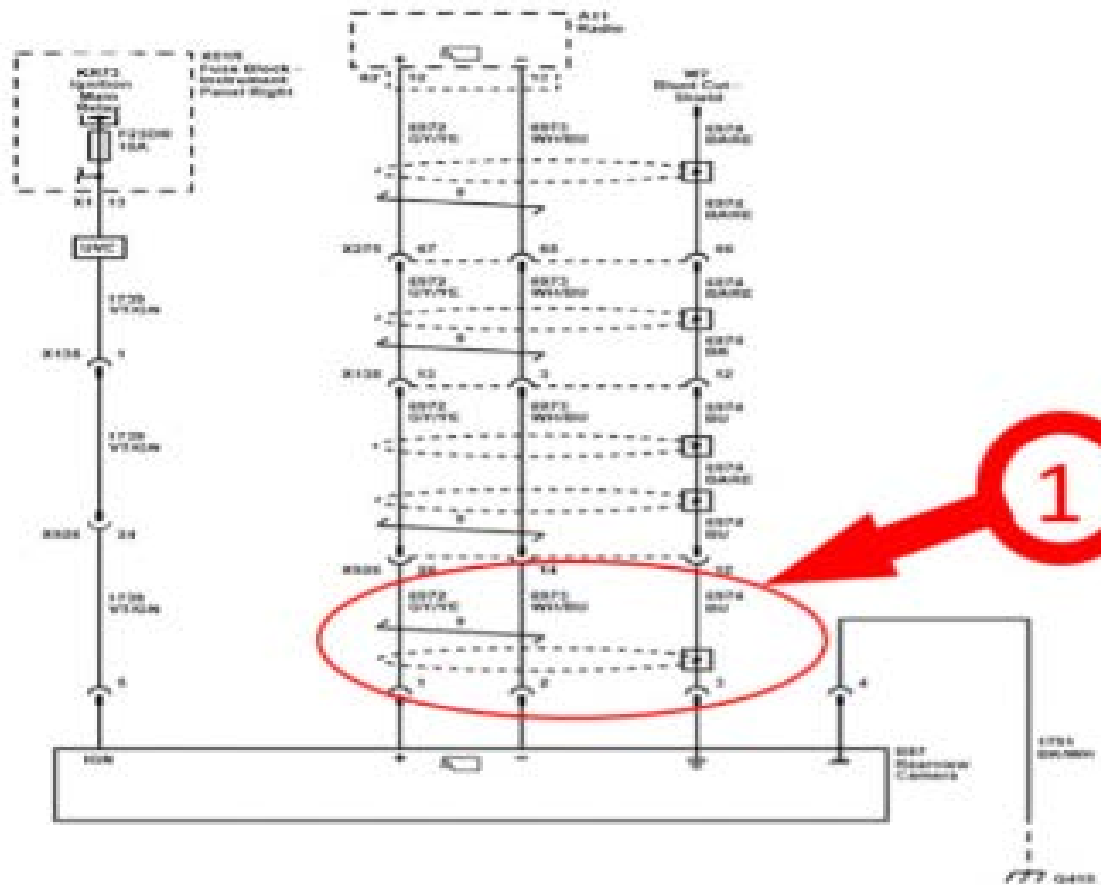
5651726

Restraining the camera image feed [+/-] from the A11 Radio to X926 harness (1).

Wrap the entire length of the new data cable (P/N 84991086) with KENT AUTOMOTIVE anti-abrasion tape (P/N 1089482) before routing the cable along the vehicle.
