Service Bulletin

Bulletin No.: 21-NA-054

Subject: Instrument Cluster Resets, Center Display Goes Blank or Gauges Inoperative, DTC U0155 Set

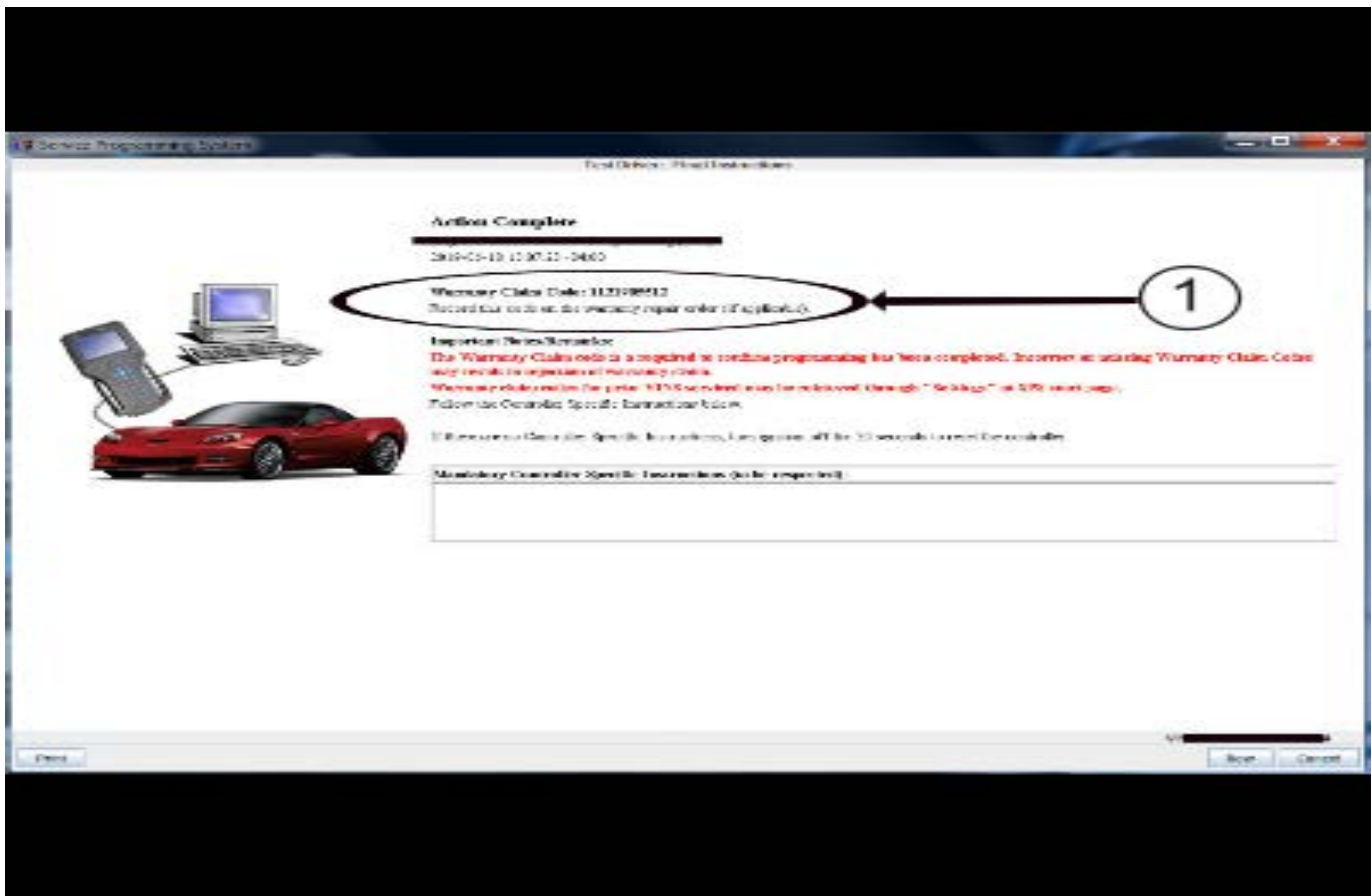
5431209

Important: To avoid warranty transaction rejections, you **MUST** record the warranty claim code provided on the SPS Warranty Claim Code (WCC) screen shown above on the job card. Refer to callout 1 above for the location of the WCC on the SPS screen.

- Record the SPS Warranty Claim Code on the job card for warranty transaction submission.
