Service Bulletin

Bulletin No.: 21-NA-169

Subject: Diagnostic Tip for DTCs Set at a Low Mileage for 9T45/50/60 Automatic Transmissions

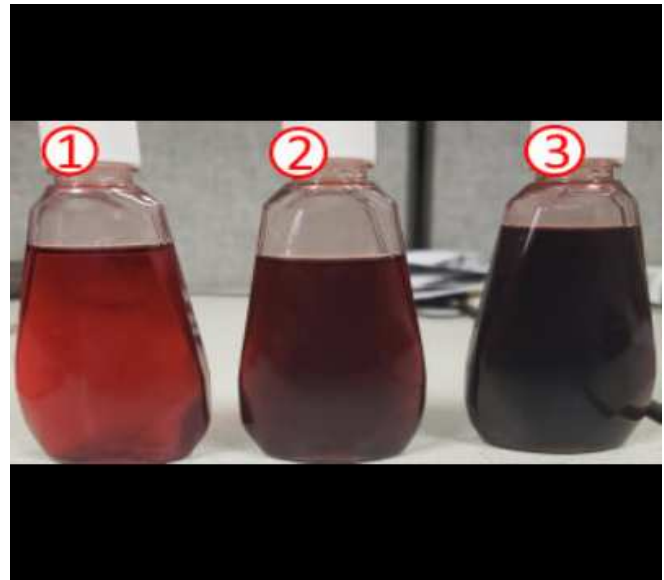
5840393

9. If fluid level is correct, then check condition of the fluid:
 - The fluid should be red or brown.
 - The fluid should be transparent so that objects or writing can be seen through it. Sample #1 is an example of acceptable fluid. Sample #2 is an example of very dark fluid. Sample #3 is an example of black fluid.

- In addition to checking the fluid color and transparency, the fluid should be checked for an odor of burnt fluid. If the fluid is very dark, black, or has a burnt odor it would indicate clutch damage has occurred internally in the transmission and it would need to be removed from the vehicle and investigated.
