Service Bulletin

Bulletin No.: 21-NA-209

Subject: Black Radio Display Screen (Triangle and Camera with the Slash Through it) with both DTCs U023C and B1A62 Setting Current in Video Processing Module (VPM)

Brand:	Model:	Model Year:		VIN:		Engine:	Transmission:
		from	to	from	to		
Cadillac	Escalade Escalade ESV	2021	2021

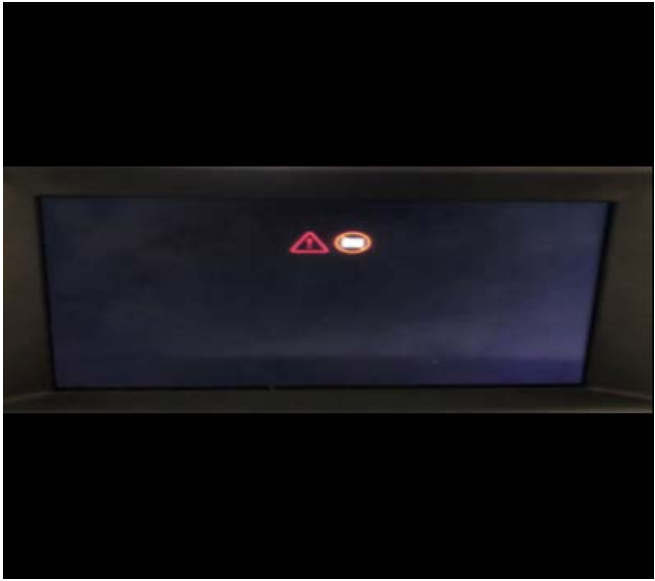
Involved Region or Country	United States, Canada, Mexico, Russia, Middle East, Japan, Cadillac Korea (South Korea)
Additional Options (RPOs)	Equipped with RPO UXP
Condition	<p>Some customers may comment on a condition present on the radio display where a black screen with a triangle and a camera with the slash through it is displayed.</p>

<p style="text-align: right;">5902524</p> <p>Technicians may find two DTCs set current or in recent history:</p> <ul style="list-style-type: none"> • DTC U023C – Loss of communication with the K157 Video Processing Module (VPM) • DTC B1A62 86
Cause	The cause of the condition may be software anomalies in the VPM.
Correction	Technicians are to pull VPM fuse F28 and leave for one minute then reinstall. After completing the fuse pull then reprogram the VPM with the latest software released.

1. Pull VPM fuse F28 and leave for one minute then reinstall.
2. Reprogram the Video Processing Module. Refer to *K157 Video Processing Module: Programming and Setup* in SI.
