Service Bulletin

Bulletin No.: 21-NA-241

Subject: Sunroof Rattle Noise

Brand:	Model:	Model Year:		Date Breakpoint:		Engine:	Transmission:
		from	to	from	to		
Chevrolet	Camaro	2021	2021	June 22, 2021	July 13, 2021	All	All

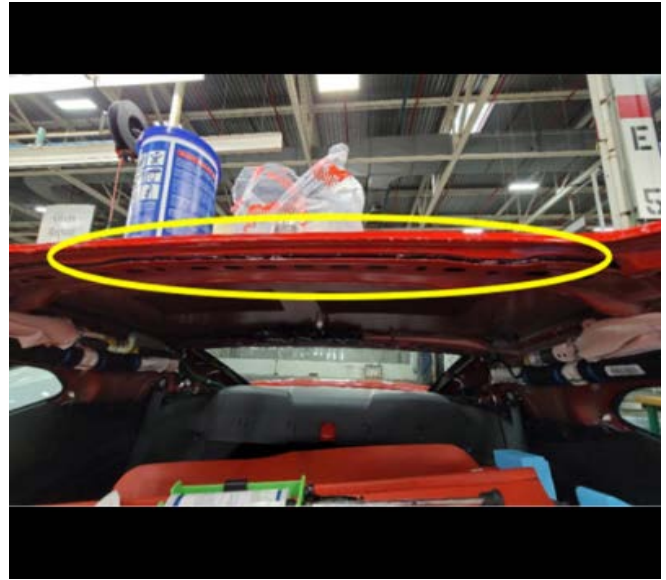
5912616

Note: The graphic above shows the Rear Roof Bow (Rear inside structural bow at rear of sunroof opening), with the adhesive installed.

6.5. Adhesive must fill the entire void.
