Service Bulletin

Bulletin No.: 21-NA-252

Subject: Electronic Park Brake Applying Intermittently After Vehicle Shutdown without DTC's

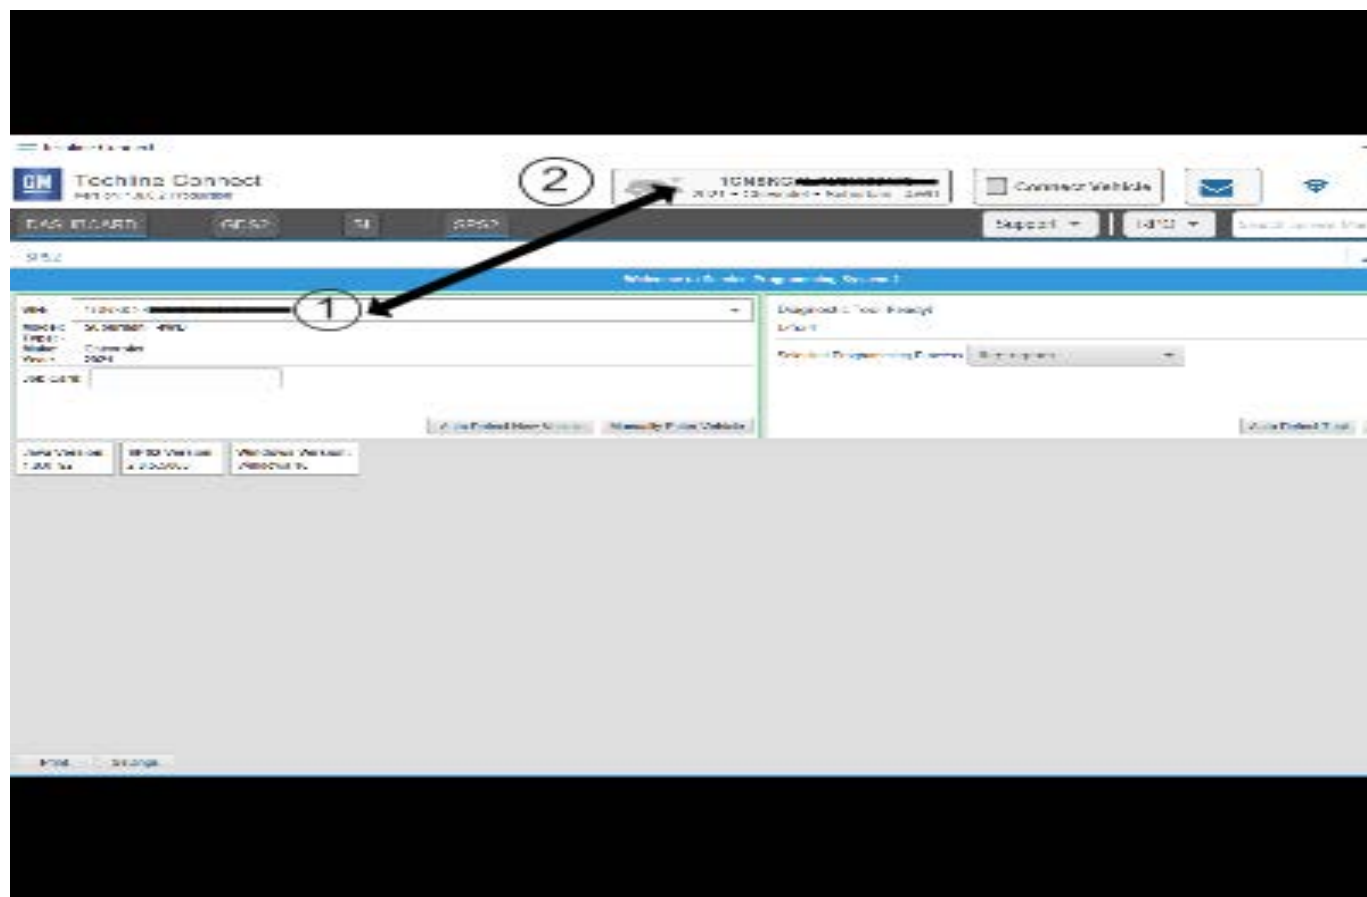
Caution: Be sure the VIN selected in the drop down menu (1) is the same as the vehicle connected (2) before beginning programming.

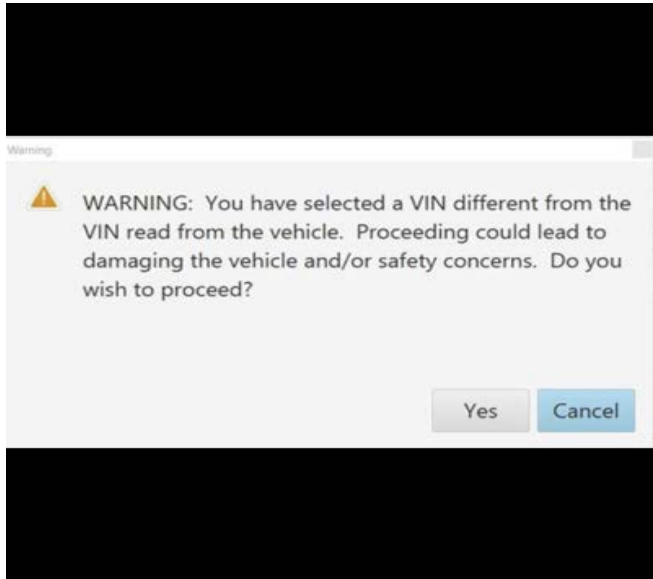
5877000

Important: If the vehicle VIN DOES NOT match, the message below will be shown
