Service Bulletin

Bulletin No.: 21-NA-274

Subject: Driveability Concerns Caused by Intake Rocker Arm Oil Control Valve, Chuggle, Surge, Misfire, Malfunction Indicator Lamp (MIL) Illuminated - DTC P0068, P0101, P0106, P0171, P0300, P219A, P16D0, P16D1, P2646 and/or P2647 Set

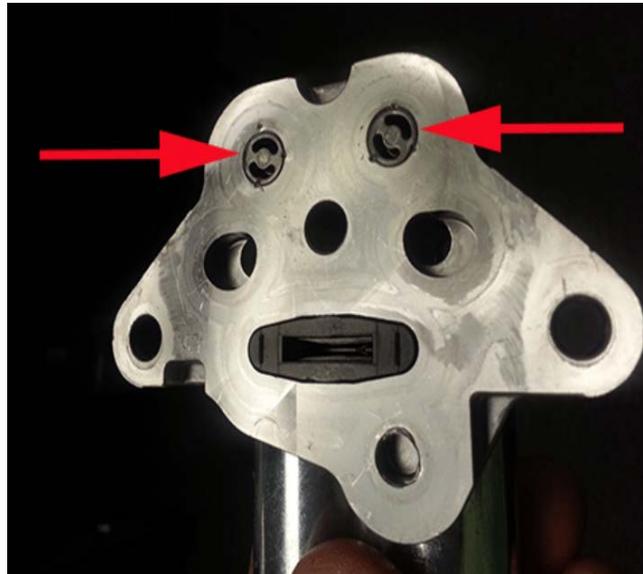
4873912

Shown above is a good valve with components still in place.

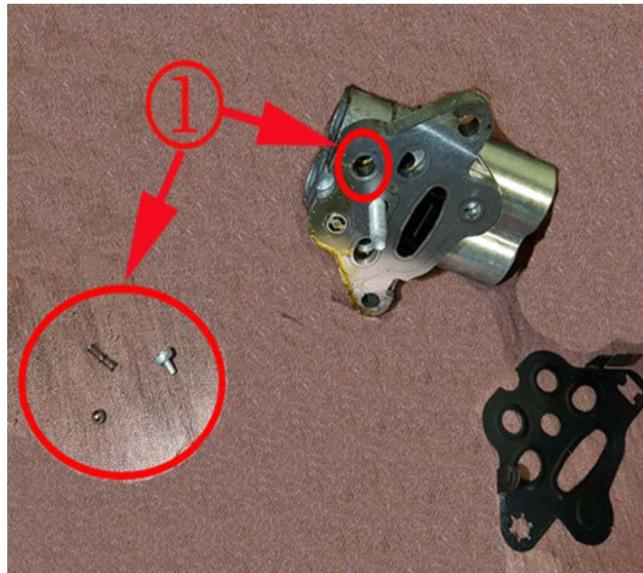
4873911

Shown above is a bad valve with components missing.

- If any of the components are missing, replace the intake rocker arm oil control valve and camshaft cover.
- ⇒ The camshaft cover must be replaced because the components become lodged in the camshaft cover oil passages and cannot be removed.
- If the intake rocker arm oil control valve is not missing any components, only replace the intake rocker arm oil control valve.
