**SERVICE BULLETIN**

**APPLICABILITY:** 2019-22MY Impreza  
 2019-22MY Crosstrek (Including Hybrid Model)  
 2019-22MY Forester  
 2019MY Legacy/ Outback  
 2019-22MY WRX  
 2019-22MY WRX STI  
 2019-22MY BRZ- Navigation -equipped ONLY  
 2019-22MY Ascent

**NUMBER:** 15-236-18R

**SUBJECT:** Reprogramming File Availability for Optimization of Harman Gen 3.1 and Gen 3.1α Audio and Navigation Head Units

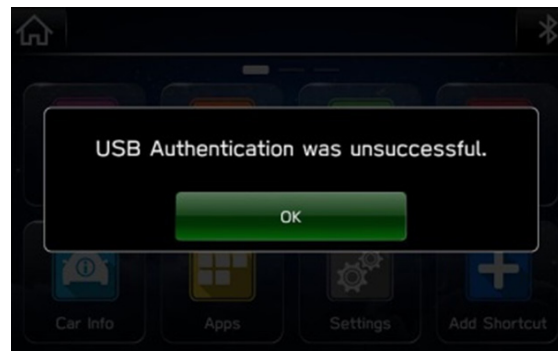
**NOTE:** If an attempt is made to install the wrong “grade” file into the wrong grade head unit (EXAMPLE: “Base” update file into a “Base Plus or Mid” or “High” head unit), the USB Authentication error screen below will be displayed:

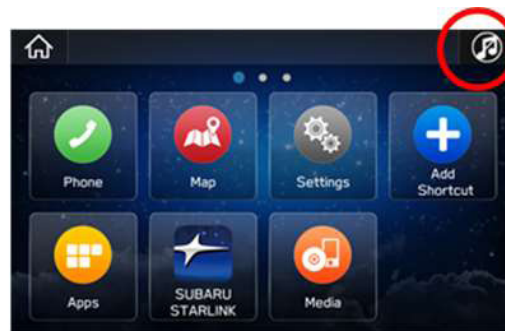
**Music playing via iPhone in CarPlay.**

**After disconnecting, no music source is selected automatically.**

If a source of music other than CarPlay has been playing when the iPhone is disconnected, the music source remains same (it is not turned off.)

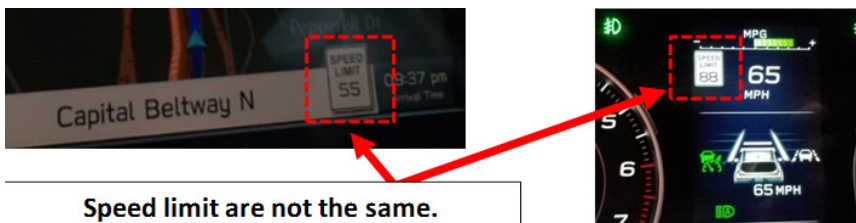
- 11) Spanish version FOTA (Firmware Over The Air) translation corrected.
- 12) Mismatch of Speed Limit between Navigation display and the Speed Limit displayed in the Combination Meter Multi-Function Display (MFD).
