SERVICE BULLETIN

APPLICABILITY: 2020-22MY Legacy and Outback
 2019-22MY Impreza
 2019-22MY Crosstrek / Crosstrek Hybrid
 2019-22MY Forester
 2019-22MY Ascent
 All Models as Listed with Gen 2 Telematics

NUMBER: 15-251-19R

SUBJECT: DTC B2A16

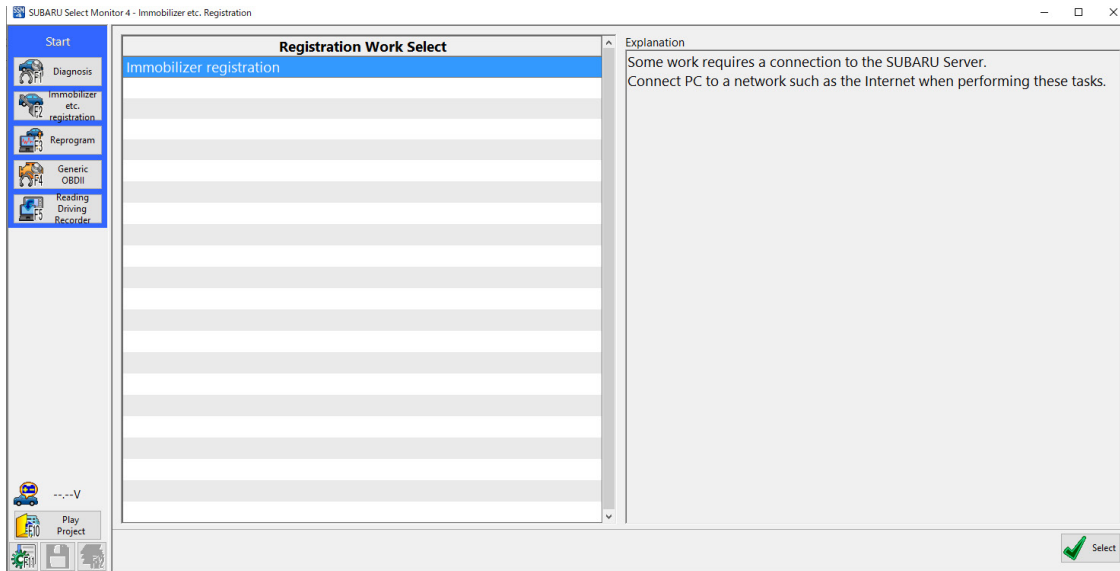
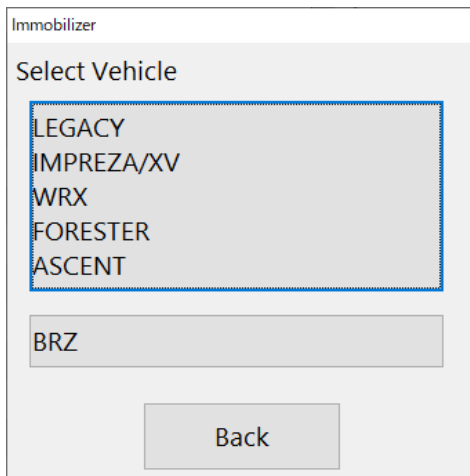
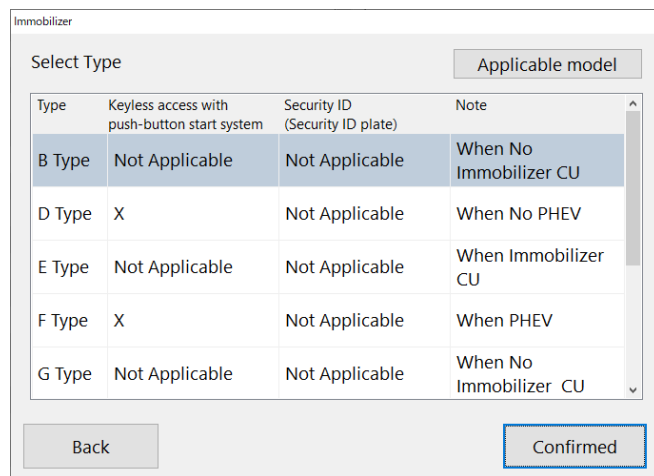
NOTE: When selecting G, H, or I Type, the latest SSM4 software (July 2019 version or later) is required along with a secure network connection. Refer to TSB **15-246-19** for additional details.

If DTC B2A16 is found in the DCM, start by registering the DCM with the vehicle immobilizer system to avoid a potentially unnecessary DCM replacement. Follow the instructions found in the applicable Immobilizer Registration Manual. See the basic SSM screenshots and additional information provided below for reference.
