Preliminary Information

PIT5648C Trailer Disconnected Check Connection Message on DIC Without a Trailer Connected (Reprogram the Trailer Lighting Control Module K68)

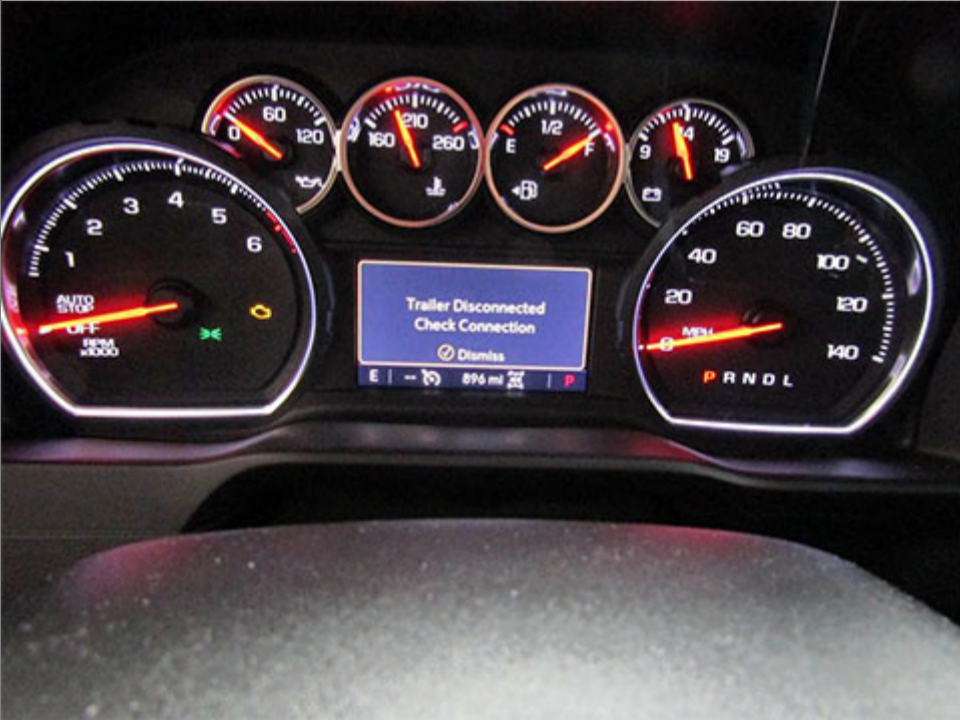
Involved Region or Country	North America
Additional Options (RPO)	With U1D - Advanced Trailering System
Condition	<p>Some customers may comment on a "Trailer Disconnected Check Connection" message being displayed on the DIC without a trailer connected, message shown below. In addition to this message, there may also be the following messages depending on the vehicle content:</p> <ul style="list-style-type: none"> - Rear Park Assist Off - Lane Change Alert System Off - Rear Cross Traffic Alert Off <p>This condition is more likely to occur with colder ambient temperatures.</p>

Cause	This concern could be caused by the Trailer Lighting Control Module software.

To correct this concern, reprogram the Trailer Lighting Control Module (K68) with the latest software available in Tis2Web, per Service Update

[N192213550](#) – Trailer Integration Module Software Error.
