TECHNICAL SERVICE BULLETIN

Illuminated ABS Indicator, Engine Will Not Turn Off And/Or Various Electrical Symptoms - BJB Cover Not Fully Seated

22-2004

Ford 2020-2022 F-Super Duty

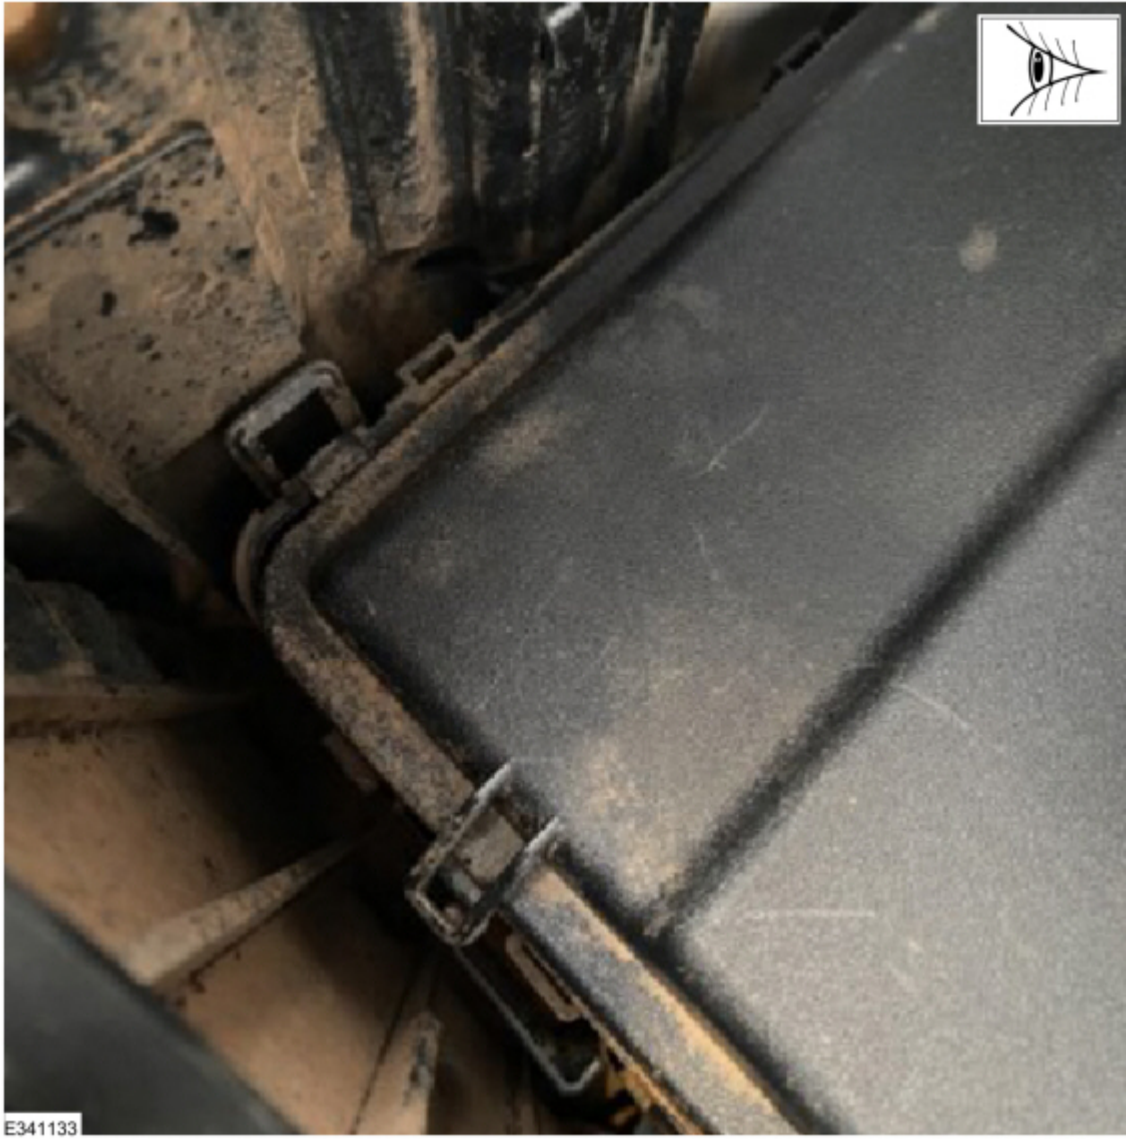
1. Visually inspect the BJB for signs of water/moisture intrusion. Are there signs of water/moisture intrusion into the BJB and/or broken cover tabs/locking fingers?

Figure 1 - Example of moisture intrusion with BJB cover on

2. Replace the BJB assembly.

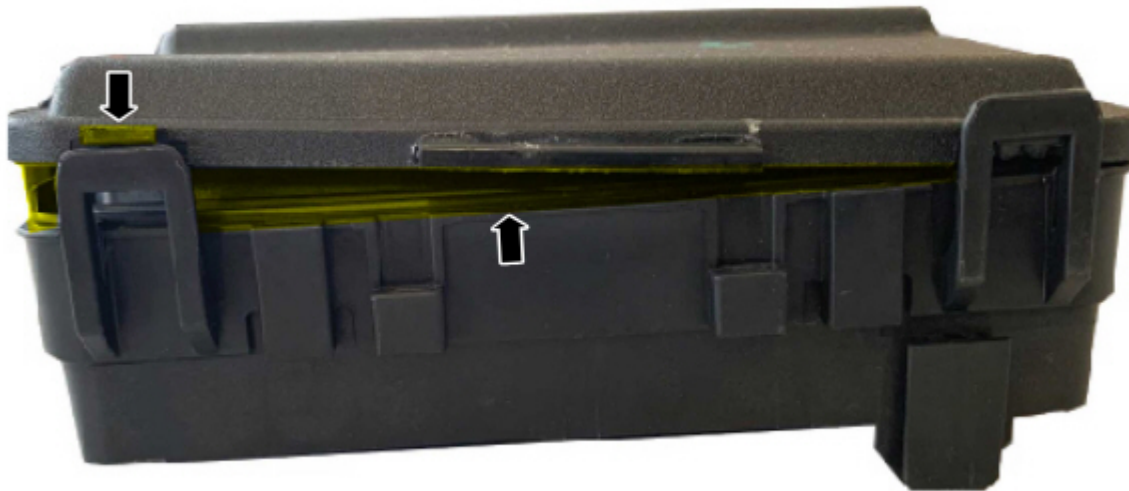
E341137

Figure 5 - Incorrect cover installation

- (9). Install the new BJB cover making sure the cover tabs/locking fingers are installed correctly.
- (10). Install the battery tray and battery back into the vehicle. Refer to WSM, Section 414-01.

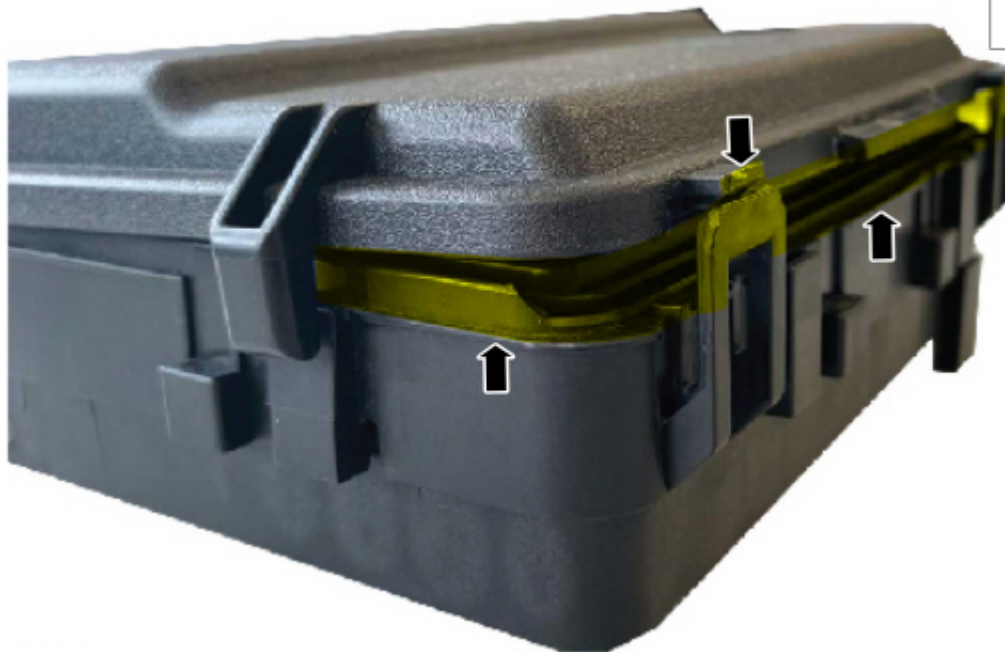
E341138

Figure 6 - Incorrect cover installation
