## TECHNICAL SERVICE BULLETIN

### 3.5L PowerBoost - Reduced Engine Power, Illuminated MIL With DTCs P0299, P0301, P0302 And/Or P0303 - Built On Or Before 30-Sep-2021

22-2017

<b>Ford</b> 2021 F-150	Engine: 3.5L PowerBoost Built on or before 30-Sep-2021
---------------------------	---

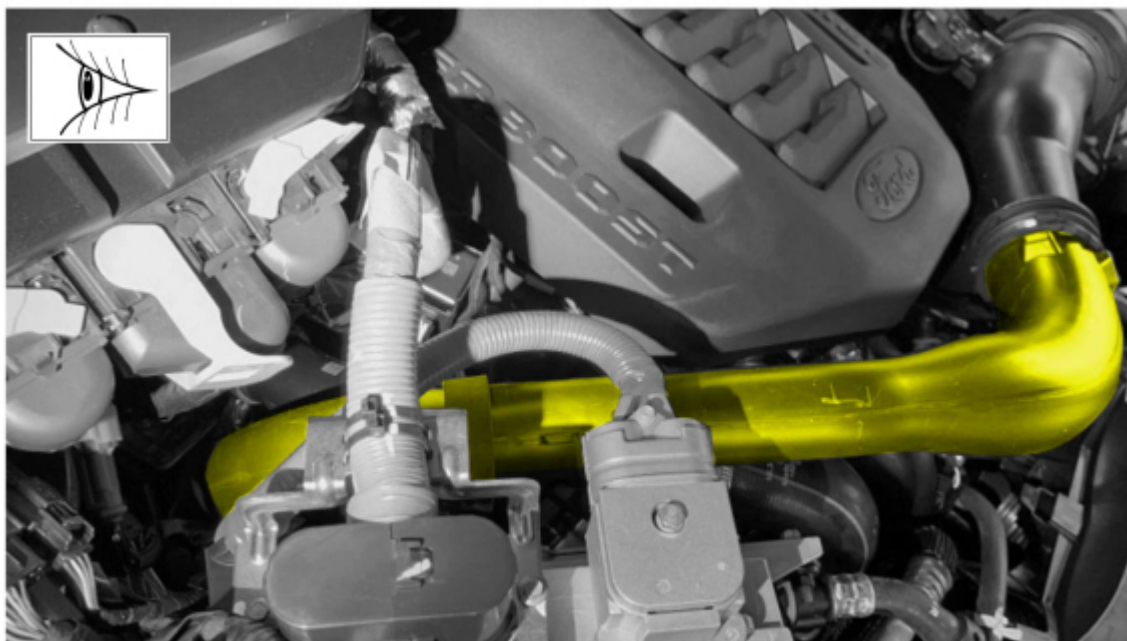
Figure 1

1. Inspect the right air cleaner outlet pipe (Figures 1-2) for a seam line in the section where the duct begins to route downwards towards the turbocharger (Figure 3). Does the right air cleaner outlet pipe exhibit a seam line?

- (1). Yes - remove the right air cleaner outlet pipe. Refer to Workshop Manual (WSM), Section 303-12D > Intake Air Distribution and Filtering > Removal and Installation. Proceed to Step 2.
  - (2). No - this article does not apply. Refer to WSM, Section 303-04I.
2. Inspect the right turbocharger for damage and/or oil leaking from the compressor wheel. Refer to the WSM, Section 303-04I > pinpoint test Step C6. Does the turbocharger exhibit damage in the turbine shaft or in the
