TECHNICAL SERVICE BULLETIN

Wind/Whistle Noise From Front A-Pillar Applique

22-2021
31 January 2022

Ford 2020-2022 Explorer
Lincoln 2020-2022 Aviator

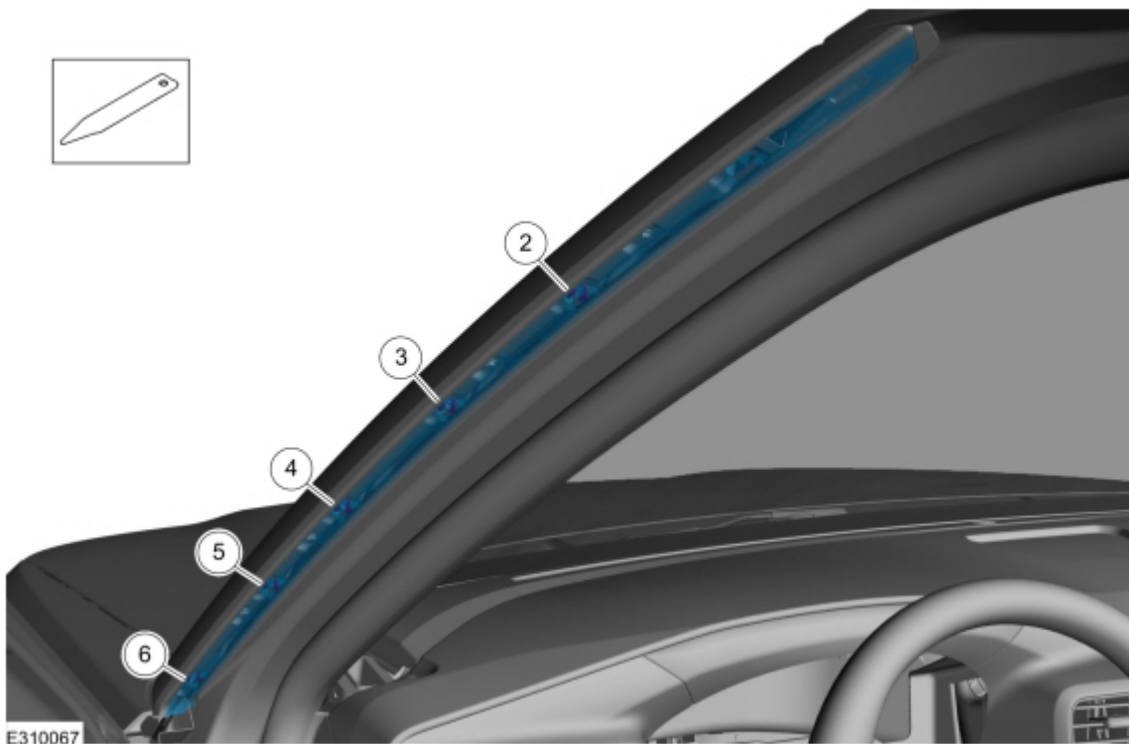
Figure 2

Issue: Some 2020-2022 Explorer/Aviator vehicles may exhibit a wind/whistle type noise at highway speeds originating from the front A-pillar applique (either side or both). This may be due to a small gap between the outboard side of the A-pillar applique and the moulding. To correct the condition, follow the Service Procedure to install thin strips of flock tape on the A-pillar applique.

2. Using Flock Tape or equivalent from the Rotunda Squeak and Rattle Kit, cut a strip 10 mm (3/8 in.) wide by 100 mm (4 in.) long and apply it to the outboard edge of the moulding between callouts 2 and 4 of Figure 2.
