# TECHNICAL SERVICE BULLETIN

## Uneven Steering Effort

**22-2022**  
01 February 2022

Ford 2015-2019 Transit
---------------------------

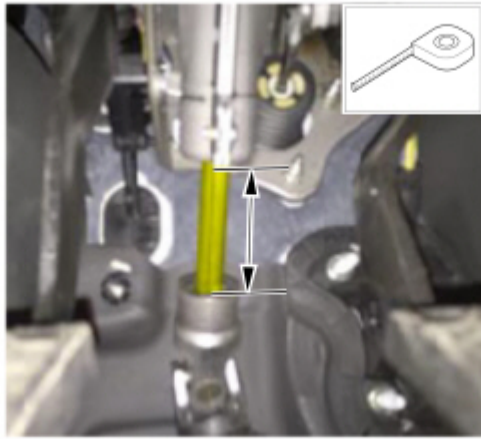
Figure 2

**Issue:** Some 2015-2019 Transit vehicles may exhibit uneven steering effort. This may be due to the steering column slider length. To correct the condition, follow the Service Procedure to adjust the steering column slider length.

3. Measure the steering column slider length. (Figure 2)

4. Is the steering column slider length 73 mm +/- 1 mm?

- (1). Yes - this article does not apply. Refer to WSM, Section 211-05 for normal diagnostics.
- (2). No - proceed to Step 5.
