## TECHNICAL SERVICE BULLETIN

### Illuminated ABS Indicator, Engine Will Not Turn Off, Will Not Shift Out Of Park And/Or Various Electrical Symptoms

**22-2044**

<b>Ford</b> 2020-2022 Super Duty
-------------------------------------

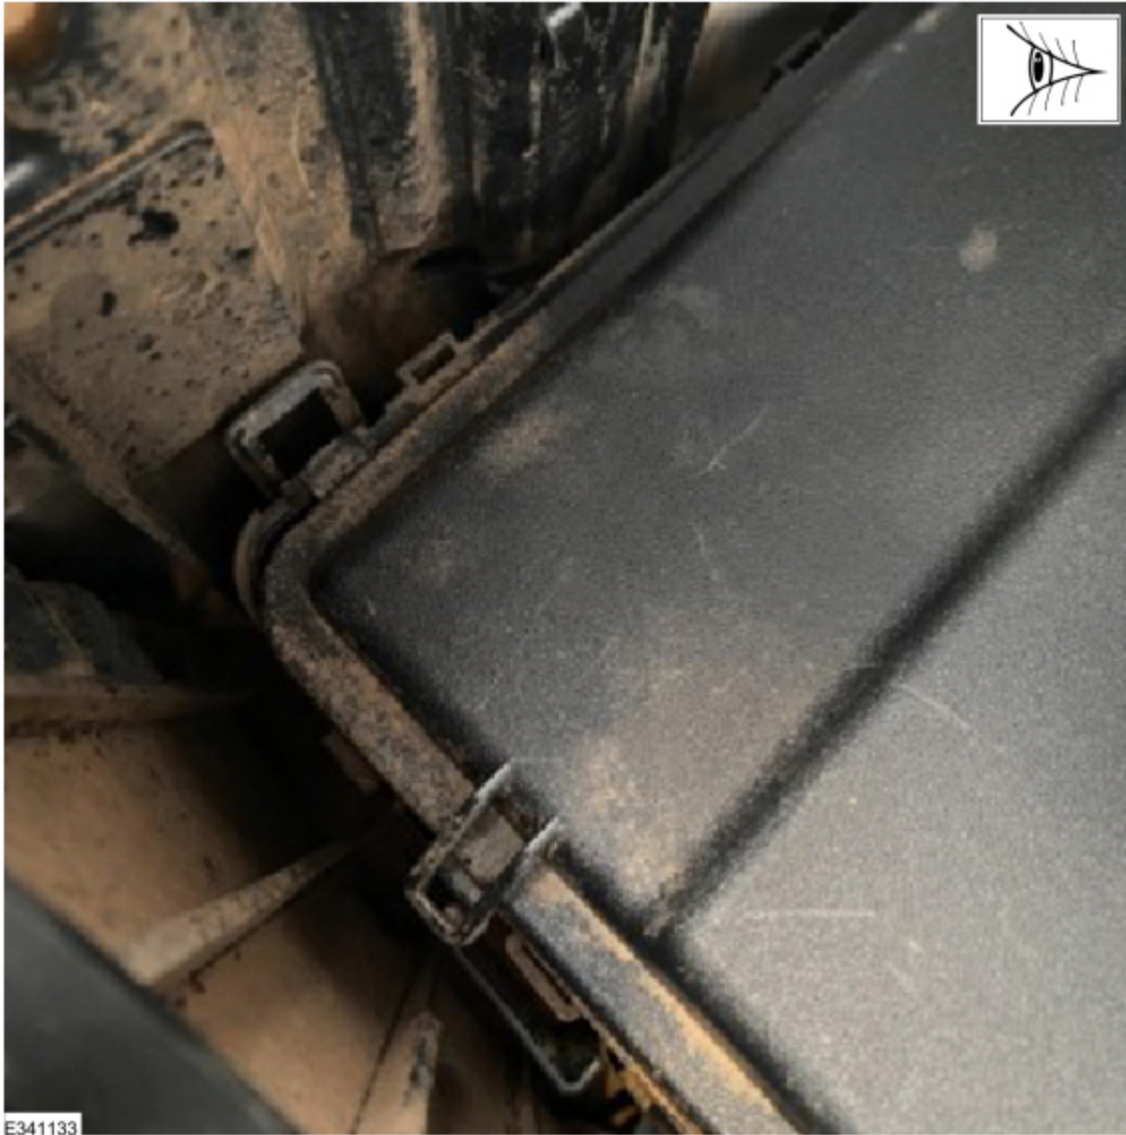
Figure 1 - Example of moisture intrusion with BJB cover on

- (1). Remove the battery and battery tray. Refer to the Workshop Manual, Section 414-01.
- (2). Remove the BJB cover.
- (3). Loosen the two BJB connector bolts and remove the battery power cable nut. Disconnect the battery power cable from the BJB.

- (4). Release the BJB from the two locking tabs on each side of the BJB.
- (5). Lift the BJB to allow access to both BJB connectors. Disconnect both connectors and remove the BJB.

- (6). Remove the cover from the new BJB and connect both connectors to the new BJB.
- (7). Install the new BJB into both locking tabs.
- (8). Attach the battery power cable and tighten the battery power cable nut to 10.5 Nm (93 lb-in). Tighten the connector bolts to 5.4 Nm (48 lb-in).

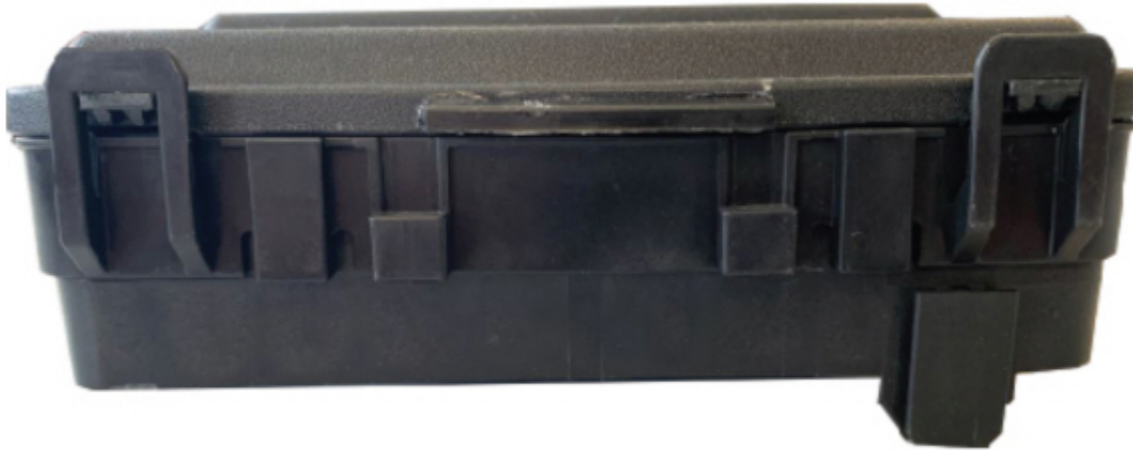
E341135

Figure 3 - Correct cover installation

- (9). Install the new BJB cover making sure the cover tabs/locking fingers are installed correctly.
- (10). Install the battery tray and battery back into the vehicle. Refer to WSM, Section 414-01.
