# TECHNICAL SERVICE BULLETIN

## Soft Top Roof - Loose Exterior Fabric On Rear Window

**22-2055**  
21 February 2022

<b>Ford</b> 2021-2022 Bronco	Soft top roof
---------------------------------	---------------

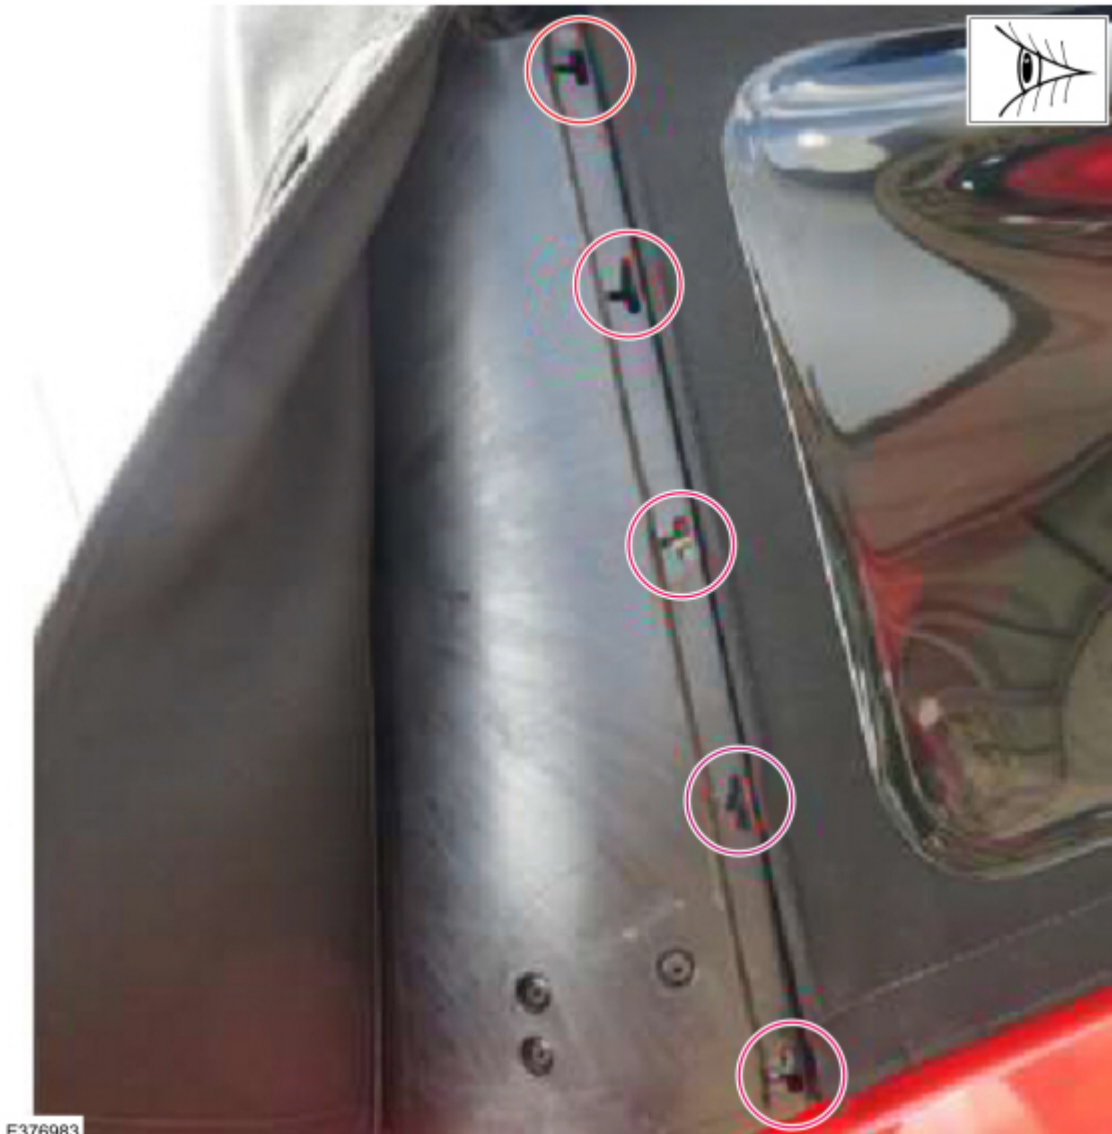
Figure 1 - Right D-pillar shown, left side similar

1. Visually inspect the 5 clips that run vertically along each D-pillar on the rear window (Figure 1)

2. Are any of these clips broken causing the rear window fabric to become loose?

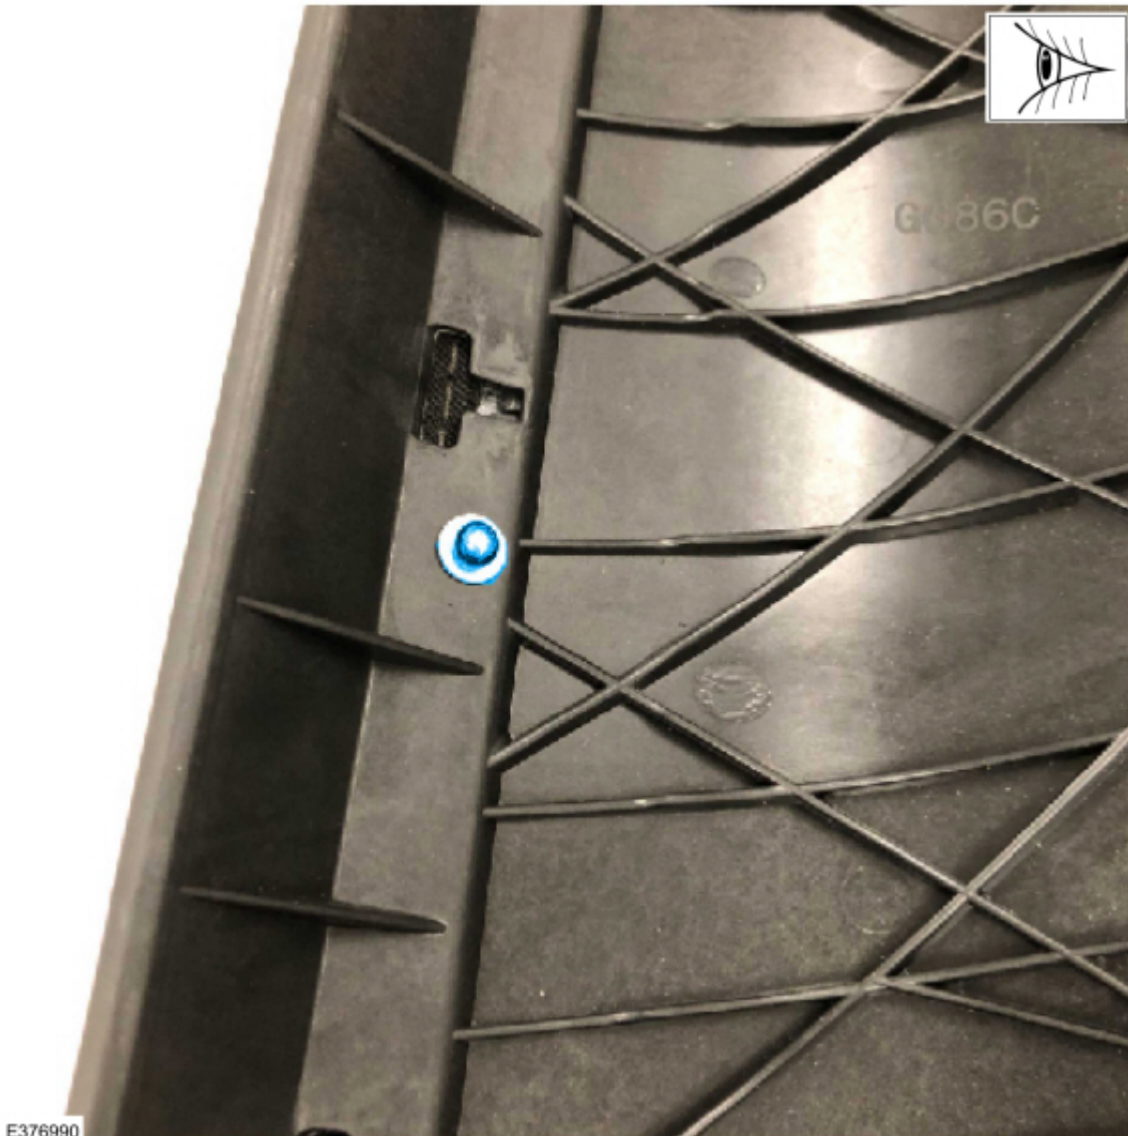
Figure 8

**NOTE:** The 5 mm gap between the D-pillar and the rear window plastic strip is critical. If this gap is too large or small, the rear window to rear quarter window fitment and appearance will be jeopardized.

**12.** Install all 5 rivets, one at a time, using one 5 mm flat washer as support around the back of each rivet. During this process, maintain the 5 mm gap as mentioned in Step 10. (Figure 8)
